Bi weekly Field Report

Surveyor Date visited Time visited Zaw La 4 Jan 2019 15:00 pm

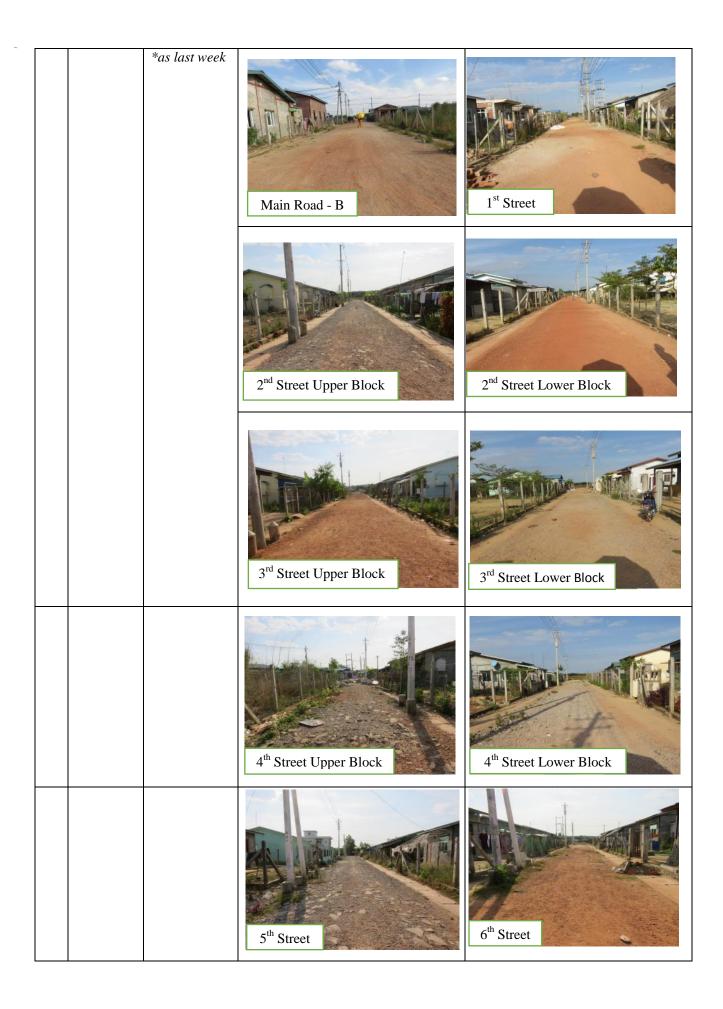
No	Item	Condition	Narrative Description and Photos	
1	(1.2) Well	Improved□ Same ■* Worse □ *as last week	living. There are eleven tube well the water basically from the pip frequency of water usage from the	lean enough to use for drinking and ls in the relocation site. Residents use beline distribution system so that the he tube wells is very low. To sustain wells, the leg pumps were kept and aps till the residents use.
			Open Well No. 1	Open Well No. 2
	(2) Drainage	Improved□ Same •* Worse □ *as last week	The drain at the corner of Main Road A and B The exit of the drain at the corner of Site village road and 3 rd street	The exit of the drain at the corner of Site village road and 2 nd street The exit of the drain at the corner of Site village road and Amain Road C
	(3) Road	Improved□ Same •*	All the roads are getting dry are	nd no problem for walking.
		Worse □	Photos

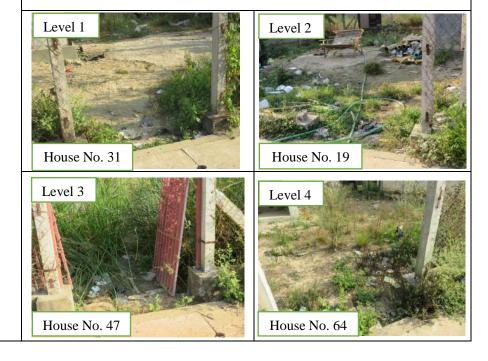
No. of HHs	
Condition	This week	Previous week
	condition	condition
Level 1	85	85
Level 2	6	5
Level 3	0	0
Level 4	0	1
