Bi weekly Field Report

No. 103

Surveyor Zaw La
 Date visited 25 Jun 2020
 Time visited 11:00 am

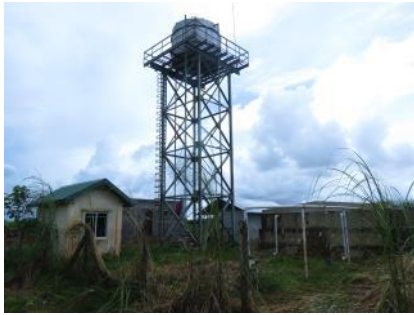
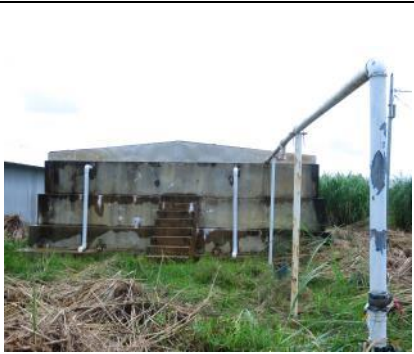
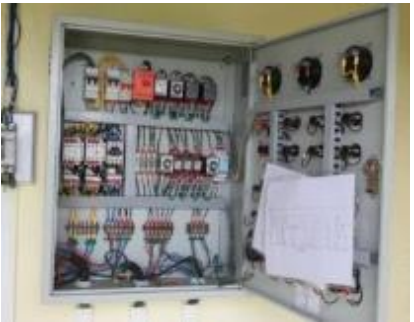
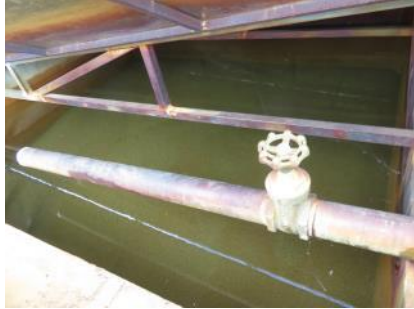
No	Item	Condition	Narrative Description and Photos
1	(1.1) Water Supply System	Improved <input type="checkbox"/> Same <input checked="" type="checkbox"/> * Worse <input type="checkbox"/> *as last week	<p><u>Narrative Description</u></p> <p>Water distribution system has been supporting ninety household of the zone B resettled families. The new well was drilled and installed the pipe line and its necessary instruments because the underground water of the previous well includes iron hydroxide and yellowish mud that clogged in the iron removal tank. The current water condition is quite good and no iron hydroxide and yellowish mud are found.</p> <p><u>Photos</u></p> <div style="display: flex; flex-wrap: wrap;"> <div style="width: 50%; text-align: center;">

<p>Water from ground water tank</p> </div> <div style="width: 50%; text-align: center;">

<p>Pipe line distribution water to houses</p> </div> <div style="width: 50%; text-align: center;">

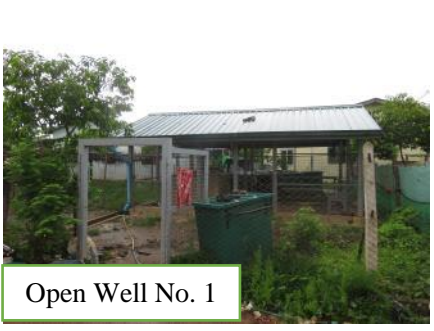
<p>Open Well No. 1</p> </div> <div style="text-align: center;">

No	Item	Condition	Narrative Description and Photos
1	(1.2) Well	Improved <input type="checkbox"/> Same <input checked="" type="checkbox"/> * Worse <input type="checkbox"/> <i>*as last week</i>	<p>– Water from two open-wells is clean enough to use for drinking and living. There are eleven tube wells in the relocation site. Residents use the water basically from the pipeline distribution system so that the frequency of water usage from the tube wells is very low. To sustain the good condition of the tube wells, the leg pumps were kept and covered the PVC pipes with the caps till the residents use.</p>
			<div style="display: flex; justify-content: space-around;"> <div style="text-align: center;">

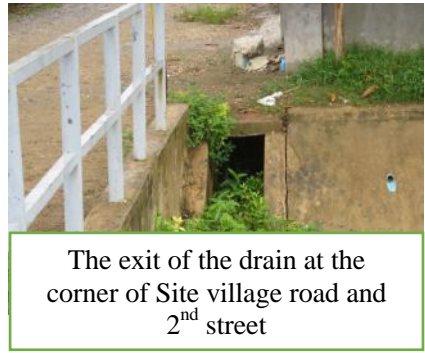
(2) Drainage	Improved <input type="checkbox"/> Same <input checked="" type="checkbox"/> * Worse <input type="checkbox"/> <i>*as last week</i>	<p>– There is no water in the drainage canals at the moment.</p> <p>Photos</p> <div style="display: grid; grid-template-columns: 1fr 1fr; gap: 5px;"> <div style="text-align: center;">

<p>The drain at the corner of Main Road A and B</p> </div> <div style="text-align: center;">

<p>The exit of the drain at the corner of Site village road and 2nd street</p> </div> <div style="text-align: center;">

<p>The exit of the drain at the corner of Site village road and 3rd street</p> </div> <div style="text-align: center;">

<p>The exit of the drain at the corner of Site village road and Main Road C</p> </div> </div>

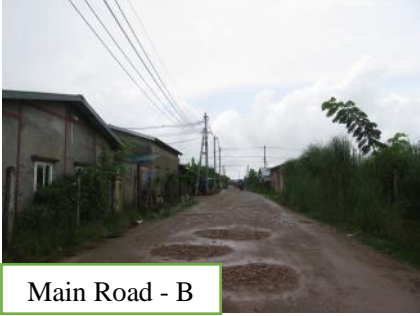
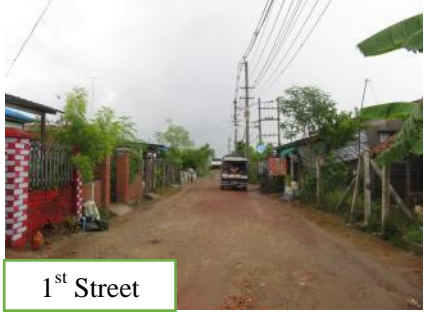
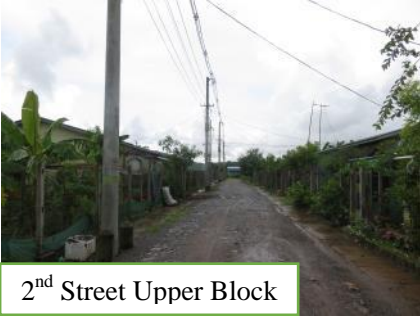
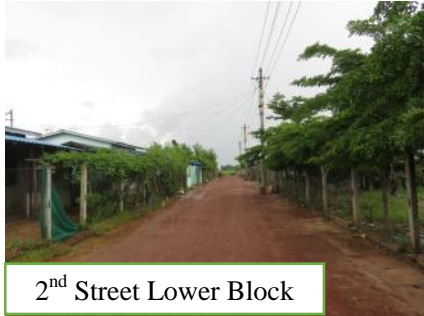
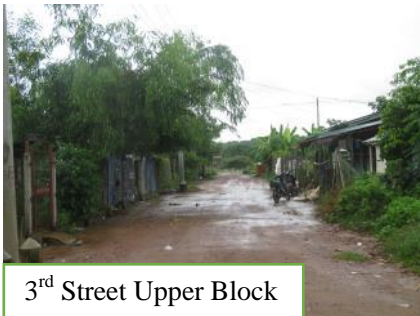
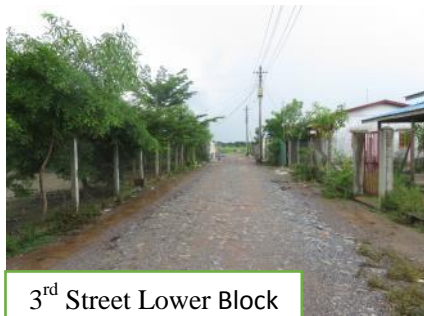
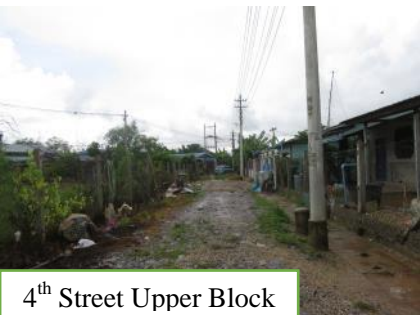
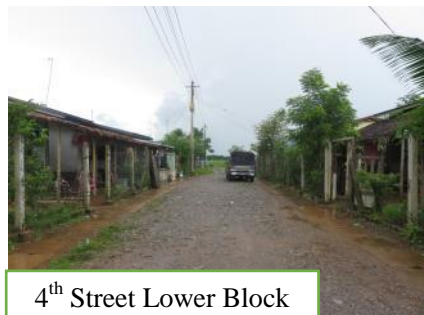
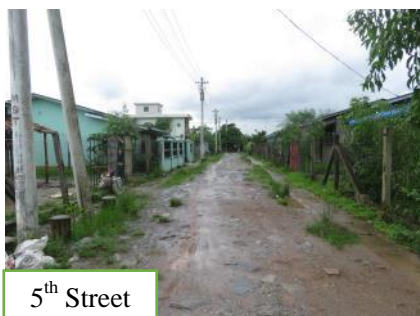
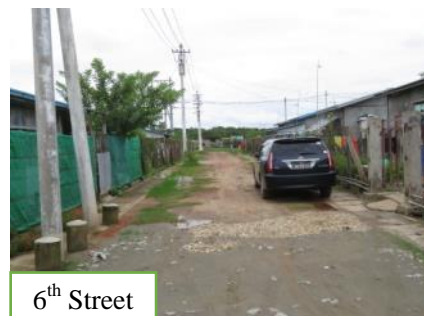
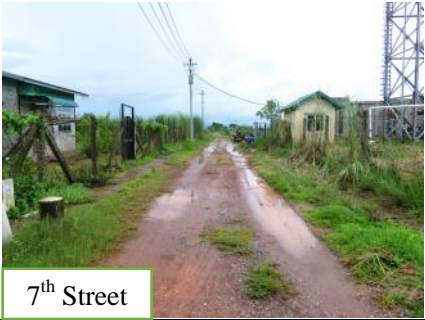
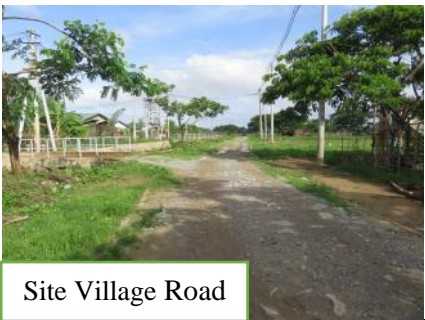
(3) Road	Improved <input type="checkbox"/> Same <input checked="" type="checkbox"/> * Worse <input type="checkbox"/> <i>*as last week</i>	<p>– Some roads are found with small ponds due to the rain in these days but no problem for walking.</p> <p>Photos</p>

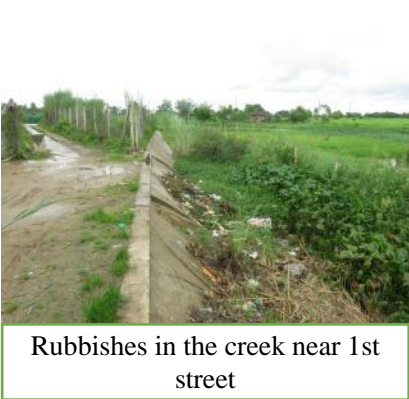
<p>Site Village Road</p>
(4) Garbage Condition	Improved <input type="checkbox"/> Same <input checked="" type="checkbox"/> * Worse <input type="checkbox"/> <i>*as last week</i>	<ul style="list-style-type: none"> - The rubbish was dumped at the creek side and even in front of the houses before the enough garbage bins are provided. - Total fourteen garbage bins have been provided and placed at the corner of each road until the end of April. After April 2018, all the garbage bins are kept by the community leader of PAPs in the communal compound of well number one of main road B. But starting from October, the garbage truck from township municipal office came and collected by giving its alarm along the Main Road B. <p>Photos</p>

<p>Rubbishes in the creek near 1st street</p>

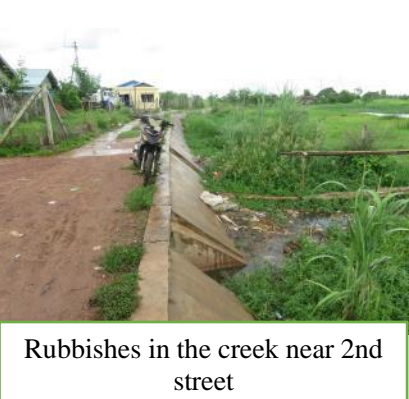
<p>Rubbishes in the creek near 2nd street</p>

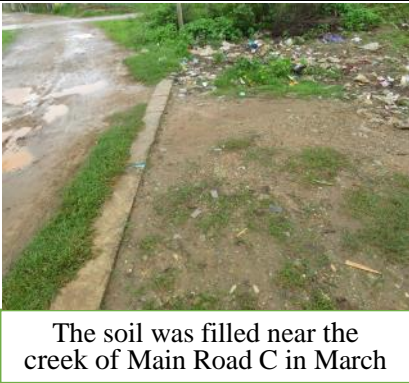
<p>The soil was filled near the creek of Main Road C in March</p>

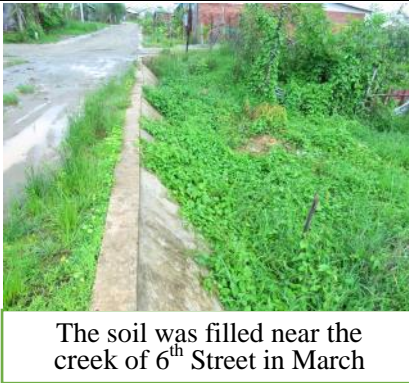
<p>The soil was filled near the creek of 6th Street in March</p>

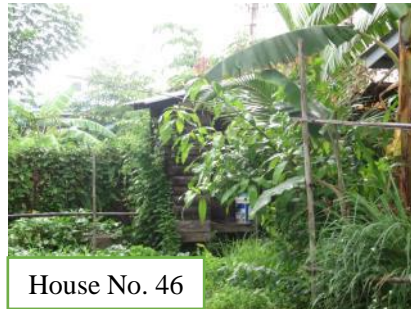
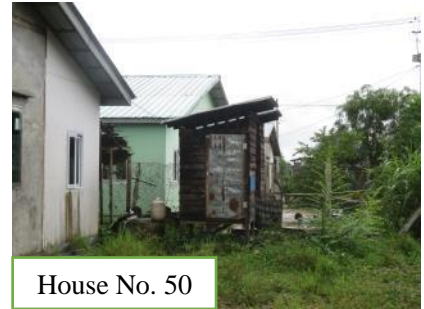
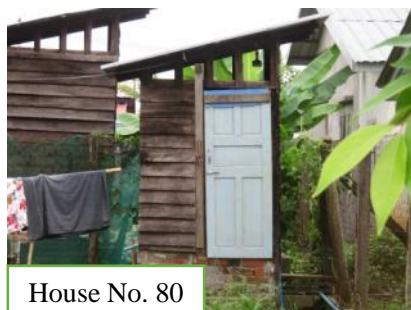
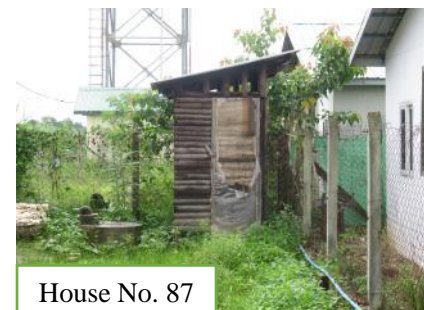
- All of the fly proof toilets are used by the residents.
- All of the toilets are repaired by the following procedures;
 - Installation the extra septic tanks beside the original
 - The pipe line system is installed from the extra tank to the ditch to flow the liquid out.

The toilet renovation plan was successfully done and there is no problem at the moment.

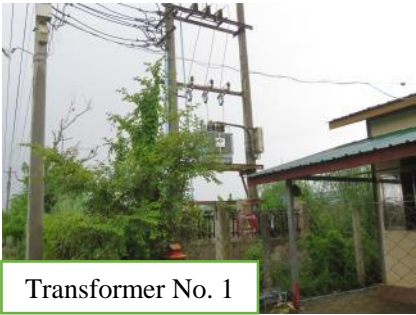
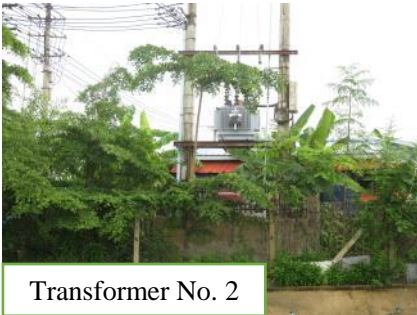
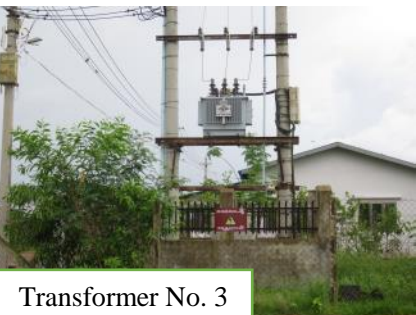
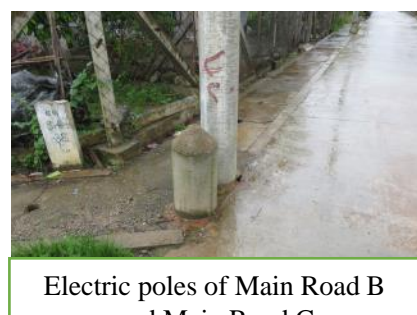
(6) Electricity	Improved <input type="checkbox"/> Same <input checked="" type="checkbox"/> * Worse <input type="checkbox"/> <i>*as last week</i>	<ul style="list-style-type: none"> - Residents get the electricity regularly. - Electric poles and transformer are being supported with the good foundations. <p>Photos</p> <div style="display: flex; flex-wrap: wrap;"> <div style="width: 50%; text-align: center;">

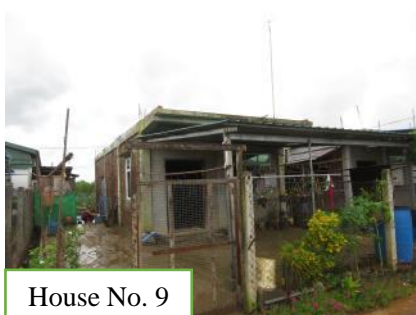
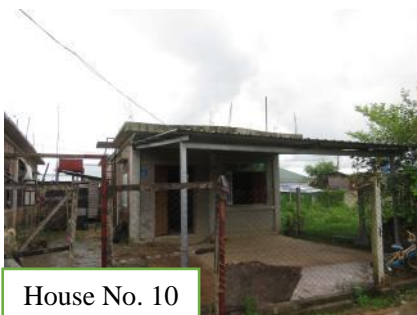
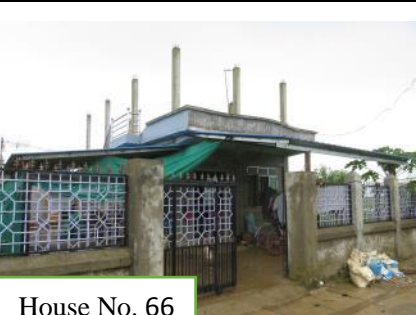
No	Item	Condition	Description and Photos
2	(1)House Construction	No. of houses which are not completed (4)	<ul style="list-style-type: none"> - In plot No.9 and 10, three houses that are planned to build as the plots are owned by father and son. The second floors of these three houses are needed to be carried on. - Plot No. 66, the house construction for the first floor has been finished and the second floor is still needed to be carried on. <p>Photos</p> <div style="display: flex; flex-wrap: wrap;"> <div style="width: 50%; text-align: center;">
