Surveyor Zaw La  
 Date visited 29 Jul 2020  
 Time visited 15:00 pm

No	Item	Condition	Narrative Description and Photos
1	(1.1) Water Supply System	Improved <input type="checkbox"/> Same <input checked="" type="checkbox"/> * Worse <input type="checkbox"/> *as last week	<p><b><u>Narrative Description</u></b></p> <p>Water distribution system has been supporting ninety household of the zone B resettled families. The new well was drilled and installed the pipe line and its necessary instruments because the underground water of the previous well includes iron hydroxide and yellowish mud that clogged in the iron removal tank. The current water condition is quite good and no iron hydroxide and yellowish mud are found.</p> <p><b><u>Photos</u></b></p> <div style="display: flex; flex-wrap: wrap;"> <div style="width: 50%; text-align: center;">

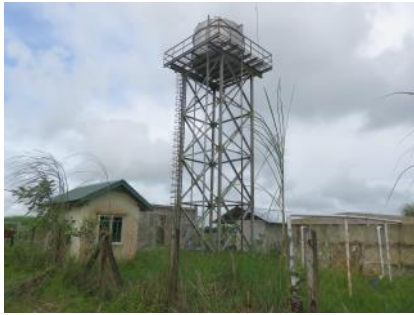
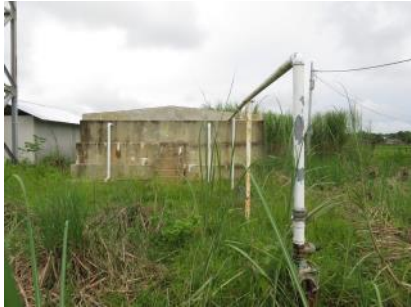
<p>Water from ground water tank</p> </div> <div style="width: 50%; text-align: center;">

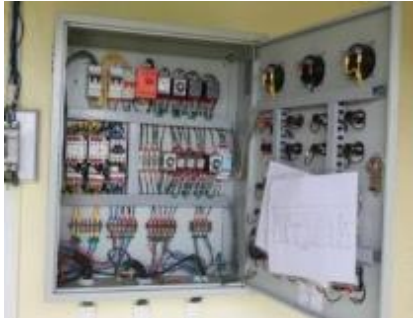
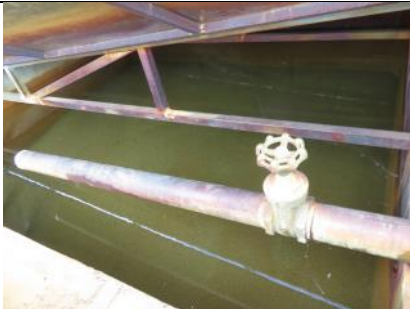
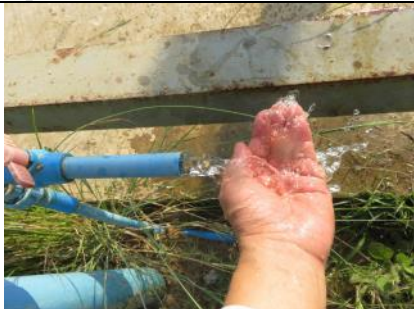
<p>Pipe line distribution water to houses</p> </div> <div style="width: 50%; text-align: center;">

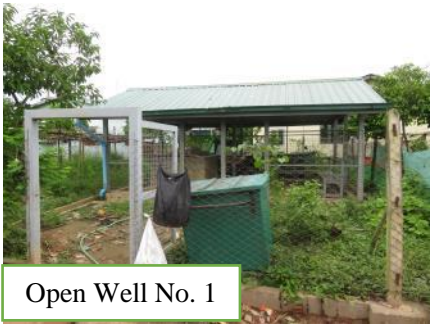
<p>Open Well No. 1</p> </div> <div style="text-align: center;">

No	Item	Condition	Narrative Description and Photos
1	(1.2) Well	Improved <input type="checkbox"/> Same <input checked="" type="checkbox"/> * Worse <input type="checkbox"/> <i>*as last week</i>	<p>– Water from two open-wells is clean enough to use for drinking and living. There are eleven tube wells in the relocation site. Residents use the water basically from the pipeline distribution system so that the frequency of water usage from the tube wells is very low. To sustain the good condition of the tube wells, the leg pumps were kept and covered the PVC pipes with the caps till the residents use.</p>
			<div style="display: flex; justify-content: space-around;"> <div style="text-align: center;">

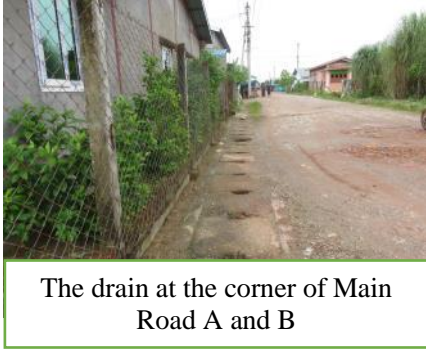
(2) Drainage	Improved <input type="checkbox"/> Same <input checked="" type="checkbox"/> * Worse <input type="checkbox"/> <i>*as last week</i>	<p>– There is no water in the drainage canals at the moment.</p> <p><b>Photos</b></p> <div style="display: grid; grid-template-columns: 1fr 1fr; gap: 5px;"> <div style="text-align: center;">

<p>The drain at the corner of Main Road A and B</p> </div> <div style="text-align: center;">

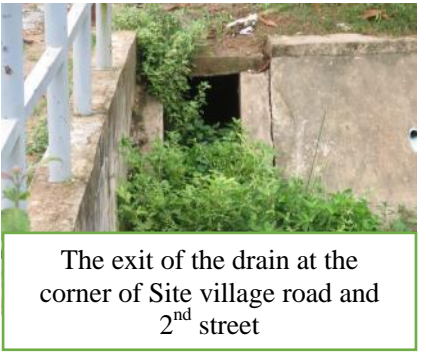
<p>The exit of the drain at the corner of Site village road and 2<sup>nd</sup> street</p> </div> <div style="text-align: center;">

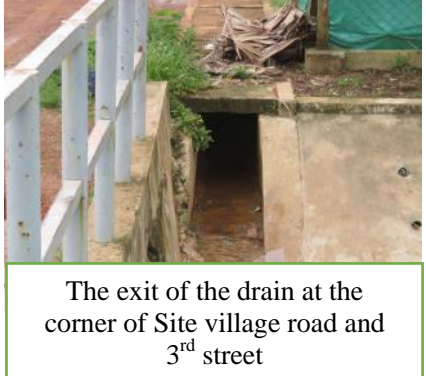
<p>The exit of the drain at the corner of Site village road and 3<sup>rd</sup> street</p> </div> <div style="text-align: center;">

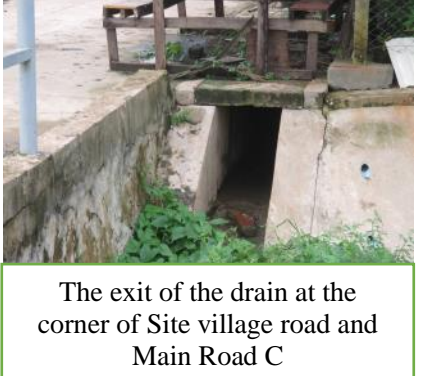
<p>The exit of the drain at the corner of Site village road and Main Road C</p> </div> </div>

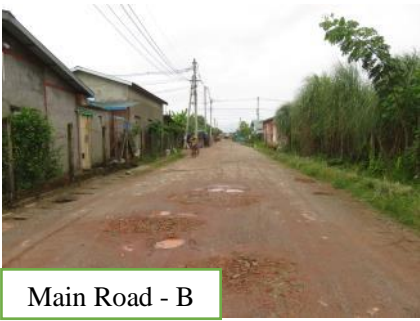
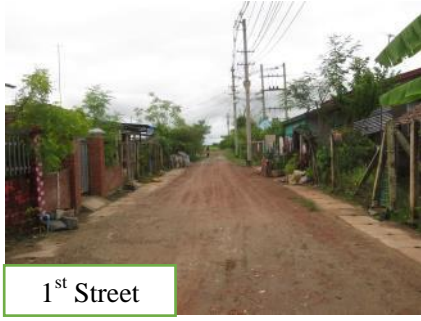
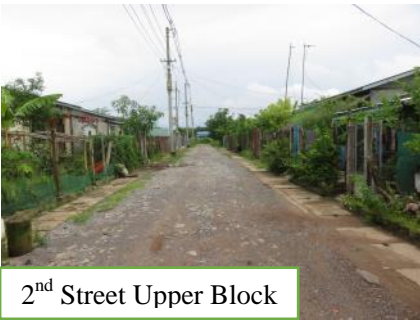
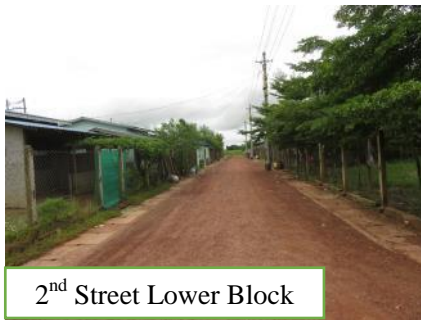
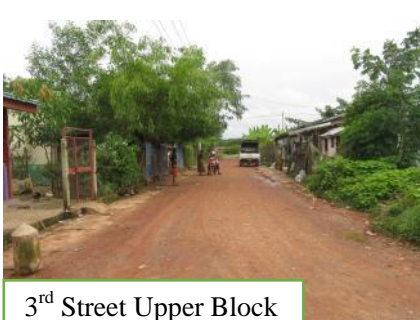
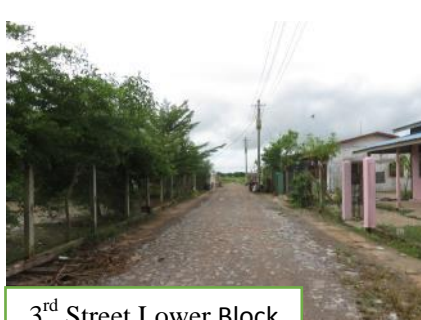
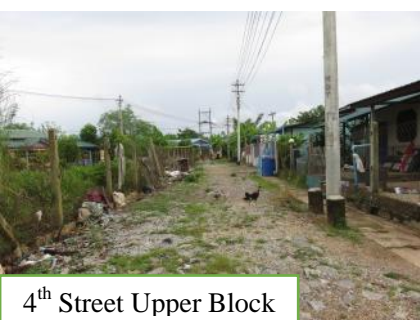
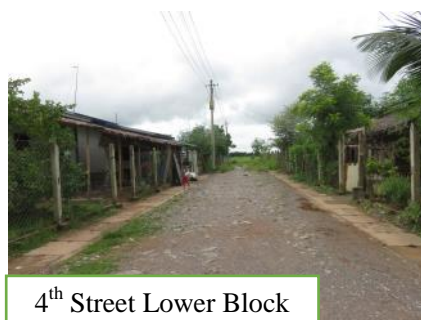
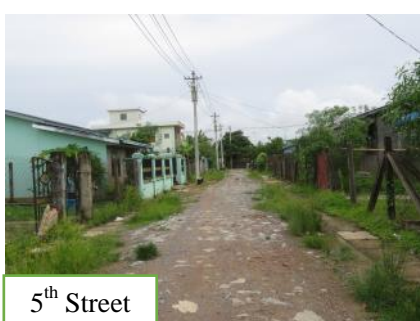
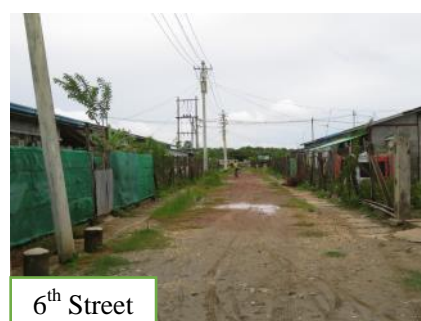
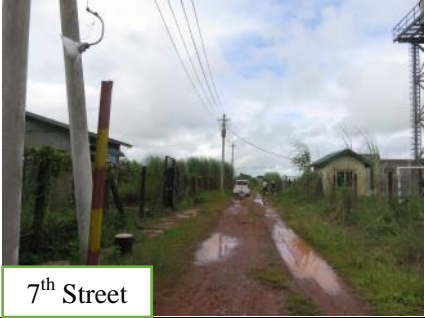
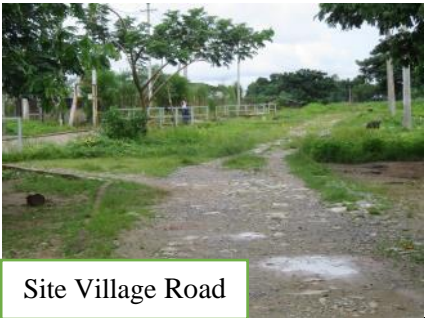
(3) Road	Improved <input type="checkbox"/> Same <input checked="" type="checkbox"/> * Worse <input type="checkbox"/> <i>*as last week</i>	<p>– Some roads are found with small ponds due to the rain in these days but no problem for walking.</p> <p><b>Photos</b></p>

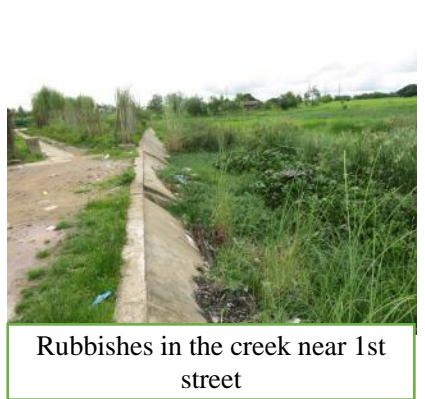
<p>Rubbishes in the creek near 1st street</p>

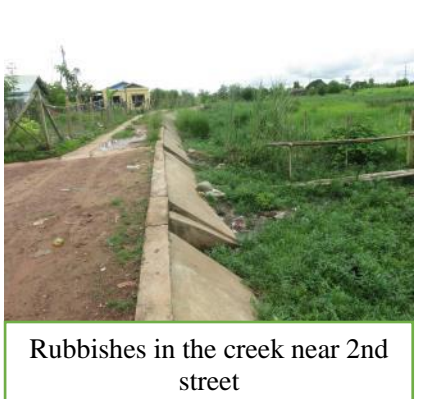
<p>Rubbishes in the creek near 2nd street</p>

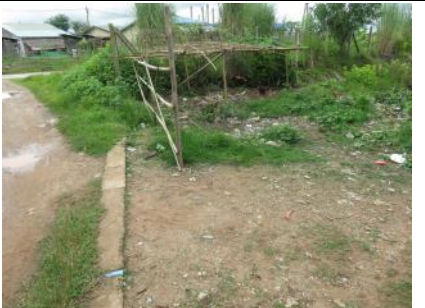
<p>The soil was filled near the creek of Main Road C in March</p>

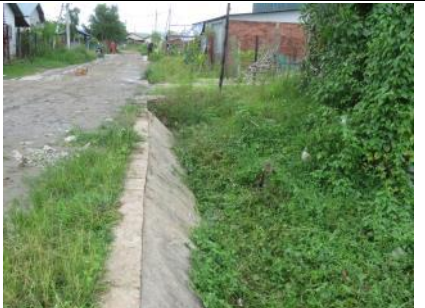
<p>The soil was filled near the creek of 6<sup>th</sup> Street in March</p>

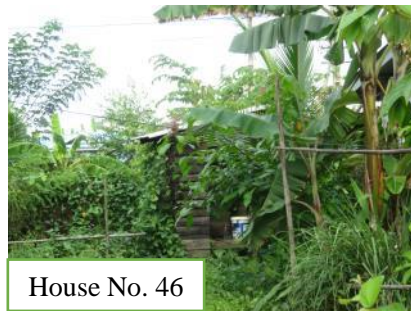
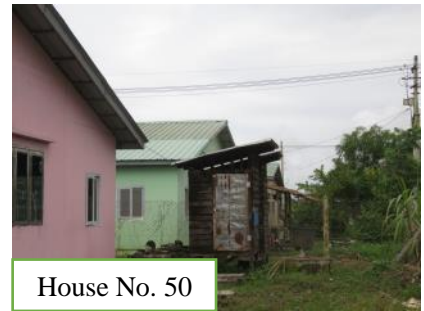
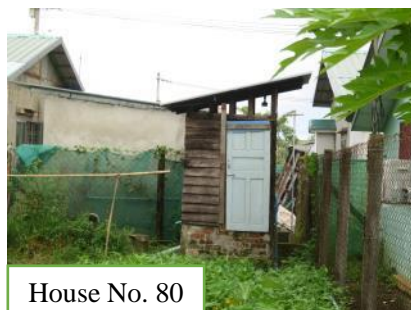
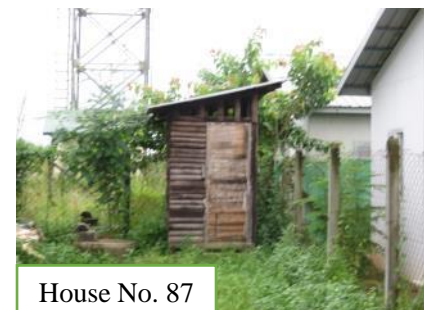
- All of the fly proof toilets are used by the residents.
- All of the toilets are repaired by the following procedures;
  - Installation the extra septic tanks beside the original
  - The pipe line system is installed from the extra tank to the ditch to flow the liquid out.

The toilet renovation plan was successfully done and there is no problem at the moment.

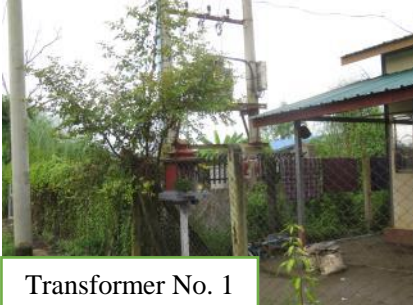
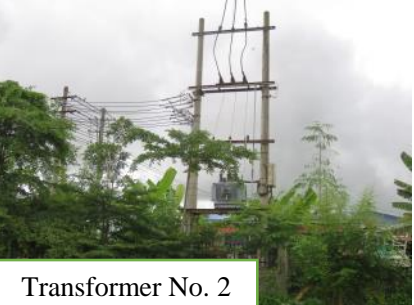
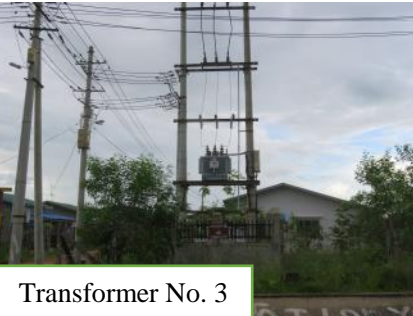
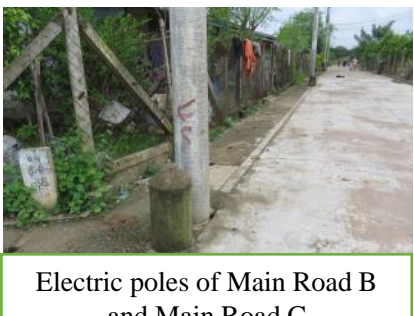
(6) Electricity	Improved <input type="checkbox"/> Same <input checked="" type="checkbox"/> * Worse <input type="checkbox"/> <i>*as last week</i>	<ul style="list-style-type: none"> <li>- Residents get the electricity regularly.</li> <li>- Electric poles and transformer are being supported with the good foundations.</li> </ul> <p><b>Photos</b></p>

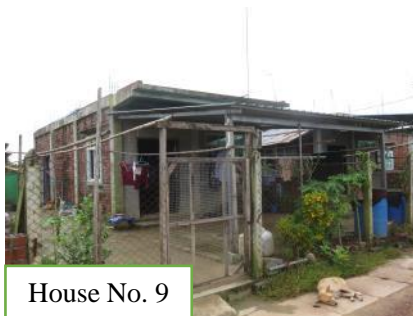
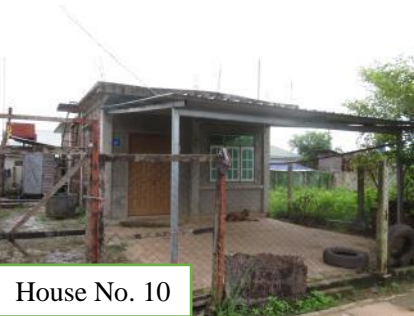
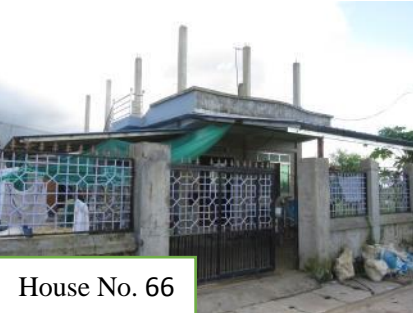
No	Item	Condition	Description and Photos	
2	(1)House Construction	No. of houses which are not completed (4)	<ul style="list-style-type: none"> <li>- In plot No.9 and 10, three houses that are planned to build as the plots are owned by father and son. The second floors of these three houses are needed to be carried on.</li> <li>- Plot No. 66, the house construction for the first floor has been finished and the second floor is still needed to be carried on.</li> </ul> <p><b>Photos</b></p>

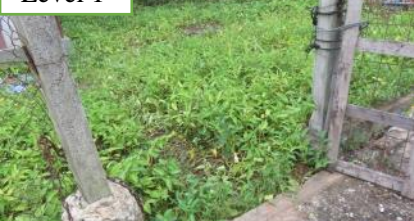
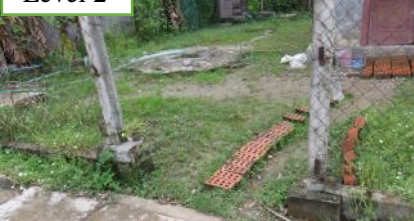
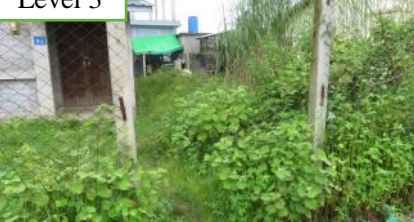
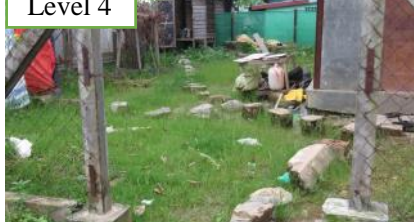
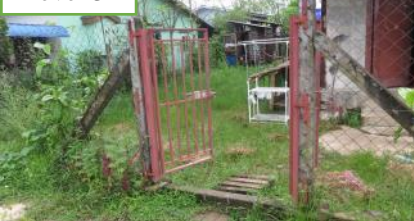
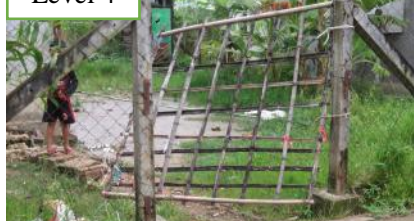
<p data-bbox="568 465 845 497">&lt;Evaluation Criteria&gt;</p> <p data-bbox="568 497 654 528"><b>Level 1</b></p> <p data-bbox="568 528 1372 591">-No mud and no standing water with their own drainage system in their compound</p> <p data-bbox="568 591 654 622"><b>Level 2</b></p> <p data-bbox="568 622 1139 654">-No mud and no standing water in their compound</p> <p data-bbox="568 654 660 685"><b>Level 3</b></p> <p data-bbox="568 685 1228 716">- Some or little mud and standing water in their compound</p> <p data-bbox="568 716 654 748"><b>Level 4</b></p> <p data-bbox="568 748 1155 779">-A lot of mud and standing water in their compound</p> <p data-bbox="568 846 654 878"><u>Photos</u></p> <div data-bbox="574 940 1002 1254"> <p data-bbox="580 949 708 981">Level 1</p>
