Surveyor: Zaw La  
 Date Visited: 18.8.2016  
 Time Visited: 14:30 to 15:30

Weather Condition: cloudy  
 The last time of heavy raining: - yesterday

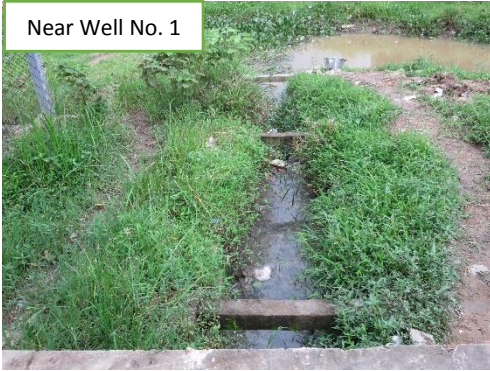
(2). Drainage	Improved <input type="checkbox"/> Same <input checked="" type="checkbox"/> * Worse <input type="checkbox"/> <i>*as last week</i>	<u>Description</u> There is some amount of water in the drainage canals due to the rain in these days and some places of stream seem to be blocking at the moment. The stream along the drainage canal may need to be rehabilitated in order to improve the water-flow along the stream.  <u>Photos</u>  <div style="display: flex; flex-wrap: wrap;"> <div style="width: 50%; text-align: center;"> <p>Near Well No. 1</p>

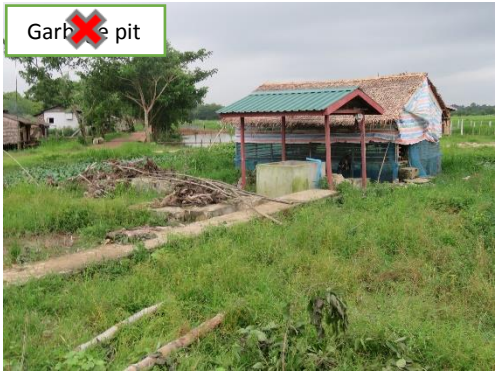
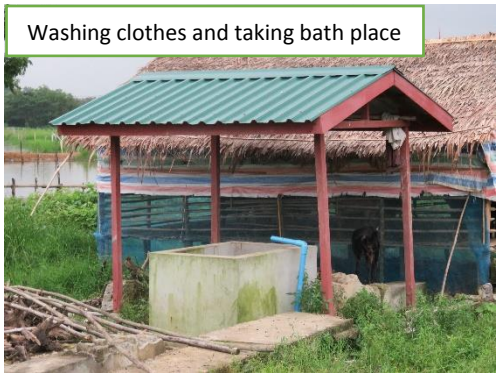
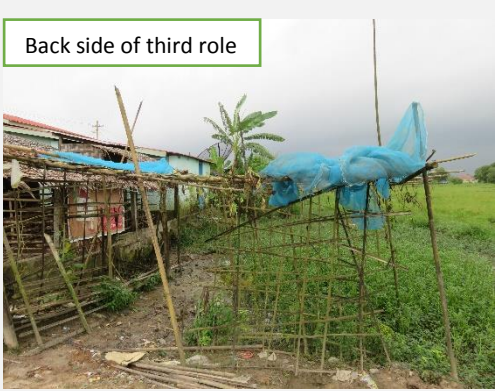
(4). Garbage Condition	<p>Improved <input type="checkbox"/></p> <p>Same <input checked="" type="checkbox"/>*</p> <p>Worse <input type="checkbox"/></p>		<p><u>Description</u></p> <ul style="list-style-type: none"> <li>- People do not want to use garbage pit again.</li> <li>- They do not like people to take washing clothes and showering near the well and therefore garbage pit was demolished and water storage tank has been constructed instead of it.</li> <li>-Trash from all houses will be collected by garbage truck biweekly until starting of the community fund.</li> <li>-There is a small vegetable planting field at the backside of Third Row where there were many trashes before the vegetable plantation was started.</li> </ul>

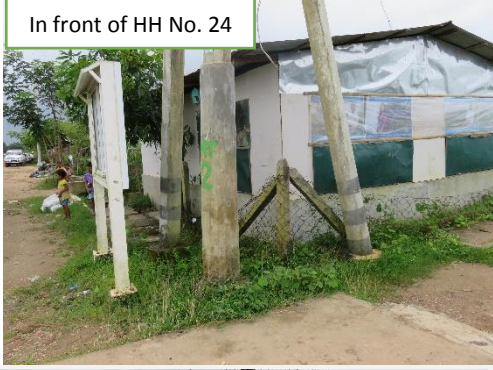
(6).	Electricity	<p>Improved <input checked="" type="checkbox"/>*</p> <p>Same <input type="checkbox"/></p> <p>Worse <input type="checkbox"/></p> <p><i>*as last week</i></p>	<p><u>Description</u></p> <ul style="list-style-type: none"> <li>-Electricity comes regularly.</li> <li>-Electric poles and transformer are being supported with a good foundation.</li> <li>-There was a hole at an electric pole which was hit by a truck car but the electric pole was renovated.</li> </ul> <p><u>Photos</u></p> <div style="display: flex; flex-wrap: wrap;"> <div style="width: 50%; text-align: center;"> <p>In front of HH No. 24</p>

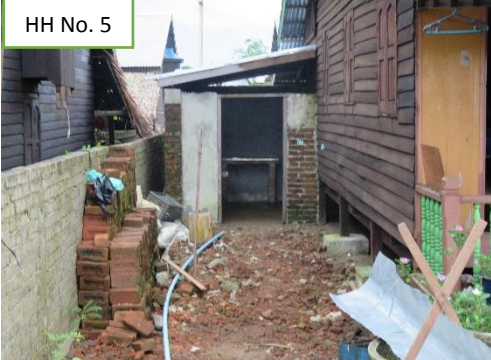
2	House Construction	No. of houses not completed (2)	<p><u>Description</u></p> <p>-HH No.5, the construction for kitchen, toilet and water tank seems to be stopped again.</p>

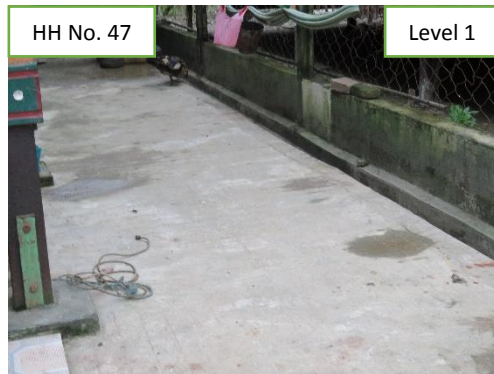
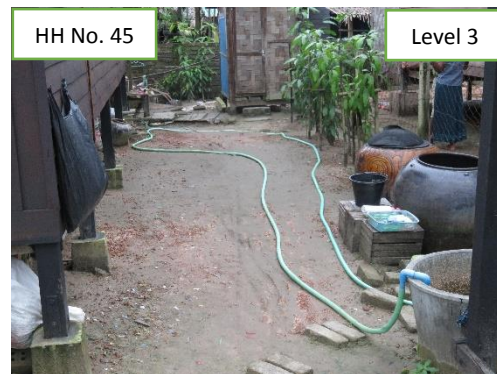
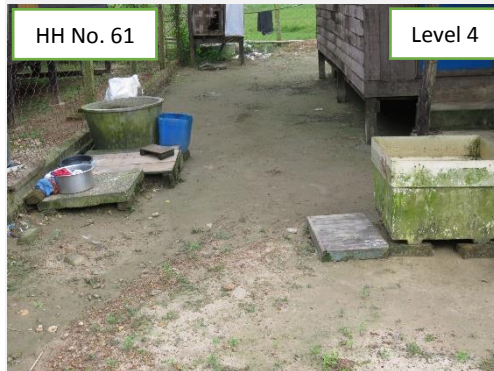
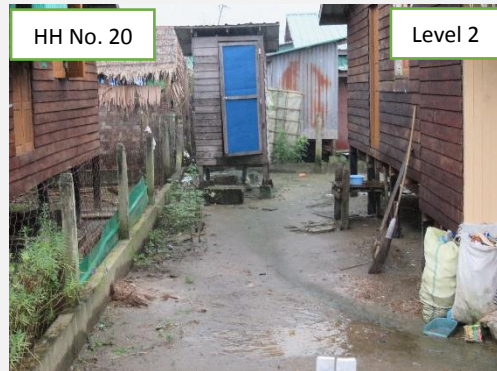
Photos

3	Living Status of PAPs (Sold house, renting, etc.)	<p><u>Description</u></p> <p>(1) House ownership  (1)-1 No. of house that are owned by PAPs (45)  (1)-2 No. of house that were sold (23)</p> <p>(2) Living condition  (2)-1 No. of houses where PAPs live (37)  (2)-2 No. of houses where original PAPs do not live (28)  (2)-3 No. of houses where nobody lives (3)</p> <p>Location Map: See ANNEX.2</p>																		
4	Other issue																			
	(1). Drainage condition for rain water in their compounds	<p><u>Description</u></p>

<p><b>&lt;Evaluation Criteria&gt;</b></p> <p><b>Level 1</b> -No mud and no standing water with their own drainage system in their compound</p> <p><b>Level 2</b> -No mud and no standing water in their compound</p> <p><b>Level 3</b> - Some or little mud and standing water in their compound</p> <p><b>Level 4</b> -A lot of mud and standing water in their compound</p>		Condition	No. of HHs		This week condition	Previous week condition	Level 1	63	63	Level 2	5	5	Level 3	0	0	Level 4	0	0
Condition	No. of HHs																			
	This week condition	Previous week condition																		
Level 1	63	63																		
Level 2	5	5																		
Level 3	0	0																		
Level 4	0	0

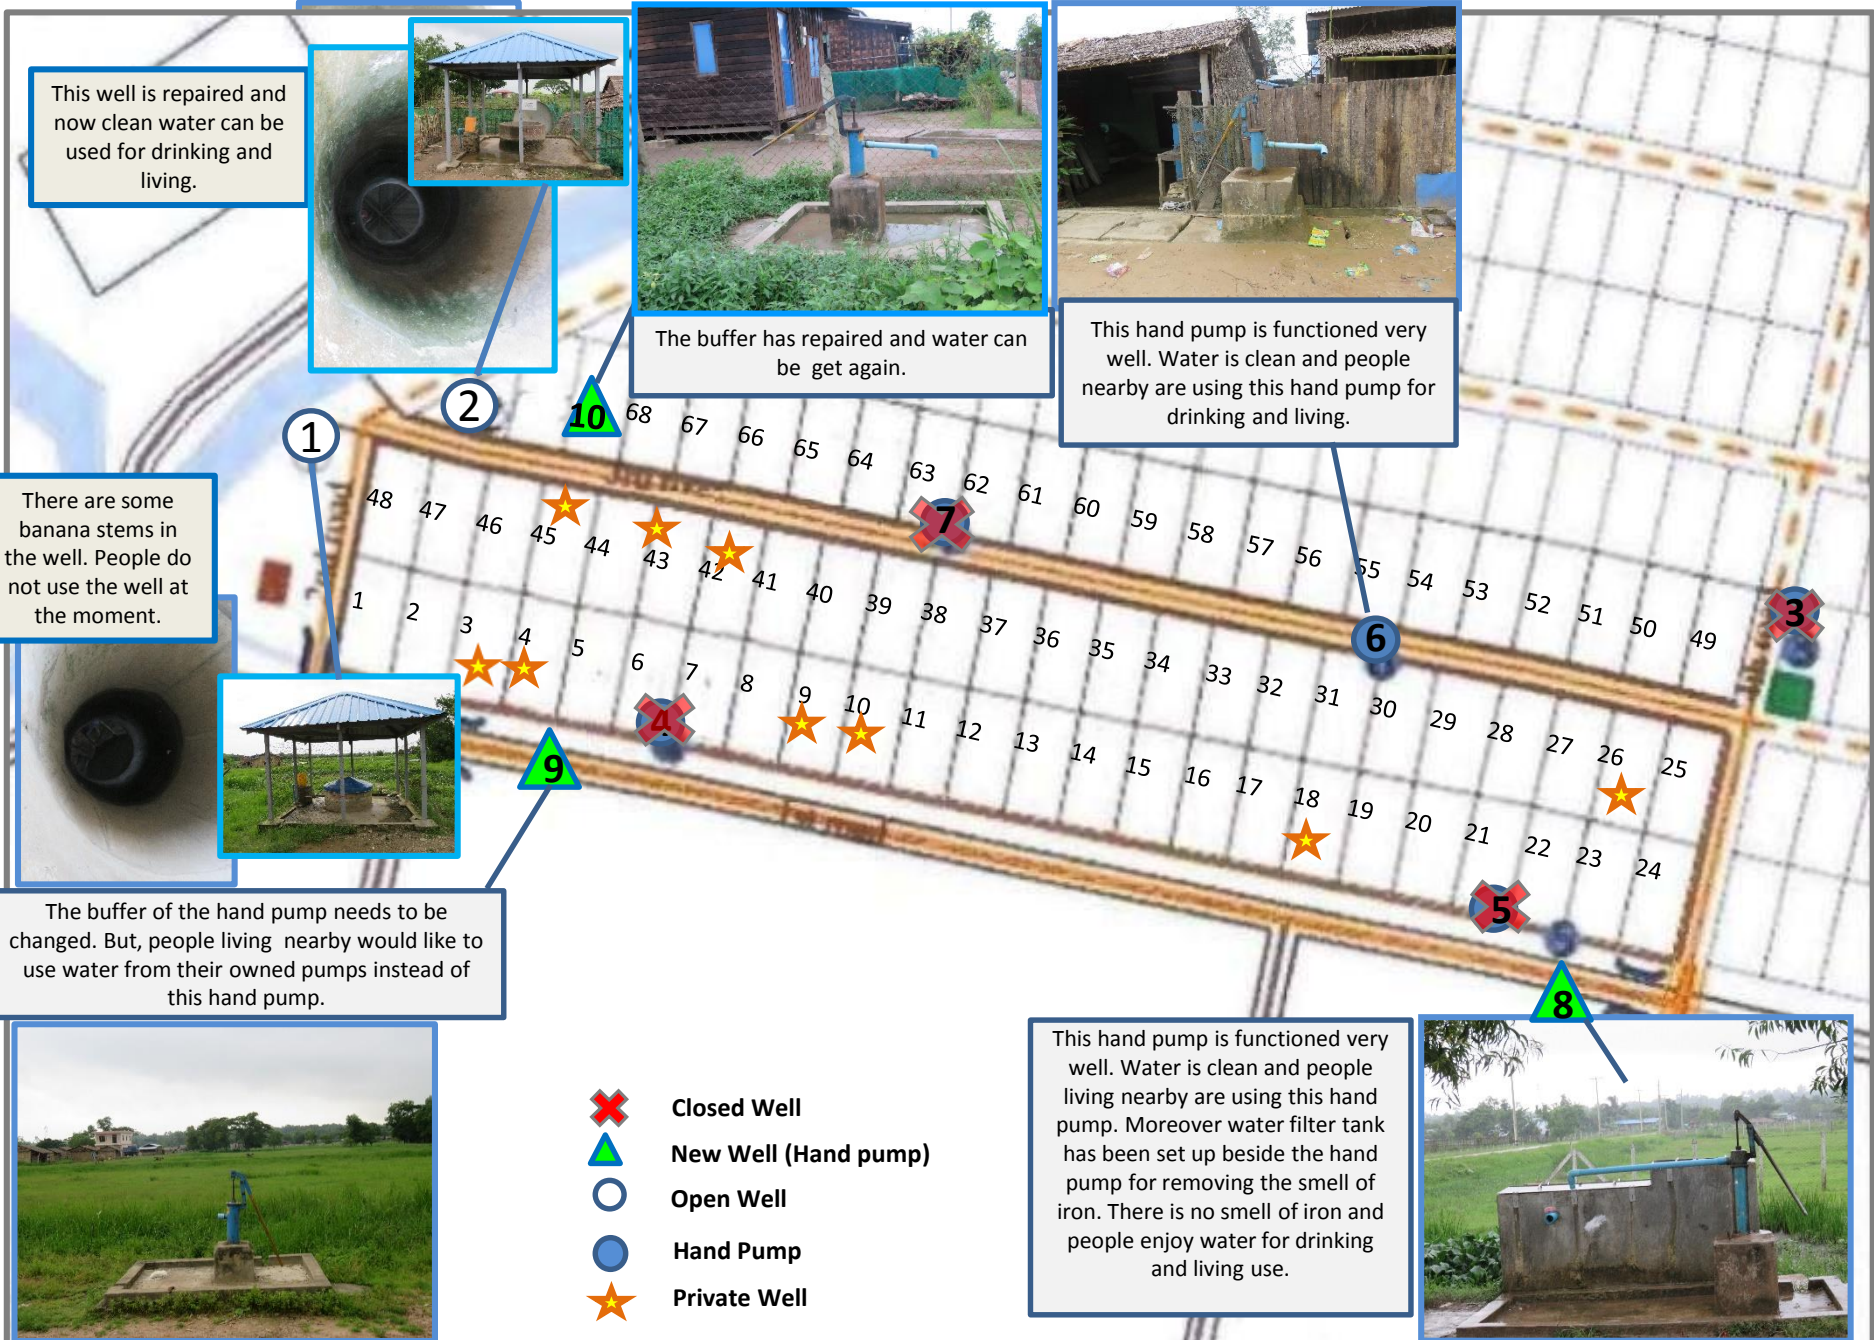
No	Item	Condition	Description and Photos
1	<b>Condition of -</b>		
	(1). Well	Improved <input type="checkbox"/> Same <input checked="" type="checkbox"/> * Worse <input type="checkbox"/>  <i>*as last week</i>	Description & Photos: -See ANNEX.1 - Water from both of two wells is clean and can be used for drinking and living. The amount of water in both wells is also being increased during these days. There are four tube wells in the relocation site. Among them, one of the hand pump needs to be repaired, but people can get water from their own tube-wells, one open-well and the rest of two hand pumps.
