Surveyor: Zaw La
 Date Visited: 13.7.2016
 Time Visited: 10:30 to 11:45

Weather Condition: Sunny
 The last time of heavy raining: - This morning

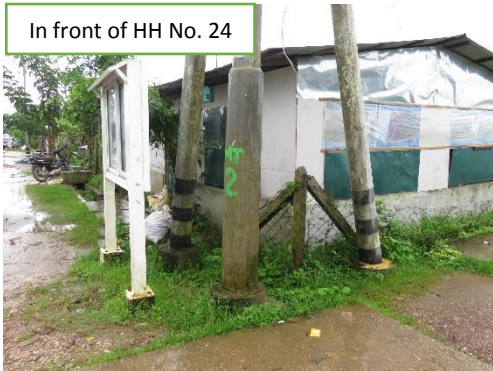
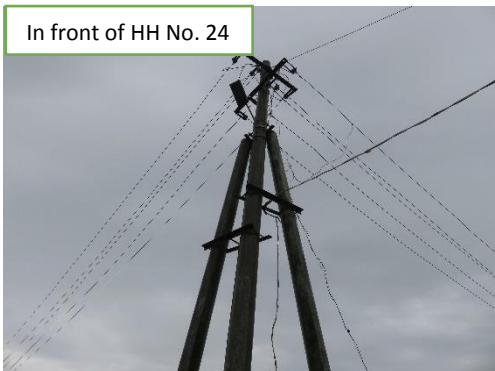
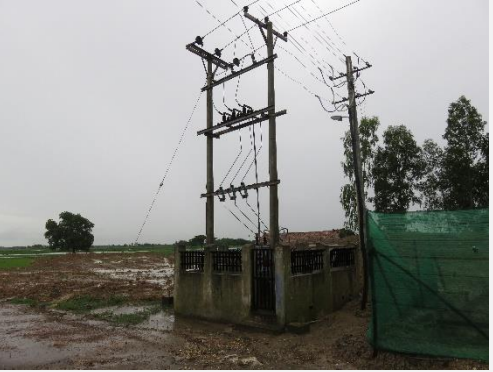
(6). Electricity	<p>Improved <input checked="" type="checkbox"/>*</p> <p>Same <input type="checkbox"/></p> <p>Worse <input type="checkbox"/></p> <p><i>*as last week</i></p>	<p><u>Description</u></p> <ul style="list-style-type: none"> -Electricity comes regularly. -Electric poles and transformer are being supported with a good foundation. -There was a hole at an electric pole which was hit by a truck car but the electric pole was renovated. <p><u>Photos</u></p> <div style="display: flex; flex-wrap: wrap;"> <div style="width: 50%;"> <p>In front of HH No. 24</p>

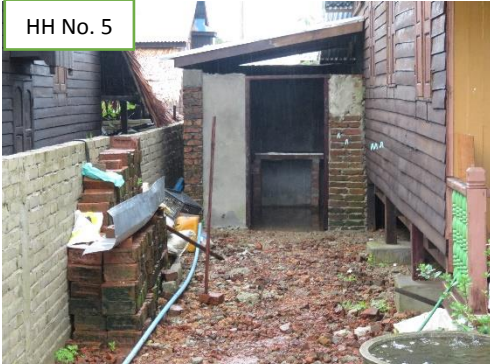
2	House Construction	No. of houses not completed (2)	<p><u>Description</u> -HH No.5, the construction for kitchen, toilet and water tank seems to be stopped again.</p>

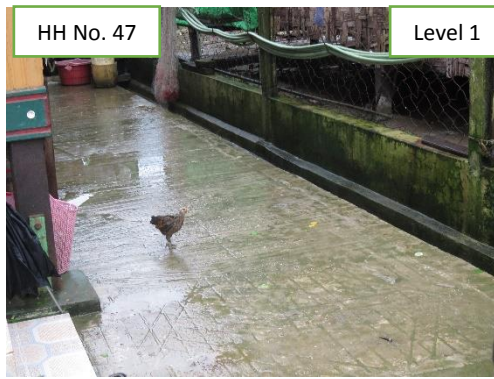
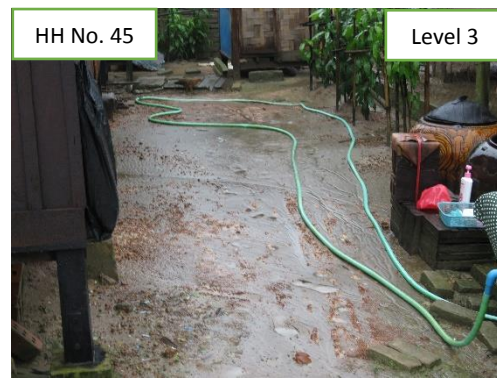
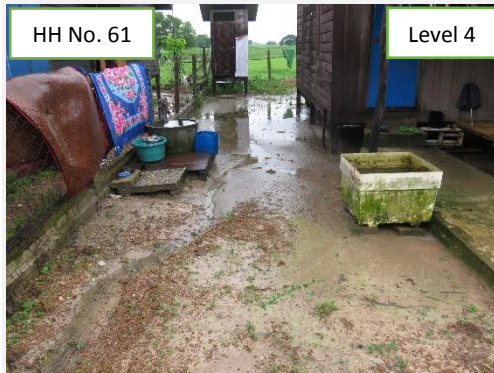
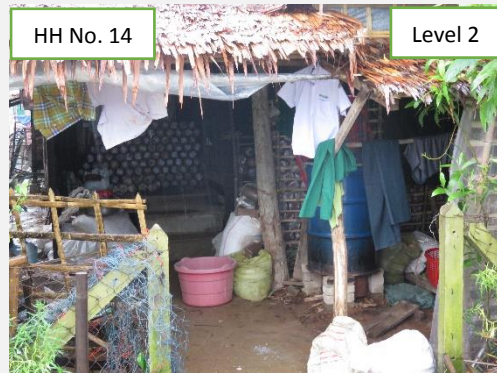
Photos

<p><Evaluation Criteria> Level 1 -No mud and no standing water with their own drainage system in their compound Level 2 -No mud and no standing water in their compound Level 3 - Some or little mud and standing water in their compound Level 4 -A lot of mud and standing water in their compound</p>	Condition	No. of HHs		This week condition	Previous week condition	Level 1	63	63	Level 2	5	5	Level 3	0	0	Level 4	0
Condition	No. of HHs																
	This week condition	Previous week condition															
Level 1	63	63															
Level 2	5	5															
Level 3	0	0															
Level 4	0	0

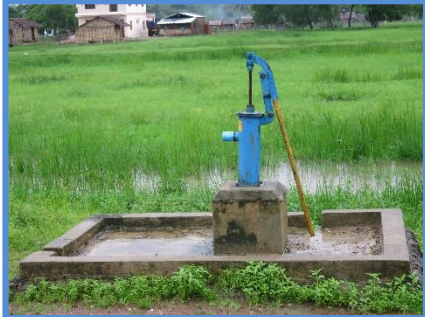
The buffer of the hand pump needs to be changed. But, people living nearby would like to use water from their owned pumps instead of this hand pump.
