Surveyor: Zaw La  
 Date Visited: 25.4.2016  
 Time Visited: 11:00 to 12:00

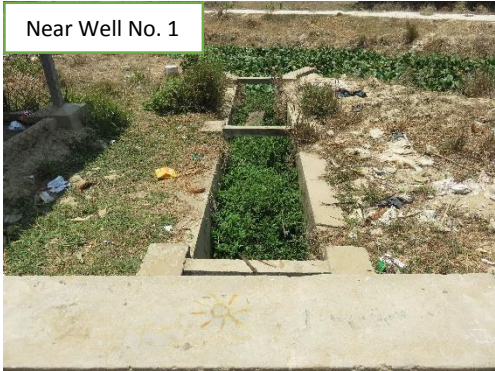
<p>Near Well No. 1</p> </div> <div style="width: 50%; text-align: center;">

(2). Drainage	Improved <input type="checkbox"/> Same <input checked="" type="checkbox"/> * Worse <input type="checkbox"/> <i>*as last week</i>	Description There is almost no water in the drainage canals. The stream along the drainage canal may need to be rehabilitated in coming summer period in order to improve the water-flow along the stream.  Photos <div style="display: flex; flex-wrap: wrap;"> <div style="width: 50%; text-align: center;">

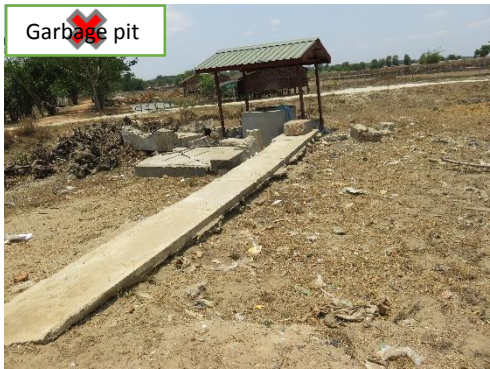
Garbage pit

(4). Garbage Condition	<p>Improved <input type="checkbox"/></p> <p>Same <input checked="" type="checkbox"/>*</p> <p>Worse <input type="checkbox"/></p>	<p><u>Description</u></p> <p>- People do not want to use garbage pit again.</p> <p>- They do not like people to take washing clothes and showering near the well and therefore garbage pit was demolished and water storage tank has been constructed instead of it.</p> <p>-Trash from all houses will be collected by garbage truck biweekly until starting of the community fund.</p> <p>-There is a small vegetable planting field at the backside of Third Row where there were many trashes before the vegetable plantation was started.</p>

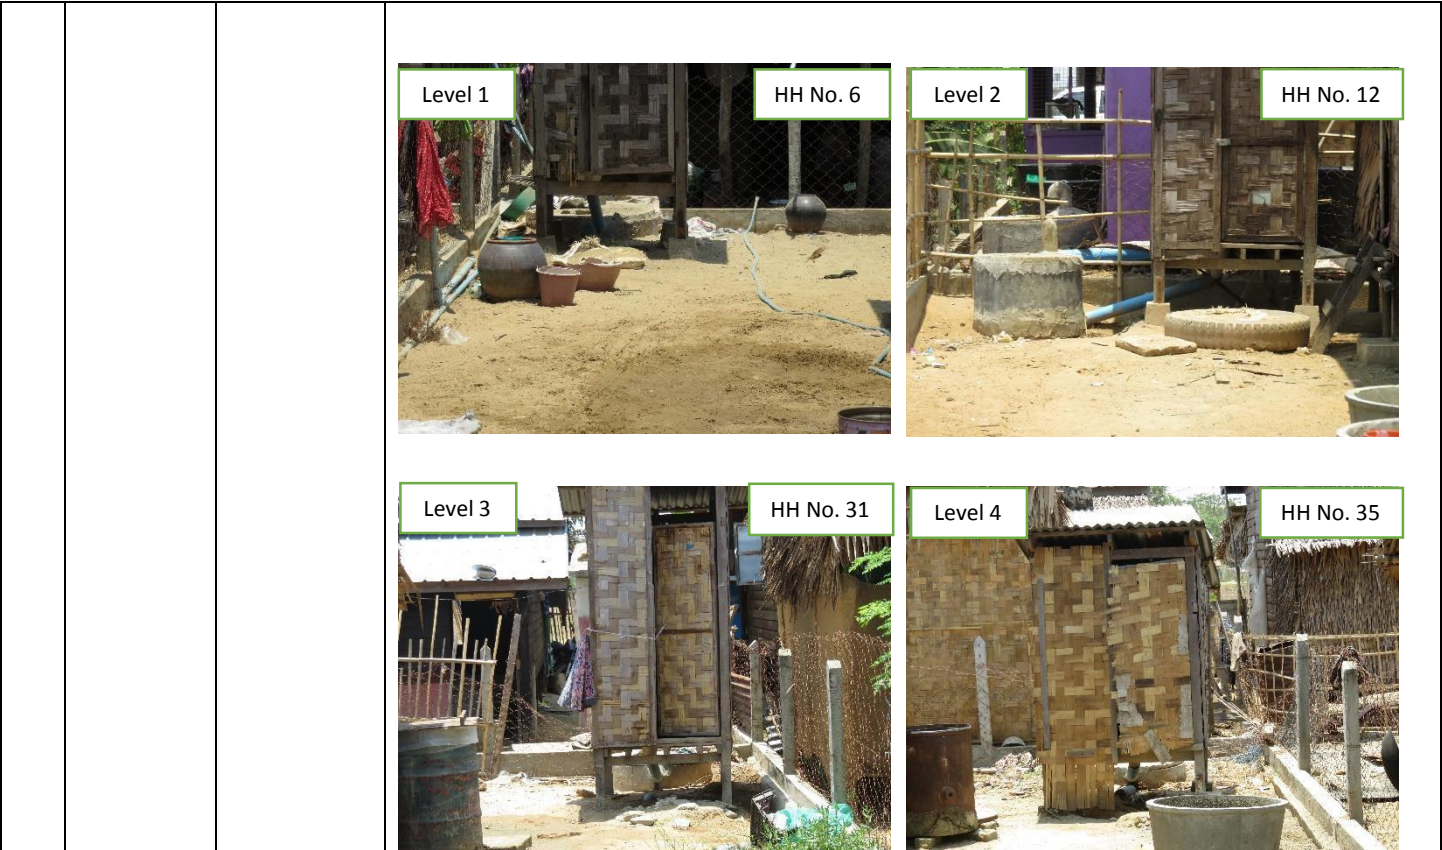
-All of the fly proof toilets are used by people.  
-Almost all of the fly proof toilets made by wood or bamboo have been lifted up as shown in pictures below and are convenient to use. Some concrete toilets are still needed to be renovated. According to discussion with community people, they would like to repair the concrete toilets by themselves and requested for financial support. JET had already paid for it.

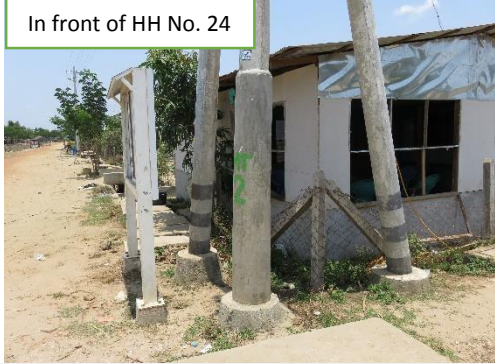
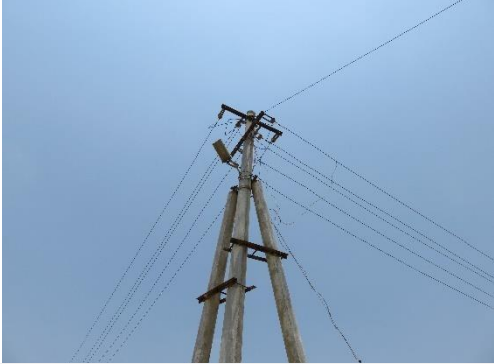
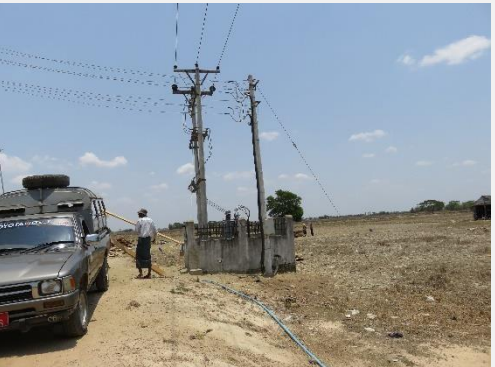
In front of HH No. 24

- Electricity comes regularly.
- Electric poles and transformer are being supported with a good foundation.
- There was a hole at an electric pole which was hit by a truck car but the electric pole was renovated.

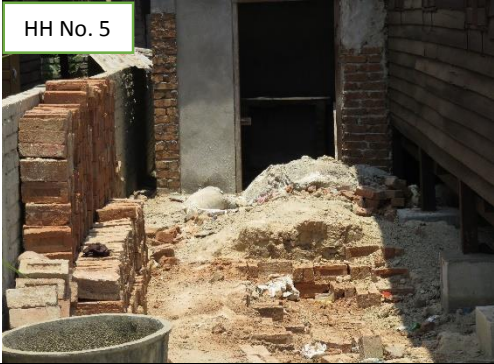
No	Item	Condition	Description and Photos																	
2	House Construction	No. of houses not completed (2)	<p><u>Description</u> -HH No.5, the construction for kitchen, toilet and water tank seems to be stopped again.</p>

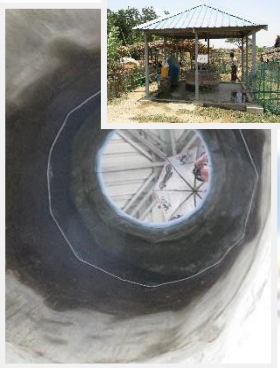
This well is repaired and now clean water can be used for drinking and living. Nevertheless, water in the well is being reduced at the moment and does not enough to use.

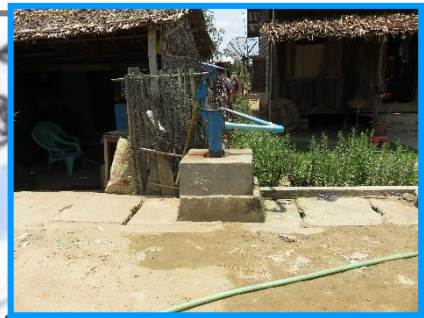
The buffer has repaired and water can be get again.

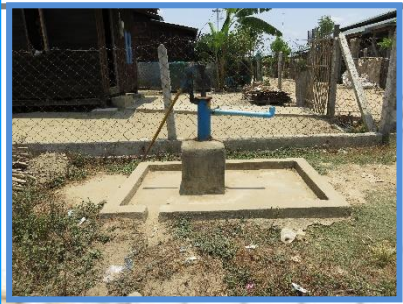
This hand pump is functioned very well. Water is clean and people nearby are using this hand pump for drinking and living.

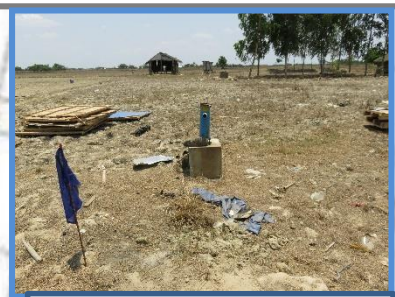
Hand pump isn't functioned.

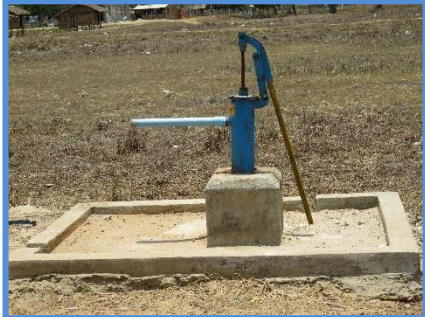
The buffer of the hand pump needs to be changed. But, people living nearby would like to use water from their owned pumps instead of this hand pump.

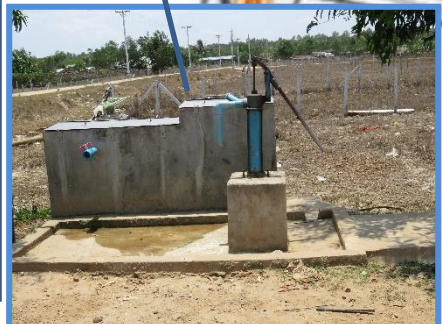
This hand pump is functioned very well. Water is clean and people living nearby are using this hand pump. Moreover water filter tank has been set up beside the hand pump for removing the smell of iron. There is no smell of iron and people enjoy water for drinking and living.
