Surveyor: Zaw La

Date Visited: 11.1.2016

No	Item	Condition	Description and Photos
1	<b>Condition of -</b>		
	(1). Well	Improved <input type="checkbox"/> Same <input checked="" type="checkbox"/> * Worse <input type="checkbox"/>  <i>*as last week</i>	Description & Photos: -See ANNEX.1 - Water from both of two wells are clean and enough to use for drinking and living. One of the hand pumps needs to be repaired, but people can get water from their own tube-wells, some hand pumps and the two wells.

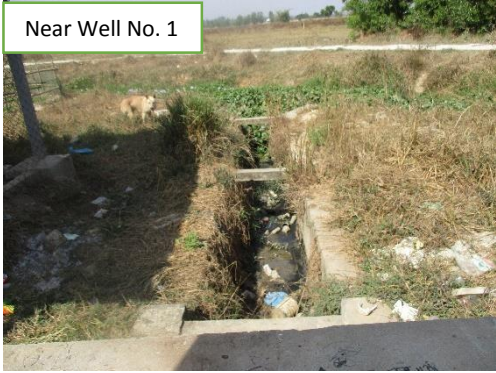
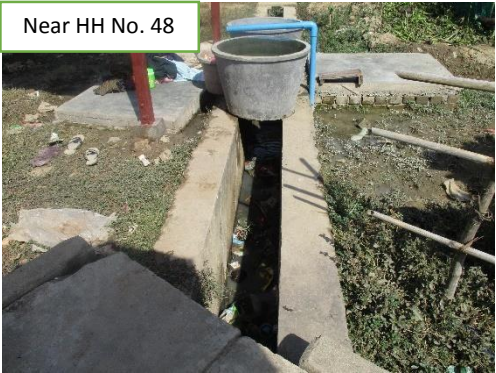
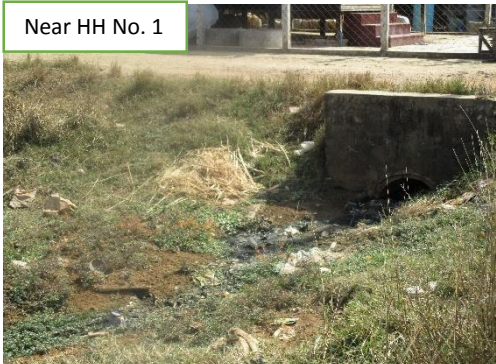
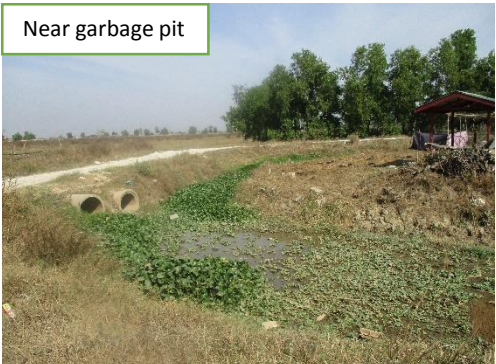
(2). Drainage	Improved <input type="checkbox"/> Same <input checked="" type="checkbox"/> * Worse <input type="checkbox"/> <i>*as last week</i>	Description -Water level in the drainage canals are decreased than last week because there was no rain. The stream along the drainage canal may need to be rehabilitated in coming summer period in order to improve the water-flow along the stream.  Photos  <div style="display: flex; flex-wrap: wrap;"> <div style="width: 50%; text-align: center;">

<p>Near Well No. 1</p> </div> <div style="width: 50%; text-align: center;">

<p>Near HH No. 48</p> </div> <div style="width: 50%; text-align: center;">

<p>Near HH No. 1</p> </div> <div style="width: 50%; text-align: center;">

<p>Near garbage pit</p> </div> </div>

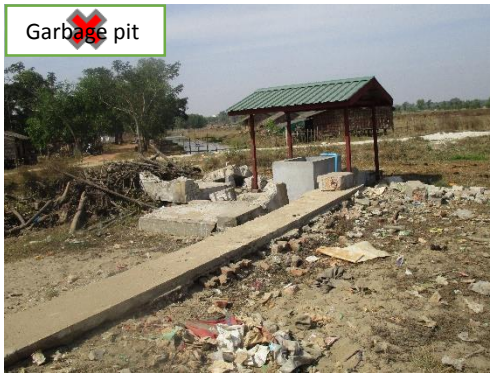
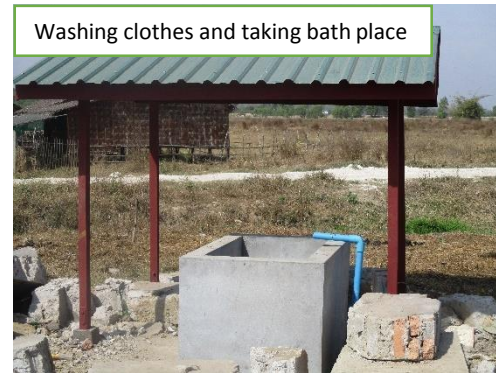
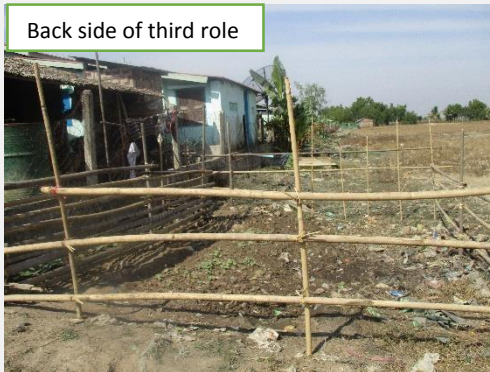
(4). Garbage Condition	<p>Improved <input type="checkbox"/></p> <p>Same <input checked="" type="checkbox"/>*</p> <p>Worse <input type="checkbox"/></p>	<p><u>Description</u> - People do not want to use garbage pit again. - They do not like people to wash shower near the well and therefore garbage pit was demolished and water storage tank has been constructed instead of it. -Trash from all houses will be collected by garbage truck biweekly until starting of the community fund. -There is a small vegetable planting field at the backside of Third Row where there were many trashes in ten days ago.</p>

Garbage pit

Washing clothes and taking bath place

Back side of third role

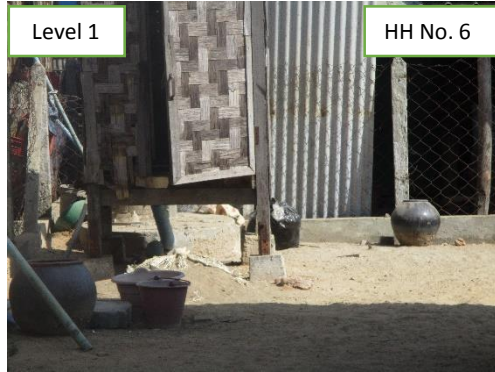
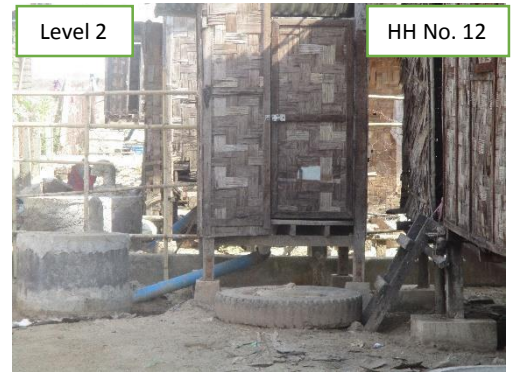
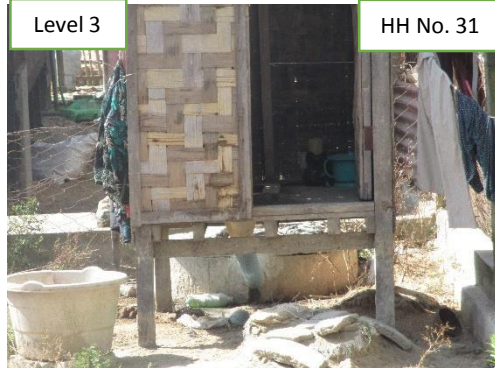
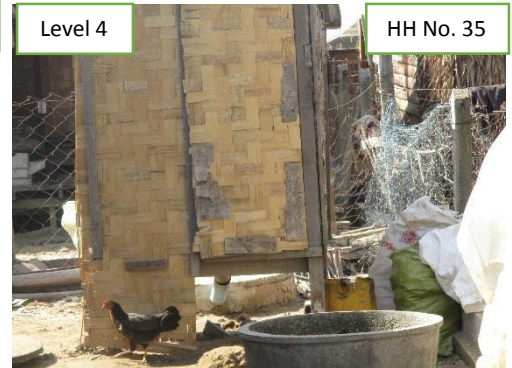
-All of the fly proof toilets are used by people.  
-Almost all of the fly proof toilets made by wood or bamboo have been lifted up as shown in pictures below and are convenient to use. Some concrete toilets are still needed to be renovated. According to discussion with community people, they would like to repair the concrete toilets by themselves and requested for financial support. JET had already paid for it.

-After filling the soil, some toilets need to be lifted up.

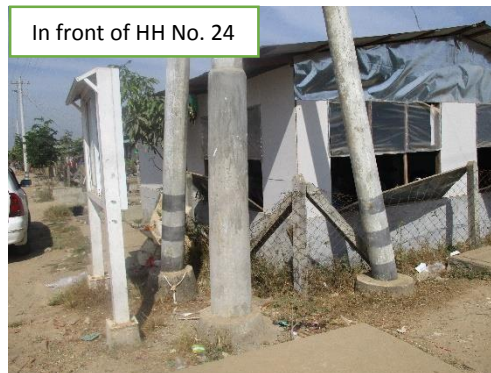
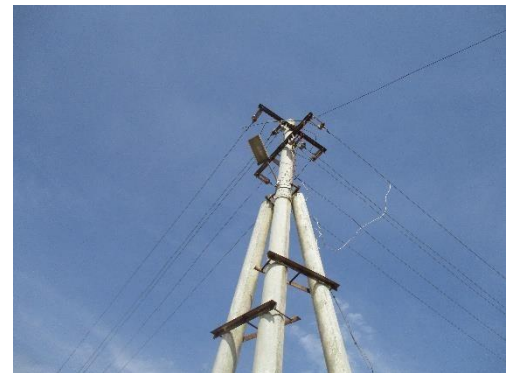
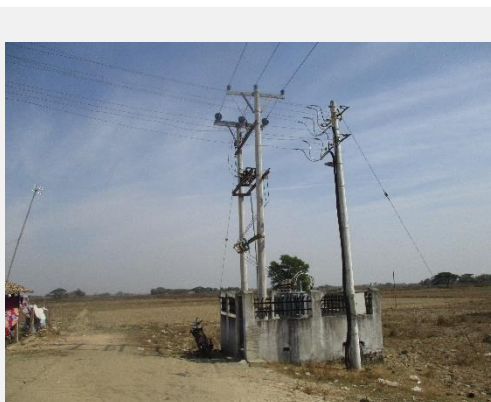
-Electricity comes regularly.  
-Electric poles and transformer are being supported with a good foundation.  
-There was a hole at an electric pole which was hit by a truck car, but the electric pole was renovated.

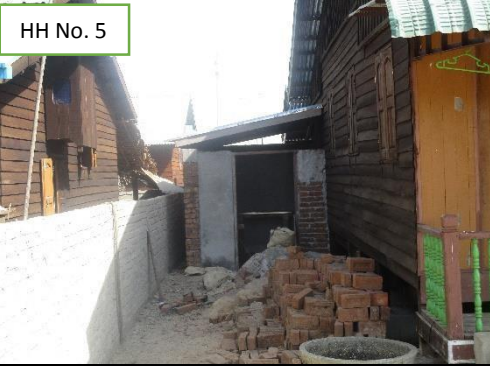
No	Item	Condition	Description and Photos																	
2	House Construct-ion	No. of houses not completed (2)	<p><u>Description</u> -HH No.5, the construction for kitchen, toilet and water tank seems to be stopped again.</p>

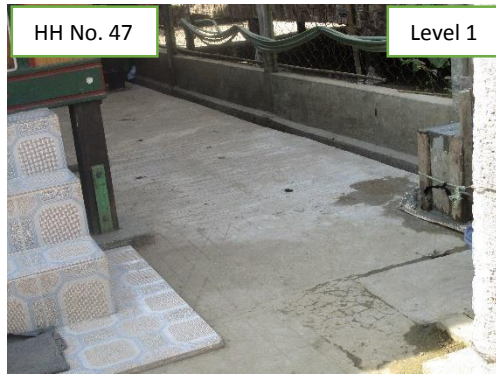
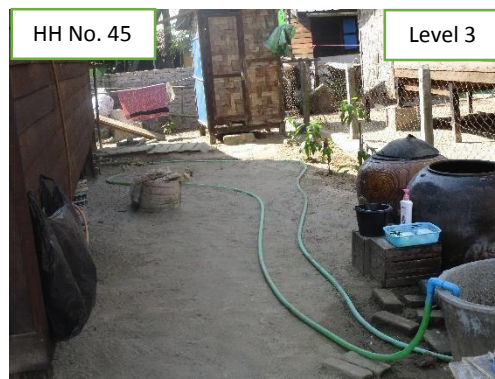
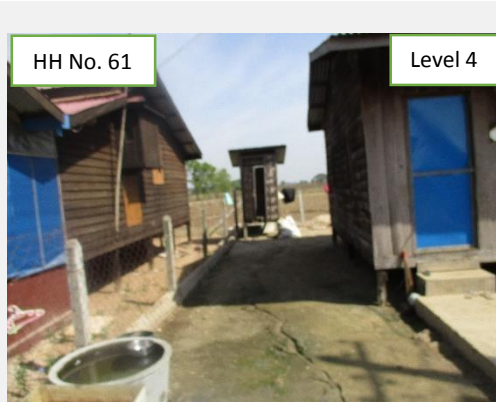
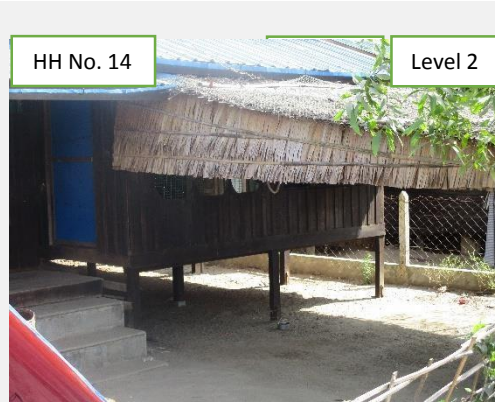
3	Living Status of PAPs (Sold house, renting, etc.)	<p><u>Description</u></p> <p>(1) House ownership            (1)-1 No. of house that are owned by PAPs (50)            (1)-2 No. of house that were sold (18)</p> <p>(2) Living condition            (2)-1 No. of houses where PAPs live (41)            (2)-2 No. of houses where original PAPs lives do not live (22)            (2)-3 No. of houses where nobody lives (5)</p>	<p>Location Map: See ANNEX.2</p>																	
4	Other issue		<p>(1). Drainage condition for rain water in their compounds</p> <p><u>Description</u> -Rainy season has started. -Some of the compounds are wet.</p>
