Surveyor: Zaw La
 Date Visited: 30.12.2015
 Time Visited: 14:15 to 15:00

No	Item	Condition	Description and Photos
1	Condition of -		
	(1). Well	Improved <input type="checkbox"/> Same <input checked="" type="checkbox"/> * Worse <input type="checkbox"/> <i>*as last week</i>	Description & Photos: -See ANNEX.1 - Water from both of two wells are clean and enough to use for drinking and living. One of the hand pump need to be repaired, but people can get water from their own tube-wells, some hand pumps and the two wells.

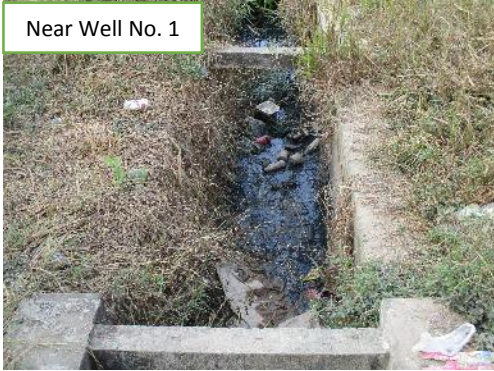
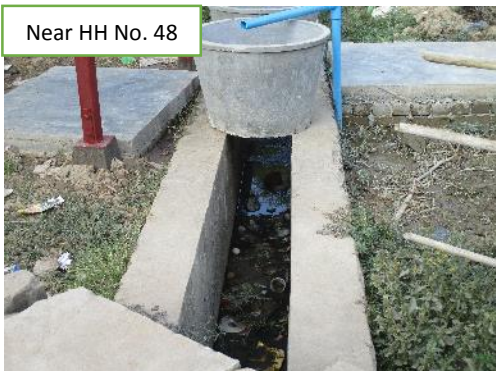
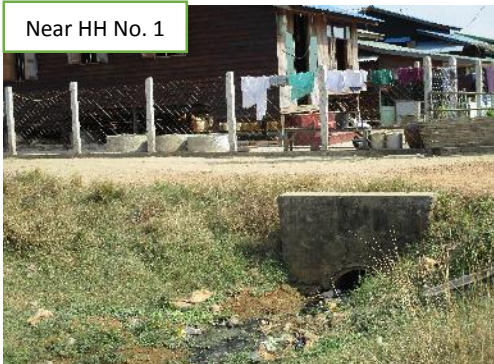
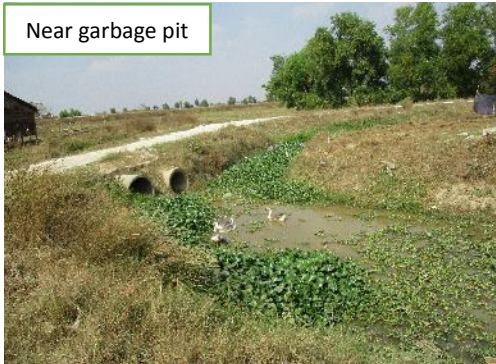
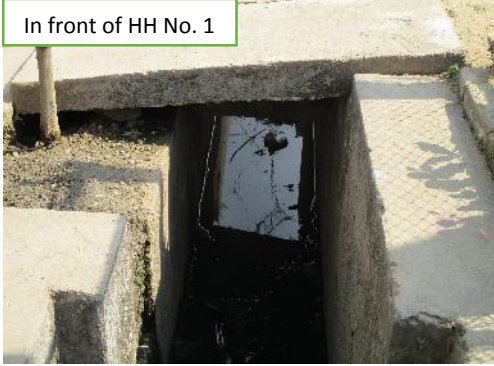
(2). Drainage	Improved <input type="checkbox"/> Same <input checked="" type="checkbox"/> * Worse <input type="checkbox"/> <i>*as last week</i>	<u>Description</u> -Water level in the drainage canals are decreased than last week because there was no rain. The stream along the drainage canal may need to be rehabilitated in coming summer period in order to improve the water-flow along the stream. <u>Photos</u>
			<div style="display: flex; flex-wrap: wrap;"> <div style="width: 50%; text-align: center;"> <p>Near Well No. 1</p>

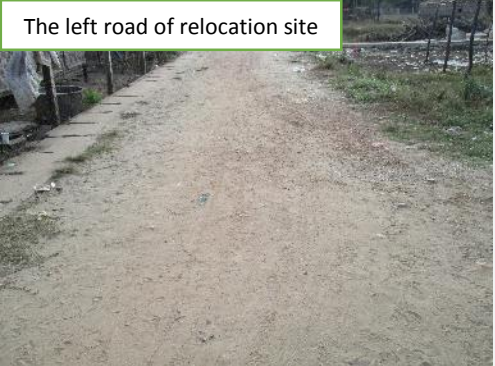
(3). Road	<p>Improved <input checked="" type="checkbox"/>*</p> <p>Same <input type="checkbox"/></p> <p>Worse <input type="checkbox"/></p> <p><i>*as last week</i></p>	<p><u>Description</u></p> <p>-The roads are being dry and no problem for walking.</p> <p><u>Photos</u></p>

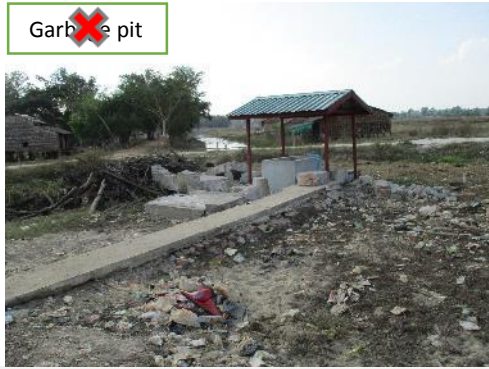
Garbage pit

(4). Garbage Condition	<p>Improved <input type="checkbox"/></p> <p>Same <input checked="" type="checkbox"/>*</p> <p>Worse <input type="checkbox"/></p>	<p><u>Description</u></p> <p>- People do not want to use garbage pit again.</p> <p>- They do not like people to wash shower near the well and therefore garbage pit was demolished and water storage tank has been constructed instead of it.</p> <p>-Trash from all houses will be collected by garbage truck biweekly until starting of the community fund.</p> <p>-There are some garbage at the backside of Third Row and it needs to be clean up as well.</p>

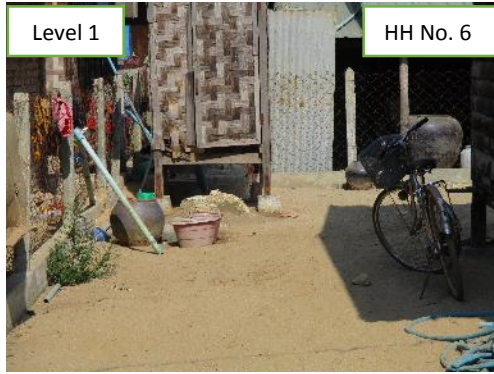
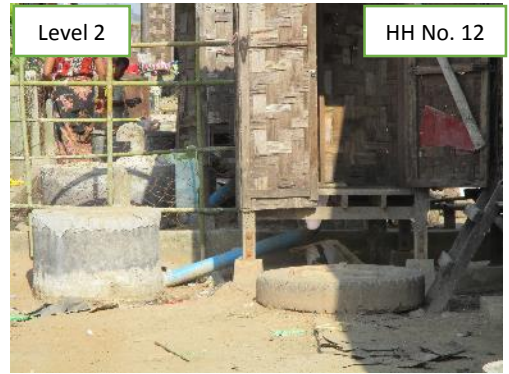
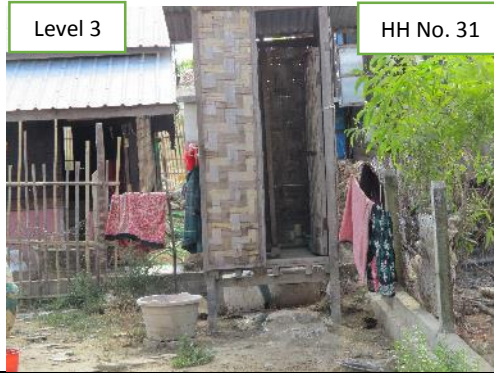
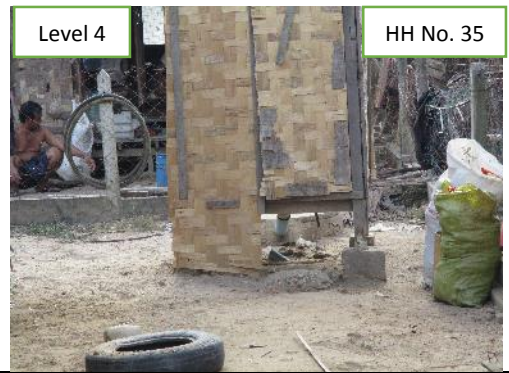
-All of fly proof toilets are used by people.
-Almost all of fly proof toilets made by wood or bamboo have been lifted up as shown in pictures below and are convenient to use. Some concrete toilets are still needed to be renovated. According to discussion with community people, they would like to repair concrete toilets by themselves and requested for financial support. JET had already paid for it.

-After filling the soil, some toilets need to be lifted up.

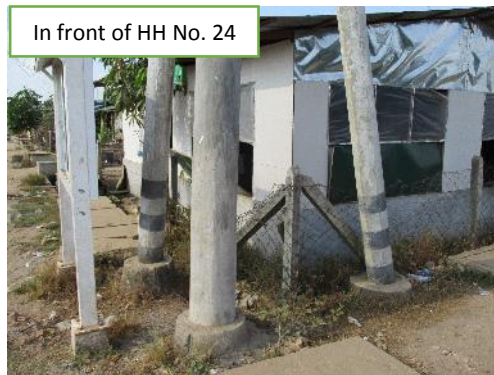
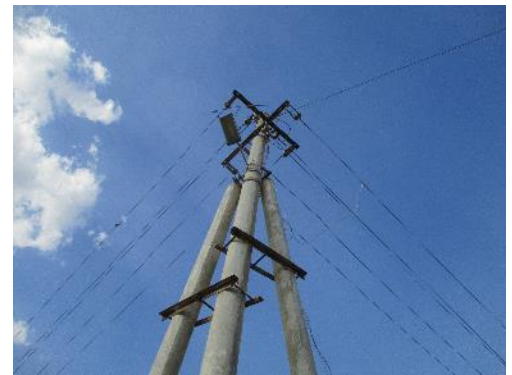
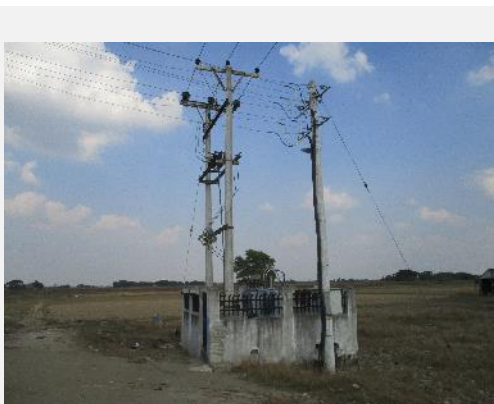
-Electricity comes regularly.
-Electric poles and transformer are being supported with a good foundation.
-There was a hole at an electric pole which was hit by a truck car, but the electric pole was renovated.

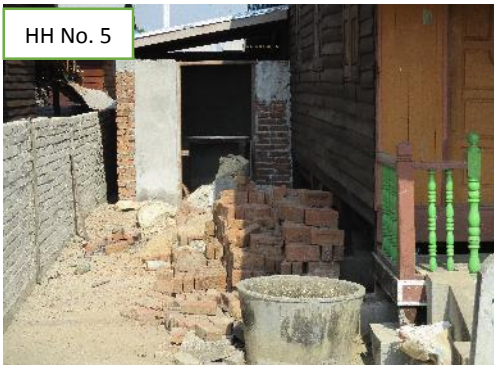
No	Item	Condition	Description and Photos																	
2	House Construction	No. of houses not completed (2)	<p><u>Description</u> -HH No.5, the construction for kitchen, toilet and water tank seems to be stopped again.</p>

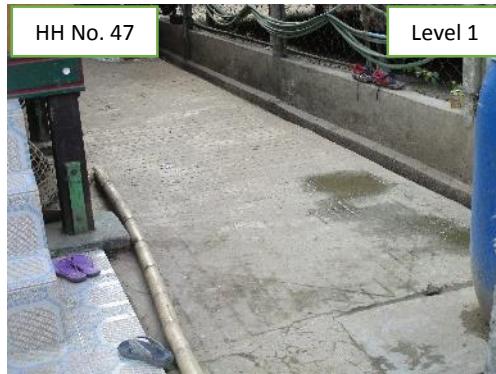
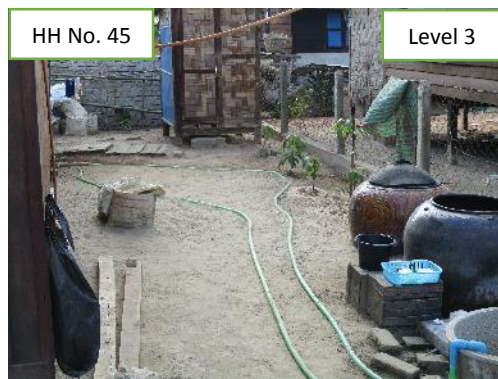
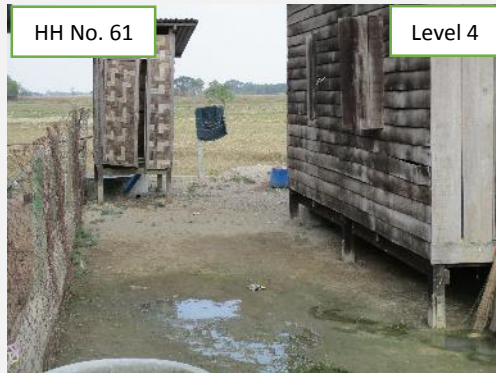
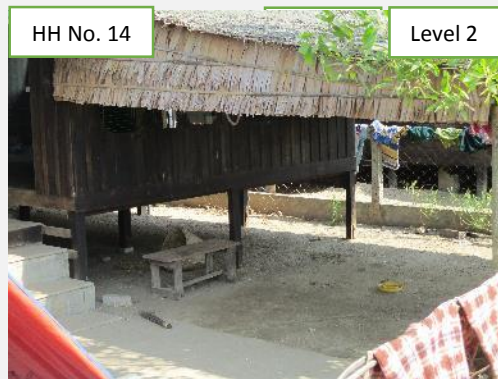
3	Living Status of PAPs (Sold house, renting, etc.)	<p><u>Description</u></p> <p>(1) House ownership (1)-1 No. of house that are owned by PAPs (50) (1)-2 No. of house that were sold (18)</p> <p>(2) Living condition (2)-1 No. of houses where PAPs live (41) (2)-2 No. of houses where original PAPs lives do not live (22) (2)-3 No. of houses where nobody lives (5)</p>	<p>Location Map: See ANNEX.2</p>																	
4	Other issue		<p>(1). Drainage condition for rain water in their compounds</p> <p><u>Description</u> -Rainy season has started. -Some of the compounds are wet.</p>
