Surveyor: Zaw La

Date Visited: 8.10.2015

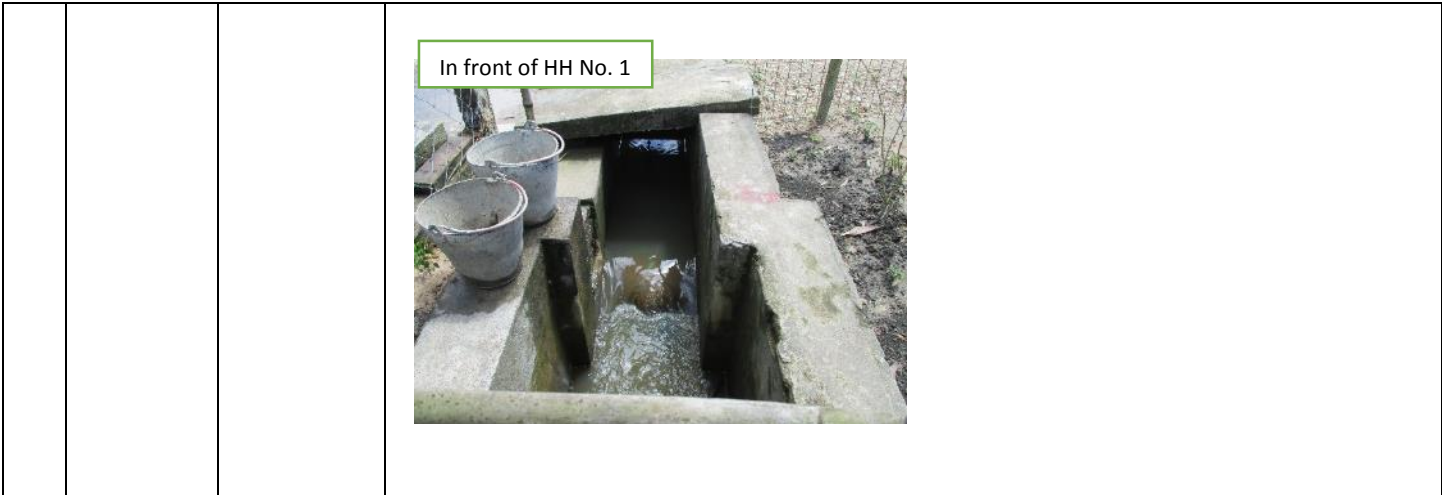
| No | Item | Condition | Description and Photos |
|---|---|---|--|
| | (2). Drainage | Improved <input type="checkbox"/> Same <input checked="" type="checkbox"/> * Worse <input type="checkbox"/> <i>*as last week</i> | Description -Water level in the drainage canals are increased than last week because there was heavy rain yesterday. The stream along the drainage canal may need to be rehabilitated in order to improve the water-flow in coming summer period. Photos <div style="display: flex; flex-wrap: wrap;"> <div style="width: 50%; text-align: center;"> <p>Near Well No. 1</p> </div> <div style="width: 50%; text-align: center;"> <p>Near HH No. 48</p> </div> <div style="width: 50%; text-align: center;"> <p>Near HH No. 1</p> </div> <div style="width: 50%; text-align: center;"> <p>Near garbage pit</p> </div> </div> |

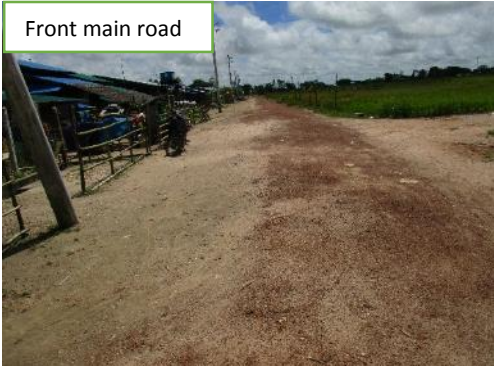
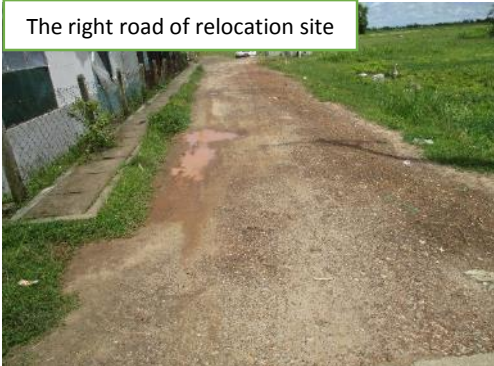
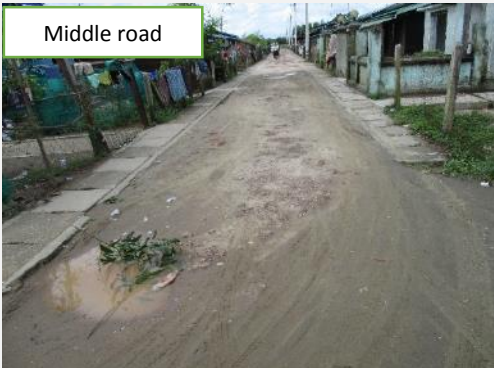
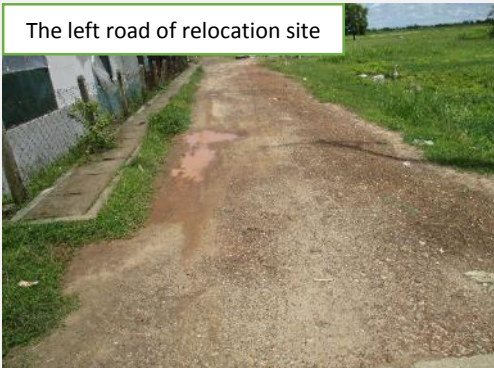
| <p>(3). Road</p> | <p>Improved <input type="checkbox"/> Same <input checked="" type="checkbox"/>* Worse <input type="checkbox"/> <i>*as last week</i></p> | <p><u>Description</u> -The roads, except some places have muddy, are almost being dry and no problem for walking.</p> <p><u>Photos</u></p> <div style="display: flex; flex-wrap: wrap;"> <div style="width: 50%; text-align: center;"> <p>Front main road</p> </div> <div style="width: 50%; text-align: center;"> <p>The right road of relocation site</p> </div> <div style="width: 50%; text-align: center;"> <p>Middle road</p> </div> <div style="width: 50%; text-align: center;"> <p>The left road of relocation site</p> </div> </div> |

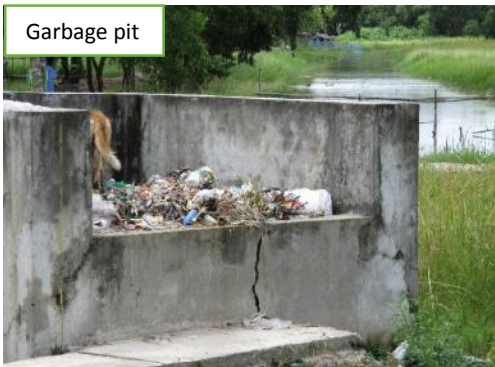
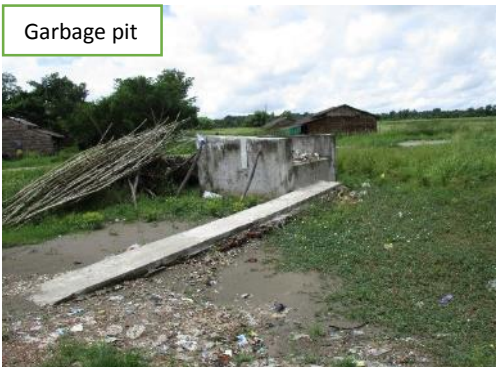
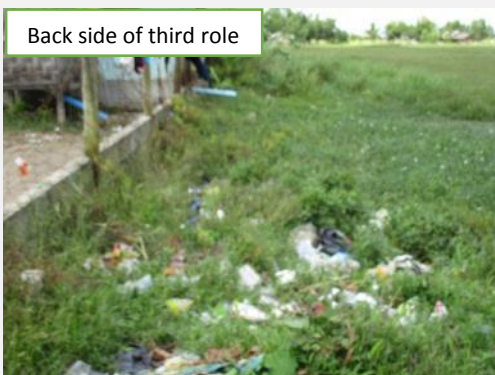
| <p>(4). Garbage Condition</p> | <p>Improved <input type="checkbox"/> Same <input checked="" type="checkbox"/>* Worse <input type="checkbox"/></p> | <p><u>Description</u> -Garbage pit is being used by people. -Garbage pit was gradually increased with trash about half-full again and it needs to be collected again. -People throw garbage at the backside of Third Row and it needs to be clean up too.</p> |

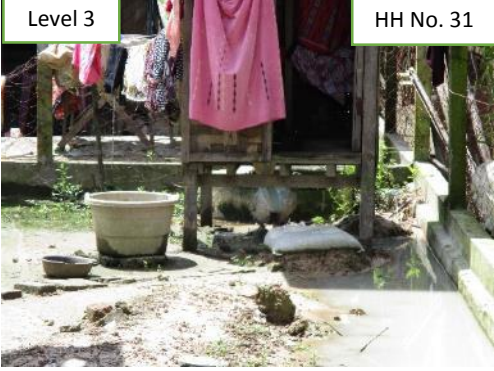
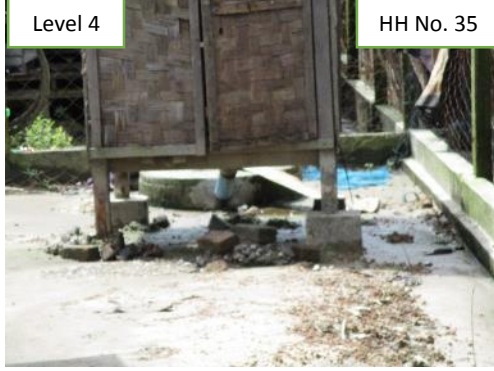
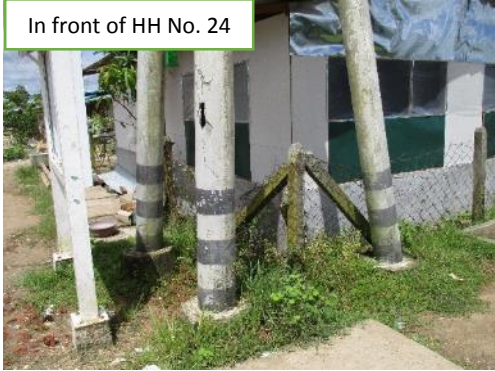
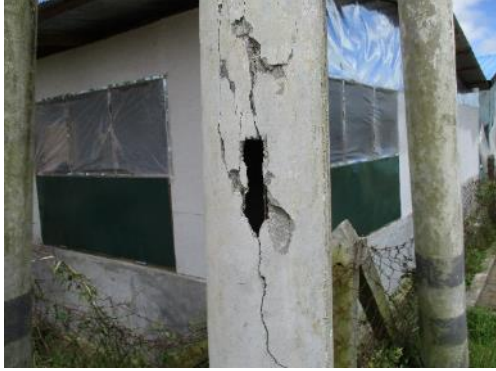
| | | | <p>Level 1 HH No. 6</p> | <p>Level 2 HH No. 12</p> |

-All of fly proof toilets are used by people.
-Almost all of fly proof toilets made by wood or bamboo have been lifted up as shown in below pictures and are convenient to use. Some concrete toilets are still needed to be renovated too as their floors are low and will be inconvenient to use sometimes when there is heavy rain and groundwater level is raised.

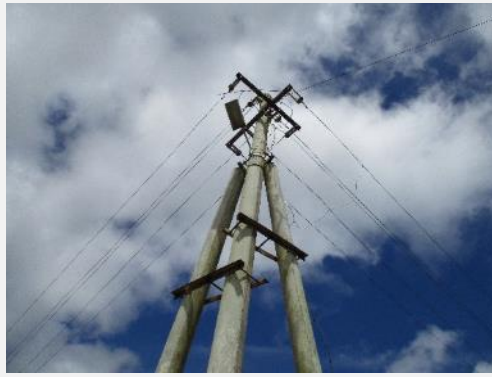
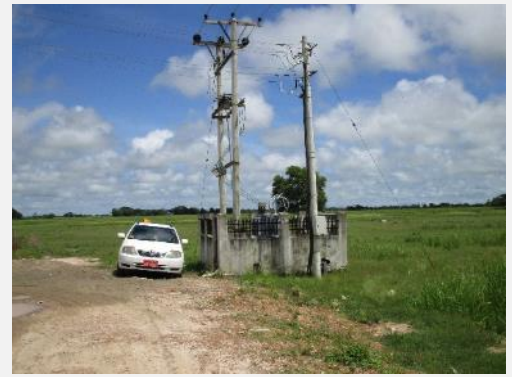
| (6). Electricity | <p>Improved <input type="checkbox"/></p> <p>Same <input checked="" type="checkbox"/>*</p> <p>Worse <input type="checkbox"/></p> <p><i>*as last week</i></p> | <p><u>Description</u></p> <ul style="list-style-type: none"> -Electricity comes regularly. -Electric poles and transformer are being supported with a good foundation. -But, there is a hole at an electric pole which was hit by a truck car. The electric pole needs to be renovated. <p><u>Photos</u></p> | <p>In front of HH No. 24</p> |

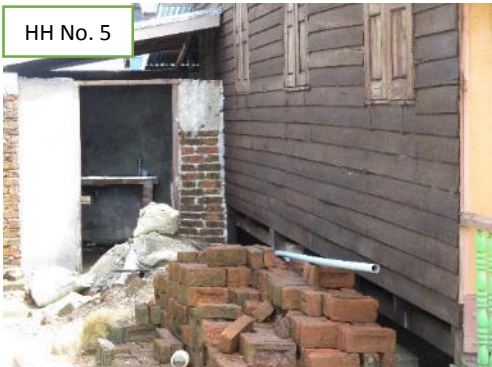
| No | Item | Condition | Description and Photos |
|---|---|--|---|
| 2 | House Construction | No. of houses not completed (2) | <p><u>Description</u> -HH No.5, the construction for kitchen, toilet and water tank seems to be stopped again.</p> |

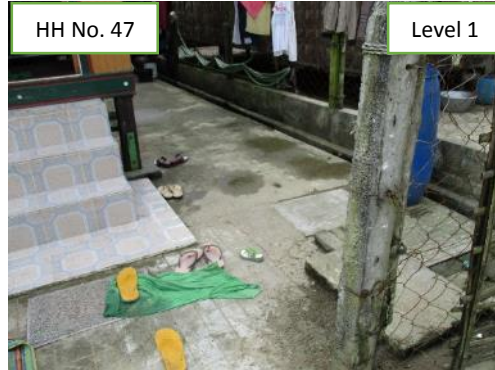
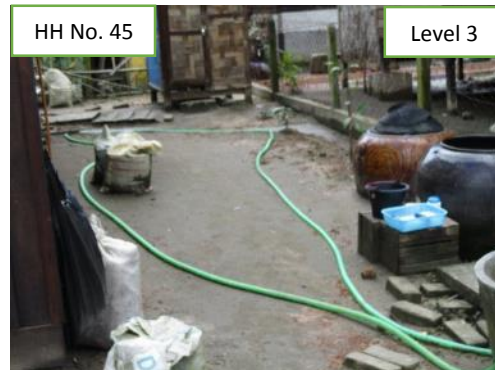
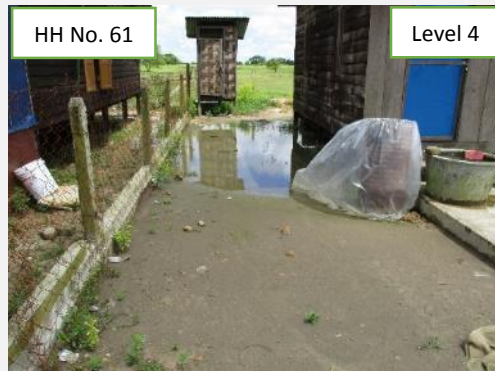
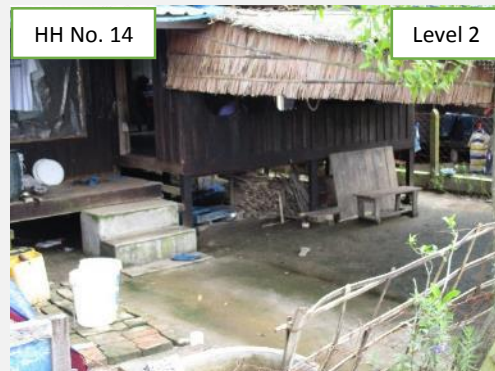
Photos

| 4 | Other issue | | | | | | | | | | | | | | | | | | | |
|---|---|--|---|---|--|---|---|---|---|---|---|---|---|---|---|---|---|---|---|--|
| | (1). Drainage condition for rain water in their compounds | <p><u>Description</u> -Rainy season has started. -Some of the compounds are wet.</p>

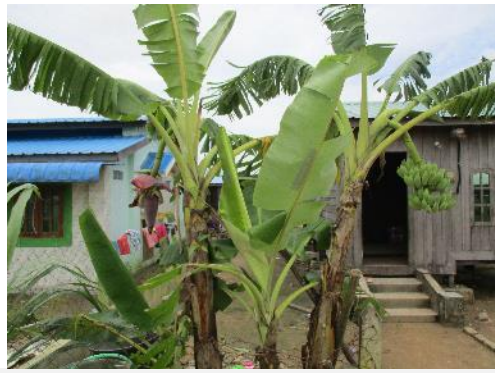
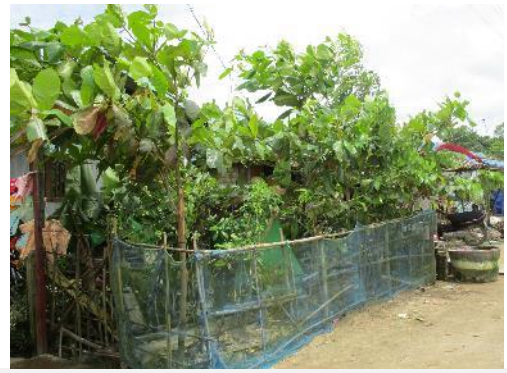
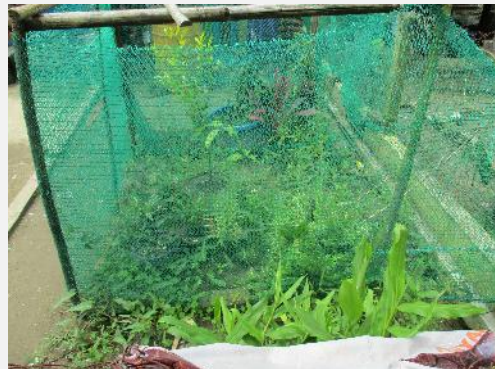
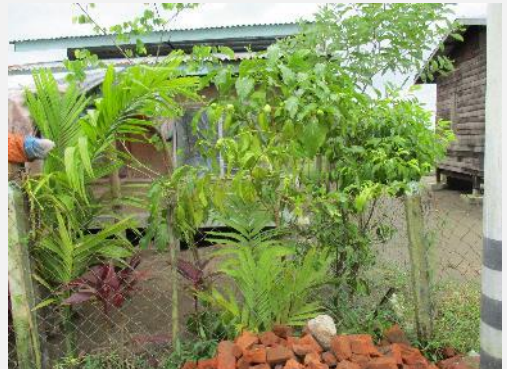
| Type | No. of HHs | Remarks |
|---|---|--|
| Vegetable | 11 | Spices, peas, roselle, etc. HH No. 15, 23, 25, 38, 39, 40, 42,45, 58, 63 and 67 |
| Floral plant | 26 | Many species. HH No. 2, 9, 14, 15, 17, 18, 19, 21, 26, 27, 30, 31, 32, 33, 38, 39, 40, 41, 42, 43, 47, 48, 58, 59, 62 and 65 |

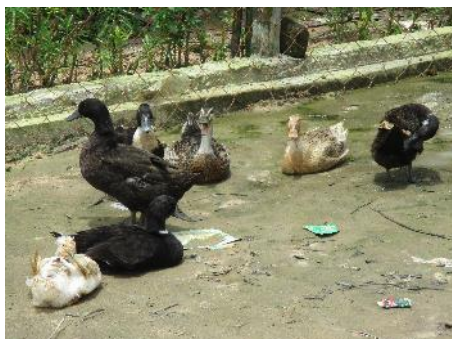
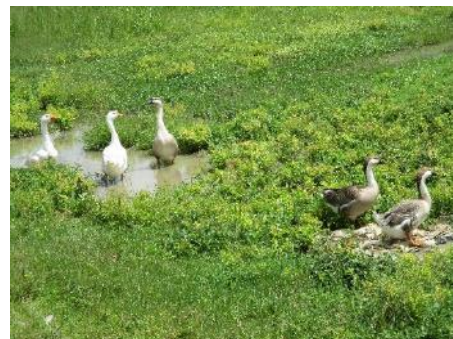
Photos

-The people are raising chicken, ducks, goats, pigs and cows.
 -Even though they have cows, some houses do not keep their cows in relocation site instead they keep in their farms or other places.

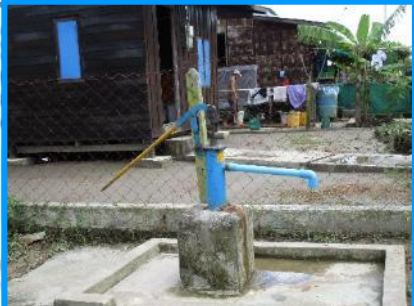
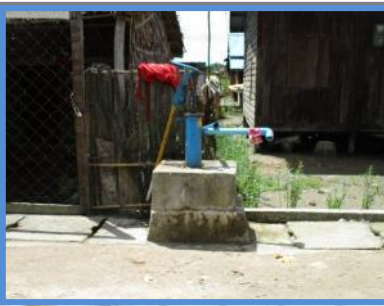
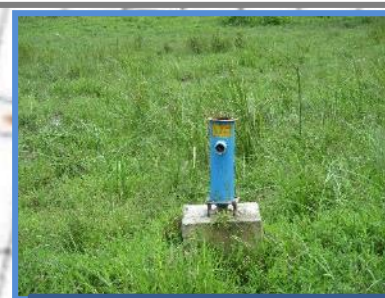
Water is clean and people nearby are using it for drinking and living use . A pulley wheel, bucket and a rope have been set up but the rope seems to be thin and it is better to be changed with thick one for the better use.

Hand pump isn't functioned.

This hand pump is functioned very well. Water is clean and people nearby are using this hand pump for drinking and living use.

As the buffer has been changed with the new one and the hand pump is functioned very well now. Water is also clean and people living nearby use it for drinking and living use again.

This well cannot be used as water is dirty. A pulley wheel, bucket and a rope have been set up but the rope seems to be thin and it is better to be changed with a thick one for the better use.

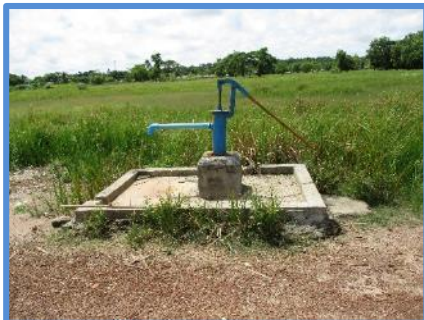
The buffer of the hand pump needs to be change. Therefore, people living nearby are using water from their owned pump or rain water at the moment.

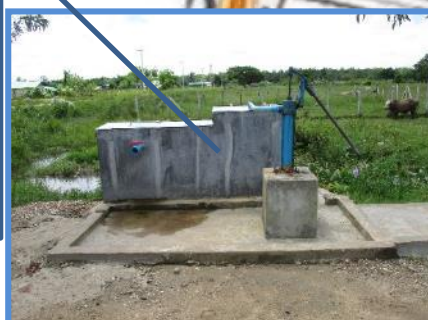
This hand pump is functioned very well. Water is clean and people living nearby are using this hand pump. Moreover water filter tank for remove the smell of iron has been set up beside the hand pump. There is no smell of iron and people enjoy water for drinking and living use.
