Weekly Field Report

Surveyor: Zaw La

Date Visited: 11.8.2015

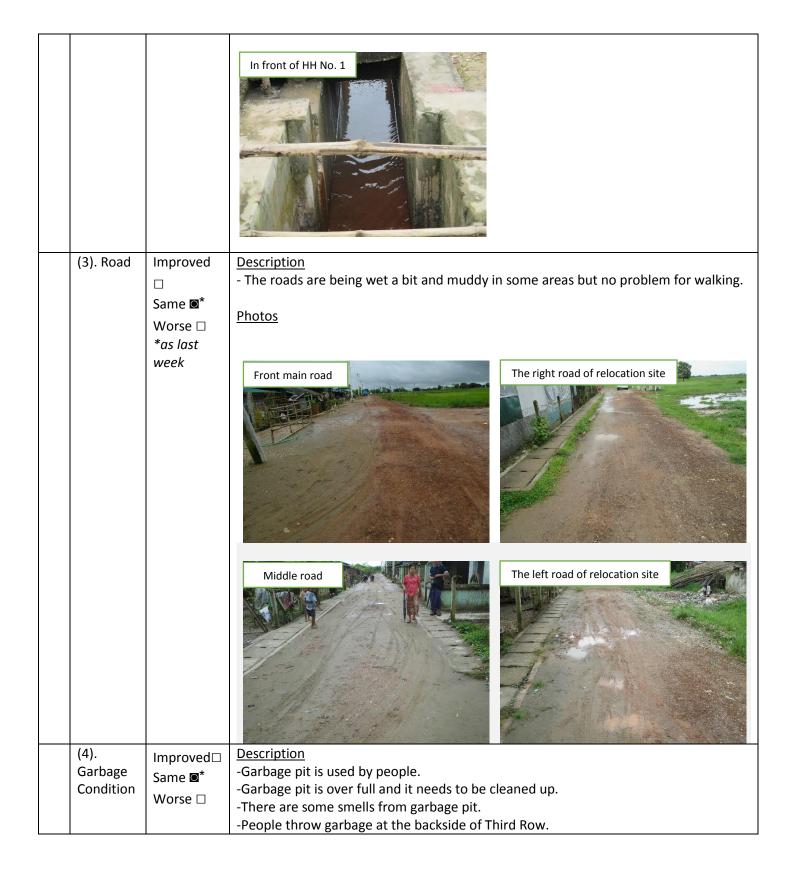
No	Item	Condition	Description and Photos		
1	Condition of -				
	(1). Well	Improved ■* Same □ Worse □ *as last week	Description & Photos: -See ANNEX.1 - Although both of the two wells are dirty with outside water last week, well no. 1 is gradually clean this week and surrounding people are using it again. To avoid entering outside water, both wells need to be renovated again in summer. All hand pumps are well functioned except the one near transformer, water is clean and the amount is enough to use.		
	(2). Drainage	Improved	Description -Water level in the drainage canals lower than last week because there was only small amount of rain last night. But, the stream along the drainage canal needs to be rehabilitated in next summer. Photos		
			Near HH No. 48 Near HH No. 48		
			Near HH No. 1 Near garbage pit
