Surveyor: Zaw La
 Date Visited: 31.8.2016
 Time Visited: 14:00 to 14:30

No	Item	Condition	Description and Photos
1	Condition of -		
	(1). Well	Improved <input type="checkbox"/> Same <input checked="" type="checkbox"/> * Worse <input type="checkbox"/> <i>*as last week</i>	Description & Photos: -See ANNEX.1 - Water from only one well is clean and can be used for drinking and living but the other well need to be cleaned as there is some trashes in the well. The amount of water in both wells is also being increased during these days. There are four tube wells in the relocation site. Among them, two of the hand pumps need to be repaired, but people can get water from their own tube-wells, one open-well and the rest of one hand pump.

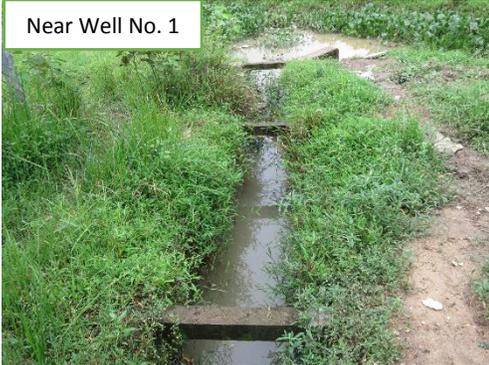
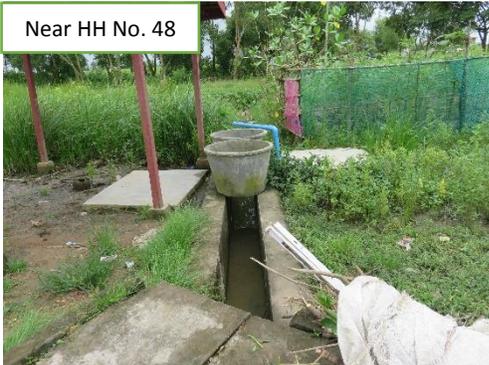
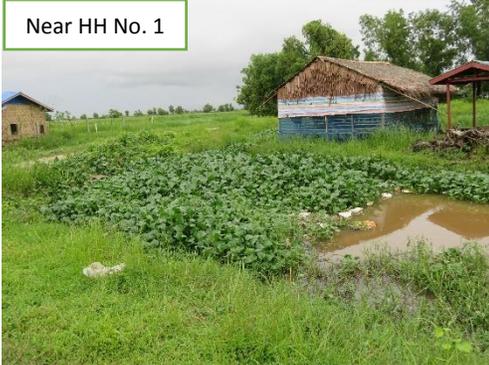
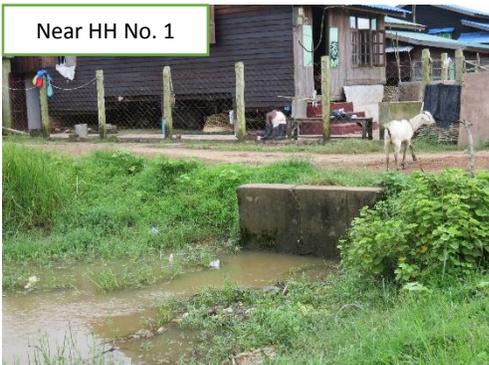
(2). <u>Drainage</u>	Improved <input type="checkbox"/> Same <input checked="" type="checkbox"/> * Worse <input type="checkbox"/> <i>*as last week</i>	<u>Description</u> There is some amount of water in the drainage canals due to the rain in the day before yesterday and some places of stream seem to be blocking at the moment. The stream along the drainage canal may need to be rehabilitated in order to improve the water-flow along the stream. <u>Photos</u> <div style="display: flex; flex-wrap: wrap;"> <div style="width: 50%; text-align: center;"> <p>Near Well No. 1</p>

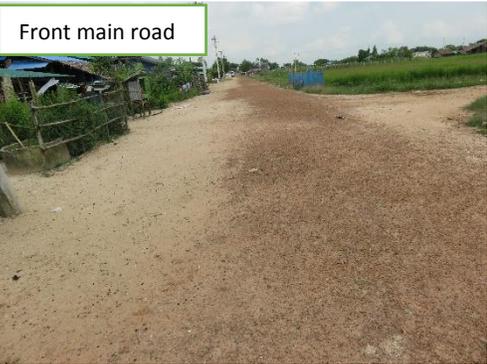
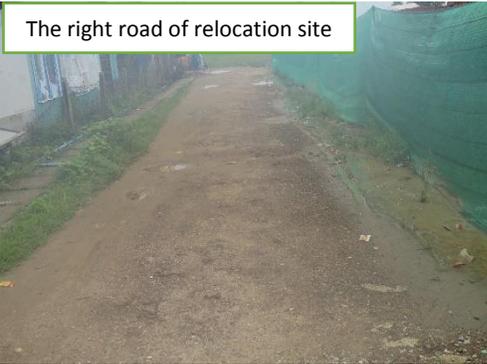
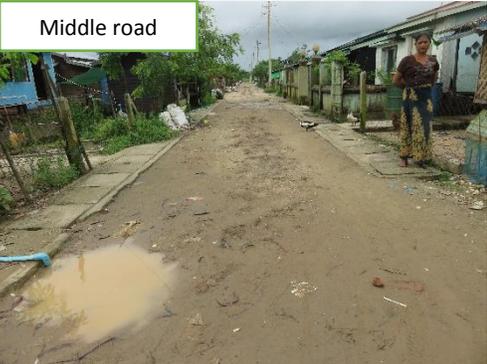
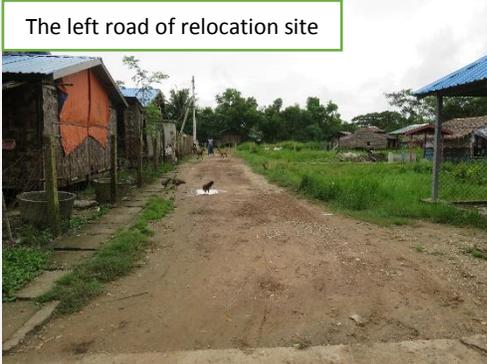
(3). Road	<p>Improved <input checked="" type="checkbox"/>*</p> <p>Same <input type="checkbox"/></p> <p>Worse <input type="checkbox"/></p> <p><i>*as last week</i></p>		<p><u>Description</u> -The roads are almost dry and no problem for walking.</p> <p><u>Photos</u></p> <div style="display: flex; flex-wrap: wrap;"> <div style="width: 50%;">

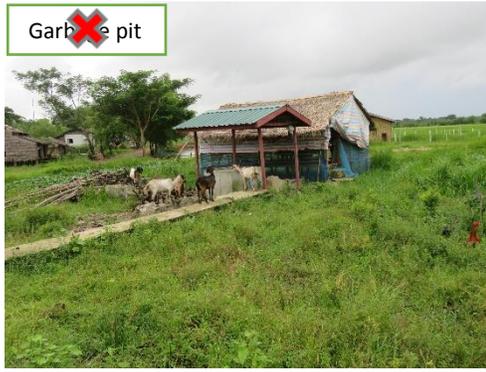
Garbage pit

(4). Garbage Condition	<p>Improved <input type="checkbox"/></p> <p>Same <input checked="" type="checkbox"/>*</p> <p>Worse <input type="checkbox"/></p>		<p><u>Description</u></p> <ul style="list-style-type: none"> - People do not want to use garbage pit again. - They do not like people to take washing clothes and showering near the well and therefore garbage pit was demolished and water storage tank has been constructed instead of it. -Trash from all houses will be collected by garbage truck biweekly until starting of the community fund. -There is a small vegetable planting field at the backside of Third Row where there were many trashes before the vegetable plantation was started.

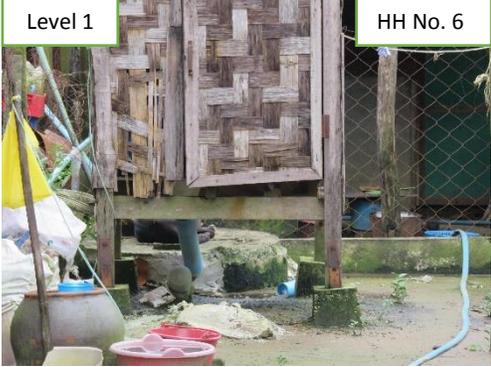
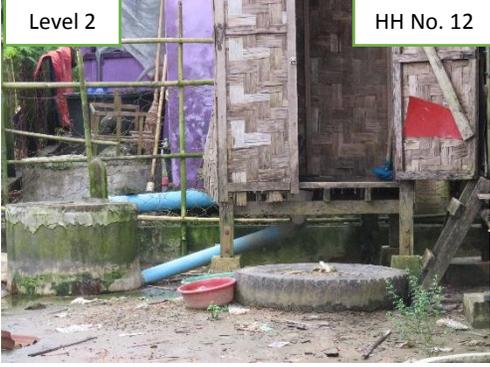
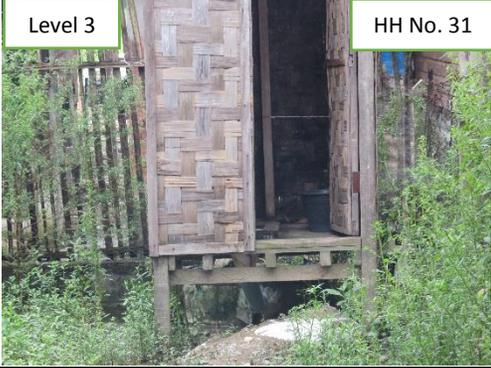
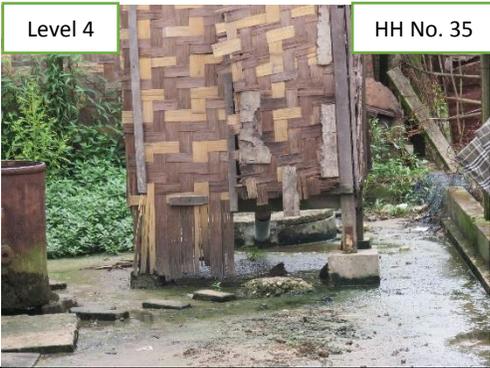
-All of the fly proof toilets are used by people.
 -Almost all of the fly proof toilets made by wood or bamboo have been lifted up as shown in pictures below and are convenient to use. Some concrete toilets are still needed to be renovated. According to discussion with community people, they would like to repair the concrete toilets by themselves and requested for financial support. JET had already paid for it.

-As the result of filling the soil and also due to the heavy rain, some toilets are inconvenience to use.

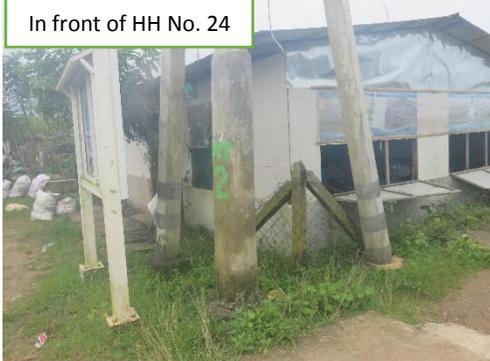
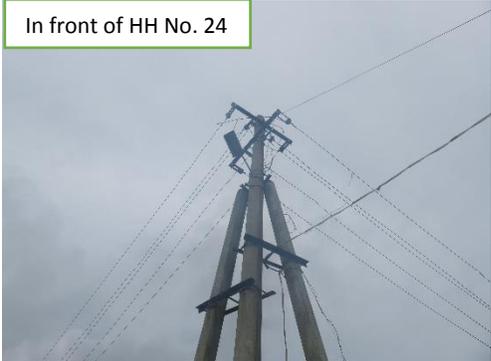
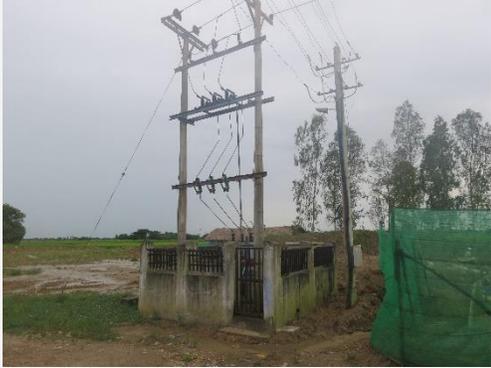
(6).	Electricity	<p>Improved <input checked="" type="checkbox"/>*</p> <p>Same <input type="checkbox"/></p> <p>Worse <input type="checkbox"/></p> <p><i>*as last week</i></p>	<p><u>Description</u></p> <ul style="list-style-type: none"> -Electricity comes regularly. -Electric poles and transformer are being supported with a good foundation. -There was a hole at an electric pole which was hit by a truck car but the electric pole was renovated. <p><u>Photos</u></p> <div style="display: flex; flex-wrap: wrap;"> <div style="width: 50%;"> <p>In front of HH No. 24</p>

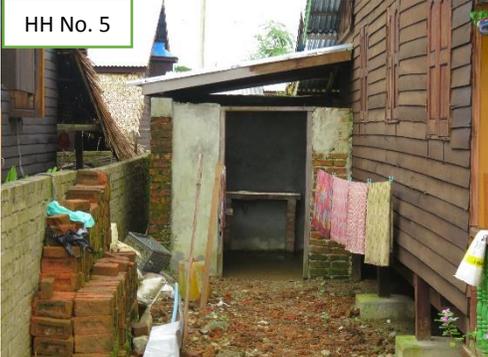
2	House Construction	No. of houses not completed (2)	<p><u>Description</u> -HH No.5, the construction for kitchen, toilet and water tank seems to be stopped again.</p>

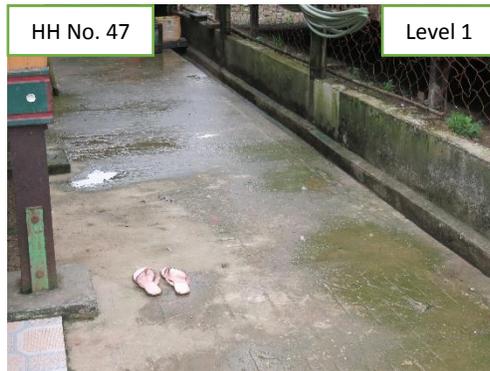
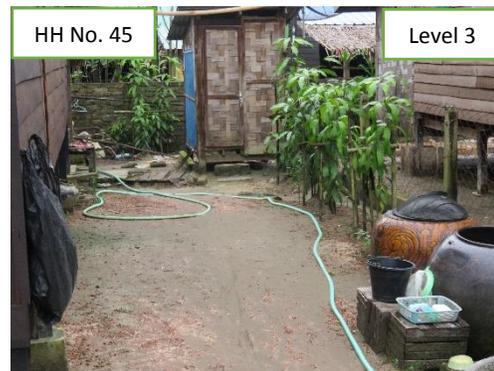
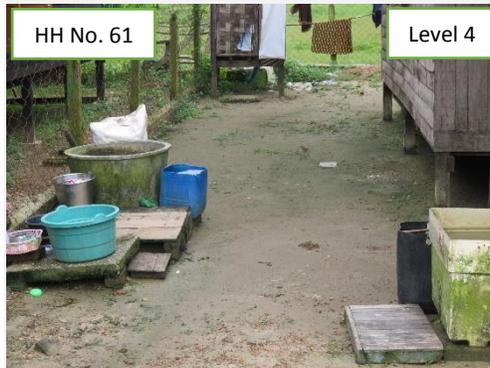
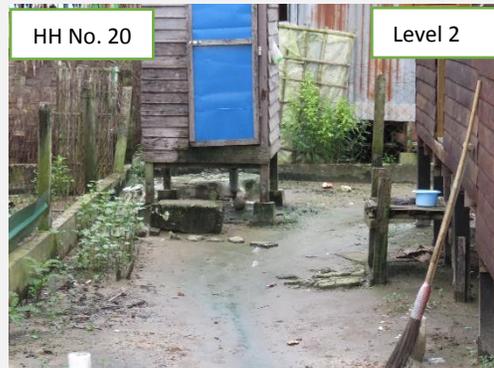
Photos

<p><Evaluation Criteria></p> <p>Level 1 -No mud and no standing water with their own drainage system in their compound</p> <p>Level 2 -No mud and no standing water in their compound</p> <p>Level 3 - Some or little mud and standing water in their compound</p> <p>Level 4 -A lot of mud and standing water in their compound</p>		Condition	No. of HHs		This week condition	Previous week condition	Level 1	63	63	Level 2	5	5	Level 3	0	0	Level 4	0	0
Condition	No. of HHs																			
	This week condition	Previous week condition																		
Level 1	63	63																		
Level 2	5	5																		
Level 3	0	0																		
Level 4	0	0

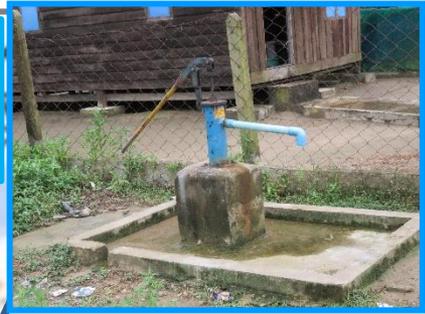
This well is repaired and now clean water can be used for drinking and living.

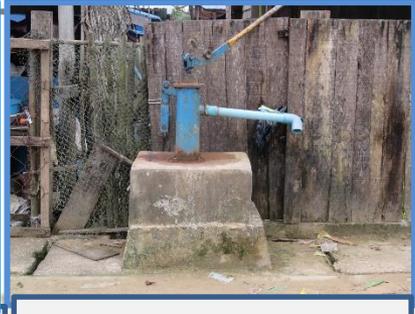
The buffer has repaired and water can be get again.

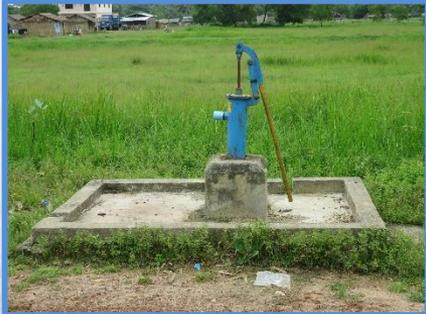
The buffer of the hand pump needs to be changed. But, people living nearby would like to use water from their owned pumps instead of this hand pump.

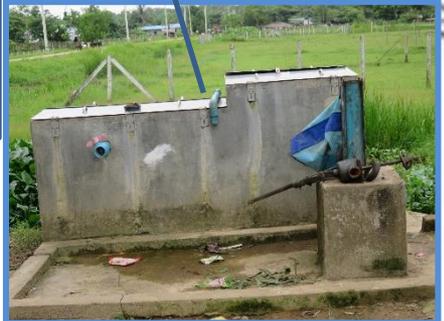
This hand pump cannot be used at the moment due to broken washer of the hand pump.
