Surveyor: Zaw La  
 Date Visited: 28.9.2016  
 Time Visited: 16:00 to 16:30

Weather Condition: cloudy  
 The last time of heavy raining: - this morning

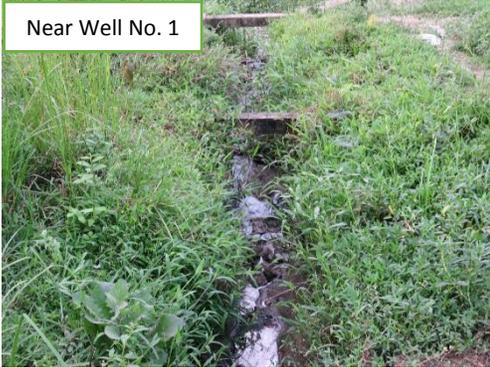
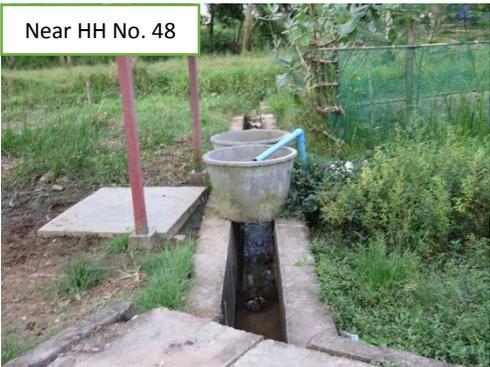
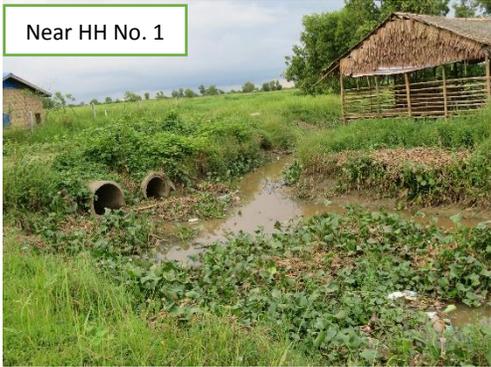
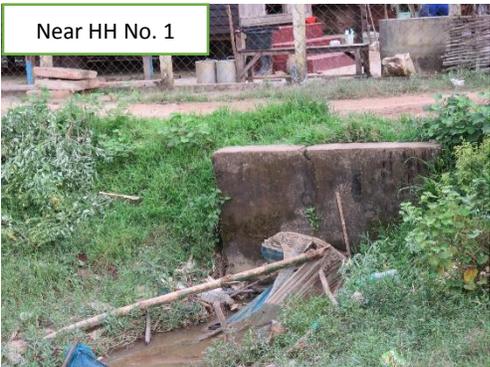
(2). <u>Drainage</u>	Improved <input type="checkbox"/> Same <input checked="" type="checkbox"/> * Worse <input type="checkbox"/> <i>*as last week</i>	<u>Description</u> There is some amount of water in the drainage canals due to the rain yesterday and some places of stream seem to be blocking at the moment. The stream along the drainage canal may need to be rehabilitated in order to improve the water-flow along the stream.  <u>Photos</u> <div style="display: flex; flex-wrap: wrap;"> <div style="width: 50%; text-align: center;"> <p>Near Well No. 1</p>

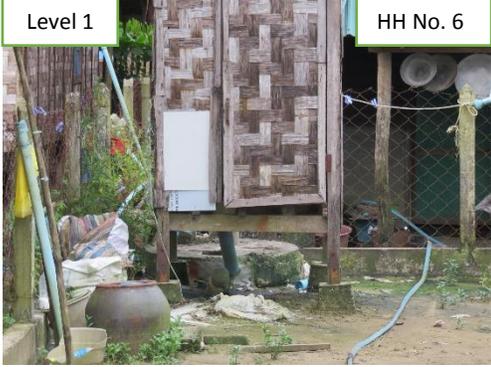
<p>HH No. 6</p> </div> <div style="width: 50%; text-align: center;"> <p>Level 2</p>

- Fly proof toilet is not needed to be repaired.
- No/rarely toilet unavailable

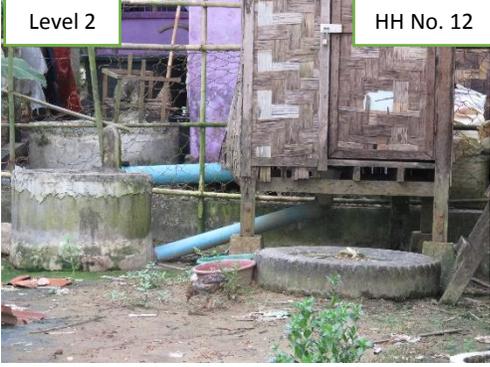
<p>HH No. 12</p> </div> <div style="width: 50%; text-align: center;"> <p>Level 3</p>

- Fly proof toilet is needed to be repaired.
- Rarely toilet unavailable

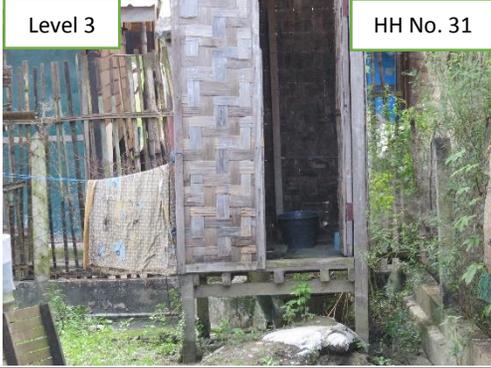
<p>HH No. 31</p> </div> <div style="width: 50%; text-align: center;"> <p>Level 4</p>

- Fly proof toilet is needed to be repaired.
- Often toilet unavailable

-As the result of filling the soil and also due to the heavy rain, some toilets are inconvenience to use.

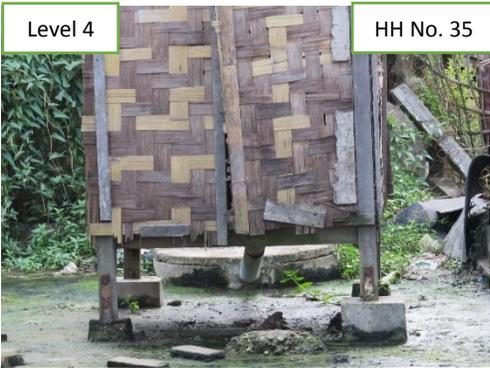
<p>HH No. 35</p> </div> </div>
--	--	--

- Fly proof toilet is urgently needed to be repaired.

<p>-Often toilet unavailable</p> <div style="display: flex; flex-wrap: wrap;"> <div style="width: 50%; text-align: center;"> <p>Level 1</p>

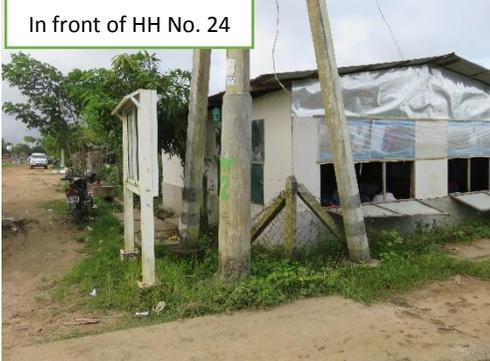
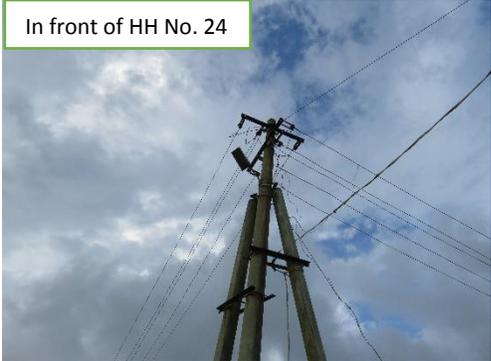
(6). Electricity	<p>Improved <input checked="" type="checkbox"/>*</p> <p>Same <input type="checkbox"/></p> <p>Worse <input type="checkbox"/></p> <p><i>*as last week</i></p>	<p><u>Description</u></p> <ul style="list-style-type: none"> <li>-Electricity comes regularly.</li> <li>-Electric poles and transformer are being supported with a good foundation.</li> <li>-There was a hole at an electric pole which was hit by a truck car but the electric pole was renovated.</li> </ul> <p><u>Photos</u></p> <div style="display: flex; flex-wrap: wrap;"> <div style="width: 50%; text-align: center;"> <p>In front of HH No. 24</p>

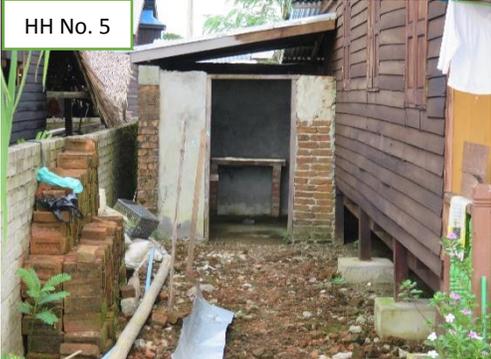
2	House Construction	No. of houses not completed (2)	<p><u>Description</u> -HH No.5, the construction for kitchen, toilet and water tank seems to be stopped again.</p>

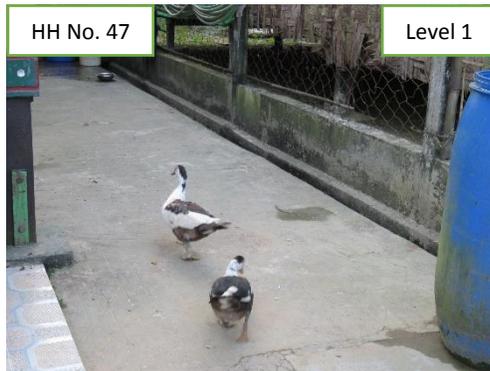
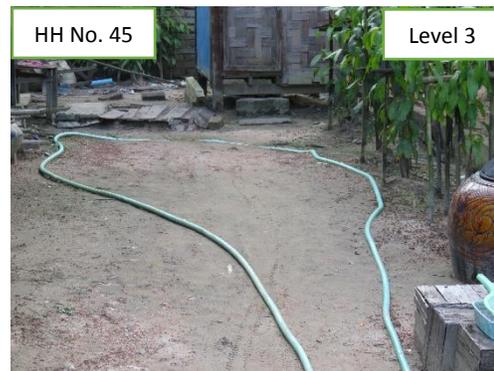
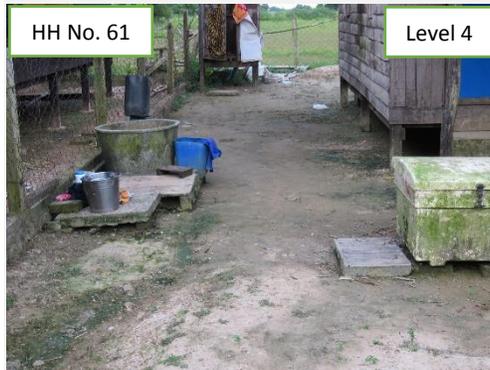
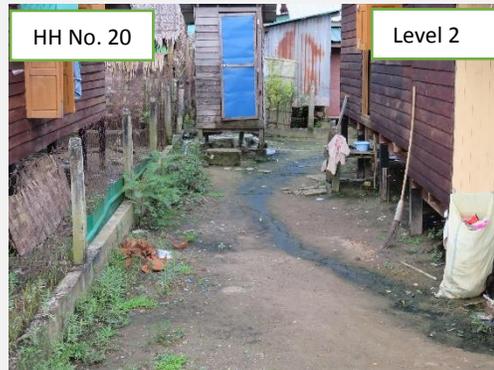
Photos

<p><b>&lt;Evaluation Criteria&gt;</b>  <b>Level 1</b> -No mud and no standing water with their own drainage system in their compound  <b>Level 2</b> -No mud and no standing water in their compound  <b>Level 3</b> - Some or little mud and standing water in their compound  <b>Level 4</b> -A lot of mud and standing water in their compound</p>		Condition	No. of HHs		This week condition	Previous week condition	Level 1	63	63	Level 2	5	5	Level 3	0	0	Level 4	0	0
Condition	No. of HHs																			
	This week condition	Previous week condition																		
Level 1	63	63																		
Level 2	5	5																		
Level 3	0	0																		
Level 4	0	0

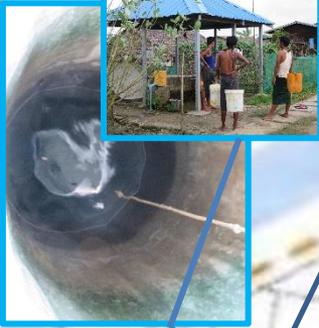
This well is repaired and now clean water can be used for drinking and living.

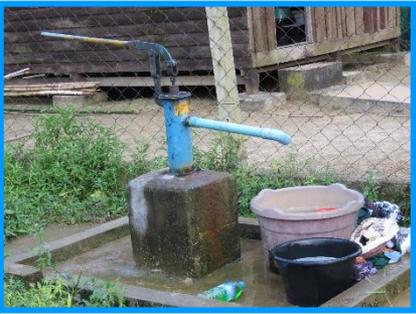
The buffer has repaired and water can be get again.

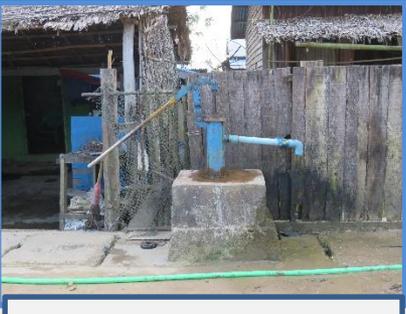
This hand pump is functioned very well. Water is clean and people nearby are using this hand pump for drinking and living.

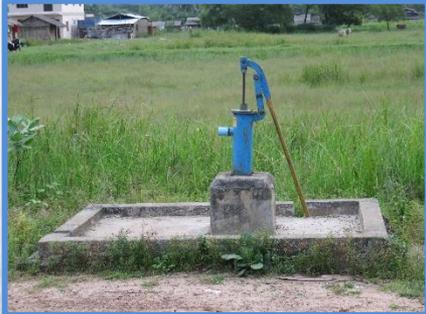
The buffer of the hand pump needs to be changed. But, people living nearby would like to use water from their owned pumps instead of this hand pump.

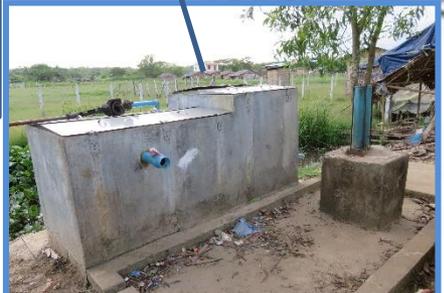
This hand pump cannot be used at the moment due to broken washer of the hand pump.
