Surveyor: Zaw La
 Date Visited: 25.11.2016
 Time Visited: 15:00 to 16:00

No	Item	Condition	Description and Photos
1	Condition of -		
	(1). Well	Improved <input type="checkbox"/> Same <input checked="" type="checkbox"/> * Worse <input type="checkbox"/> <i>*as last week</i>	Description & Photos: -See ANNEX.1 - Water from only one open-well is clean and can be used for drinking and living but the other open-well need to be cleaned as there is some trashes in the well. There are four tube wells in the relocation site. Among them, two of the hand pumps need to be repaired, but people can get water from their own tube-wells, one open-well and the rest of one hand pump.

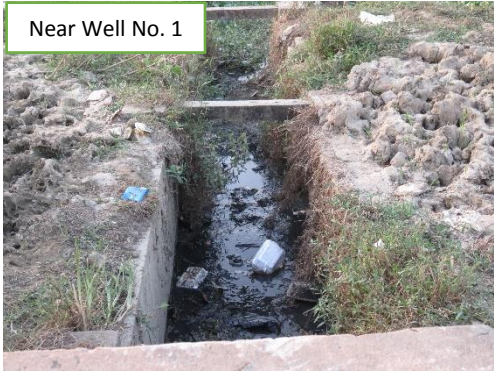
<p>Near Well No. 1</p> </div> <div style="width: 50%; text-align: center;">

(2). <u>Drainage</u>	Improved <input type="checkbox"/> Same <input checked="" type="checkbox"/> * Worse <input type="checkbox"/> <i>*as last week</i>	<u>Description</u> There is some amount of water in the drainage canals and some places of stream seem to be blocking at the moment. The stream along the drainage canal may need to be rehabilitated in order to improve the water-flow along the stream. <u>Photos</u> <div style="display: flex; flex-wrap: wrap;"> <div style="width: 50%; text-align: center;">

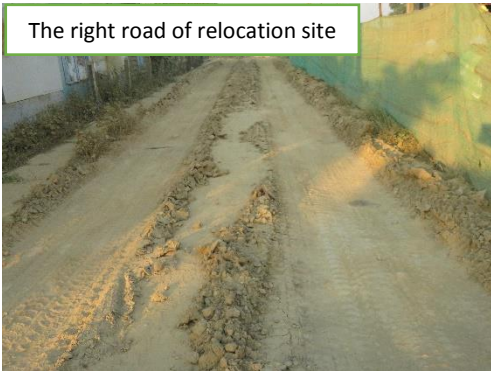
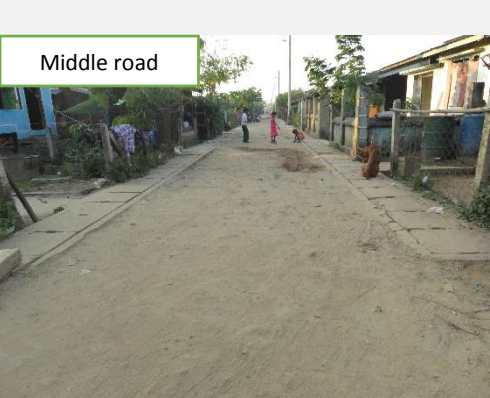
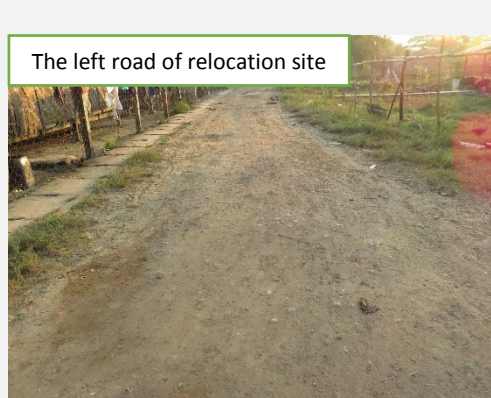
(3). Road	<p>Improved <input checked="" type="checkbox"/>*</p> <p>Same <input type="checkbox"/></p> <p>Worse <input type="checkbox"/></p> <p><i>*as last week</i></p>	<p><u>Description</u></p> <p>-The roads are dry and no problem for walking.</p> <p><u>Photos</u></p>

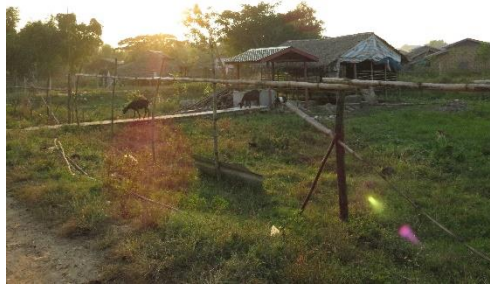
Garbage pit

(4). Garbage Condition	<p>Improved <input type="checkbox"/></p> <p>Same <input checked="" type="checkbox"/>*</p> <p>Worse <input type="checkbox"/></p>	<p><u>Description</u></p> <p>- People do not want to use garbage pit again.</p> <p>- They do not like people to take washing clothes and showering near the well and therefore garbage pit was demolished and water storage tank has been constructed instead of it.</p> <p>-Trash from all houses will be collected by garbage truck biweekly until starting of the community fund.</p> <p>-There was a small seasonal vegetable planting field at the backside of Third Row. Now the season is over and there will be a small plantation field in next season.</p>

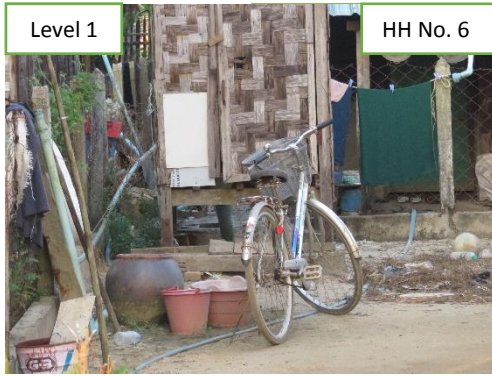
HH No. 6

-All of the fly proof toilets are used by people.
-Almost all of the fly proof toilets made by wood or bamboo have been lifted up as shown in pictures below and are convenient to use. Some concrete toilets are still needed to be renovated. According to discussion with community people, they would like to repair the concrete toilets by themselves and requested for financial support. JET had already paid for it.

- Fly proof toilet is not needed to be repaired.
- No/rarely toilet unavailable

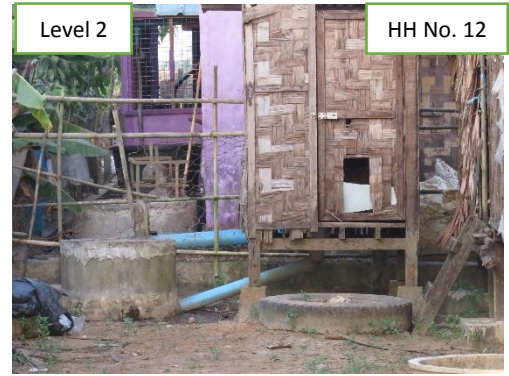
HH No. 12

- Fly proof toilet is needed to be repaired.
- Rarely toilet unavailable

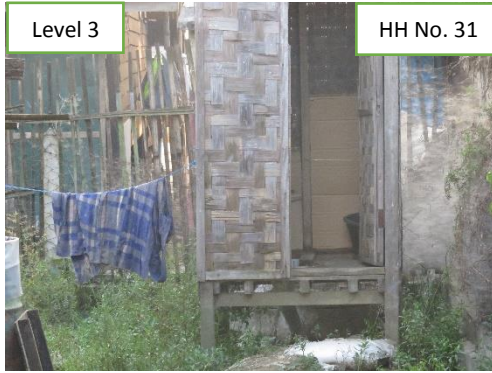
HH No. 31

- Fly proof toilet is needed to be repaired.
- Often toilet unavailable
- As the result of filling the soil and also due to the heavy rain, some toilets are inconvenience to use.

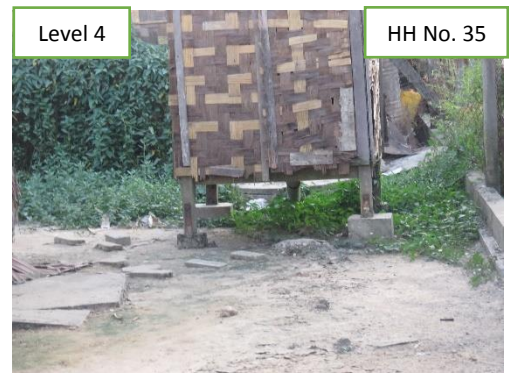
HH No. 35

- Fly proof toilet is urgently needed to be repaired.

-Often toilet unavailable

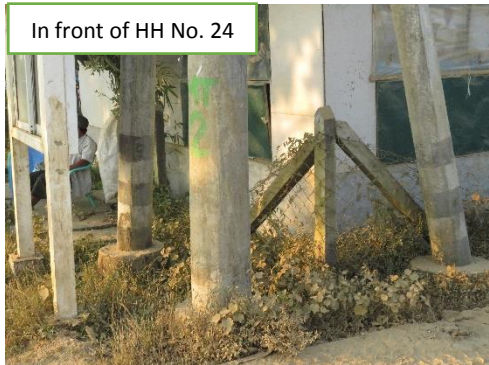
In front of HH No. 24

-Electricity comes regularly.
-Electric poles and transformer are being supported with a good foundation.
-There was a hole at an electric pole which was hit by a truck car but the electric pole was renovated.

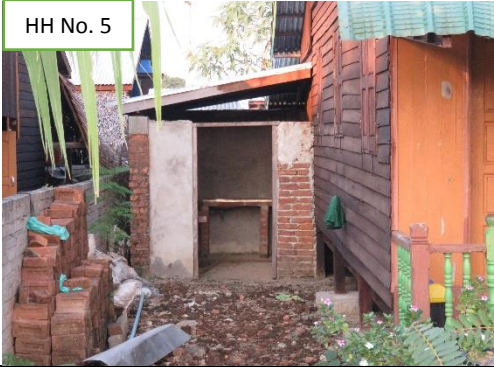
No	Item	Condition	Description and Photos																	
2	House Construction	No. of houses not completed (2)	<p><u>Description</u> -HH No.5, the construction for kitchen, toilet and water tank seems to be stopped again.</p>

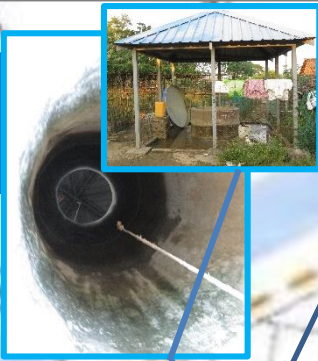
This well is repaired and now clean water can be used for drinking and living.

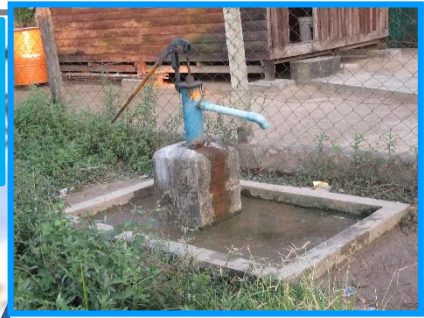
The buffer has repaired and water can be get again.

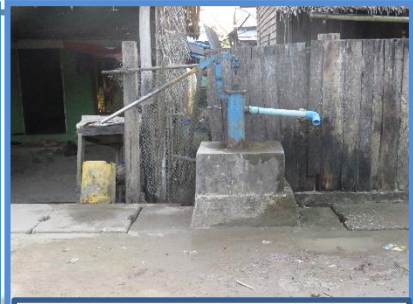
This hand pump is functioned very well. Water is clean and people nearby are using this hand pump for drinking and living.

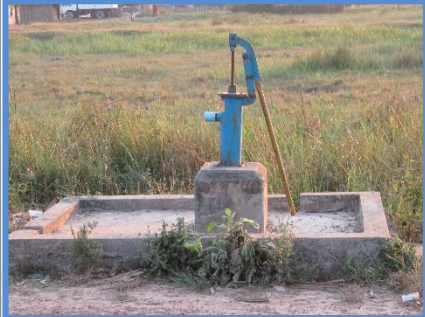
The buffer of the hand pump needs to be changed. But, people living nearby would like to use water from their owned pumps instead of this hand pump.

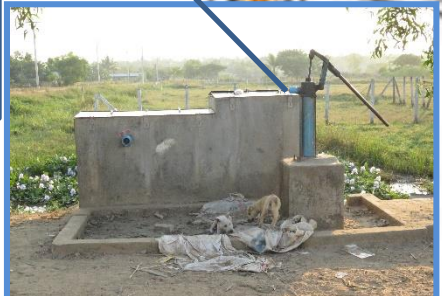
This hand pump cannot be used at the moment due to broken washer of the hand pump.
