Surveyor <u>Zaw La</u> Date visited <u>26 Apr 2018</u>		Weather Condition Sunny		
	Time visited $16:15 \text{ am}$		The last time of heavy raining Oct, 2017		
N O	Item	Condition	Description and Photos		
1	(1) Well	Improved□ Same <b>©</b> * Worse □ *as last week	<ul> <li>Water from two open-wells is clean and can be used for drinking and living. There are eleven tube wells in the relocation site. People mainly use water from pipeline water distribution system so that no body use the tube wells and JET asked them to let know if the tube wells are need to be repaired.</li> </ul>		
			Open Well No. 1		
			Tube Well No. 1		
			Tube Well No.3		
			Tube Well No.5

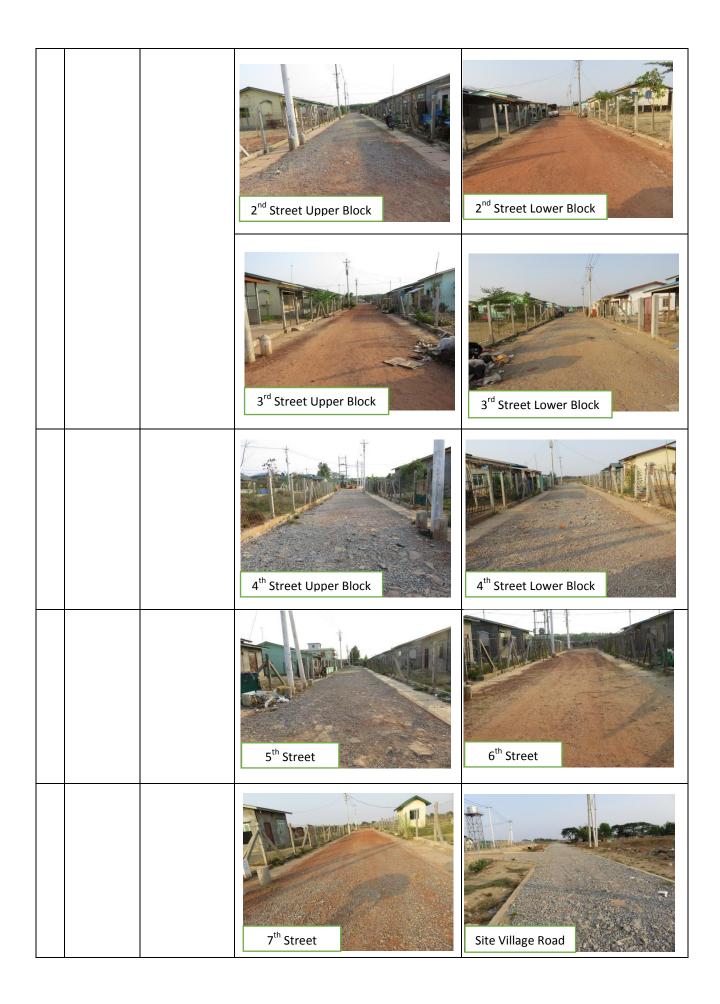
Tube Well No.7	Tube Well No.6		
(2) Drain	age Same <b>■</b> * Worse □	<ul> <li>There is no water in the draina</li> <li>Photos</li> </ul>	ge canals at the moment.		
	*as last week	Drain at the corner of Main Road A and B	Drain exit at the corner of Site village road and 2 <sup>nd</sup> street		
		Drain exit at the corner of Site village road and 3 <sup>rd</sup> street	Drain exit at the corner of Site village road and Main Road C		
(3) Ro	oad Improved□ Same ■* Worse □	<ul> <li>All the roads are dry and no problem for walking.</li> <li><u>Photos</u></li> </ul>			
	*as last week	Main Road - B	1 <sup>st</sup> Street

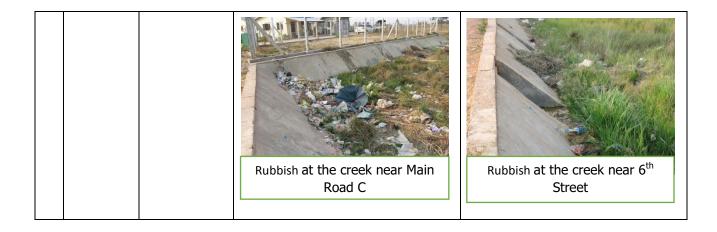
(4) Garbage Condition	Improved□ Same <b>©</b> * Worse □ *as last week	<ul> <li>People throw the trash at the corner of road, beside the creek and even in front of their houses before they got enough garbage bins.</li> <li>There are fourteen garbage bins are provided and they are kept the corner of each road and almost all garbage bins are full and there are some trashes beside the creek.</li> </ul>		
		<u>Photos</u>		
		Rubbish bin at the corner of Main Road B and Road No. 1	Rubbish bin at the corner of Main Road B and Road No. 2	
		Rubbish bin at the corner of Main Road B and Road No. 3	Rubbish bin at the corner of Main Road B and Road No. 4	
		Rubbish bin at Main Road - C	Rubbish bin at the corner of Creek Road and 5 <sup>th</sup> Street	
		Rubbish at the creek near 1st street	Rubbish at the creek near 2nd street
