# **Weekly Field Report**

Surveyor: Zaw La

Date Visited: 25.2.2016

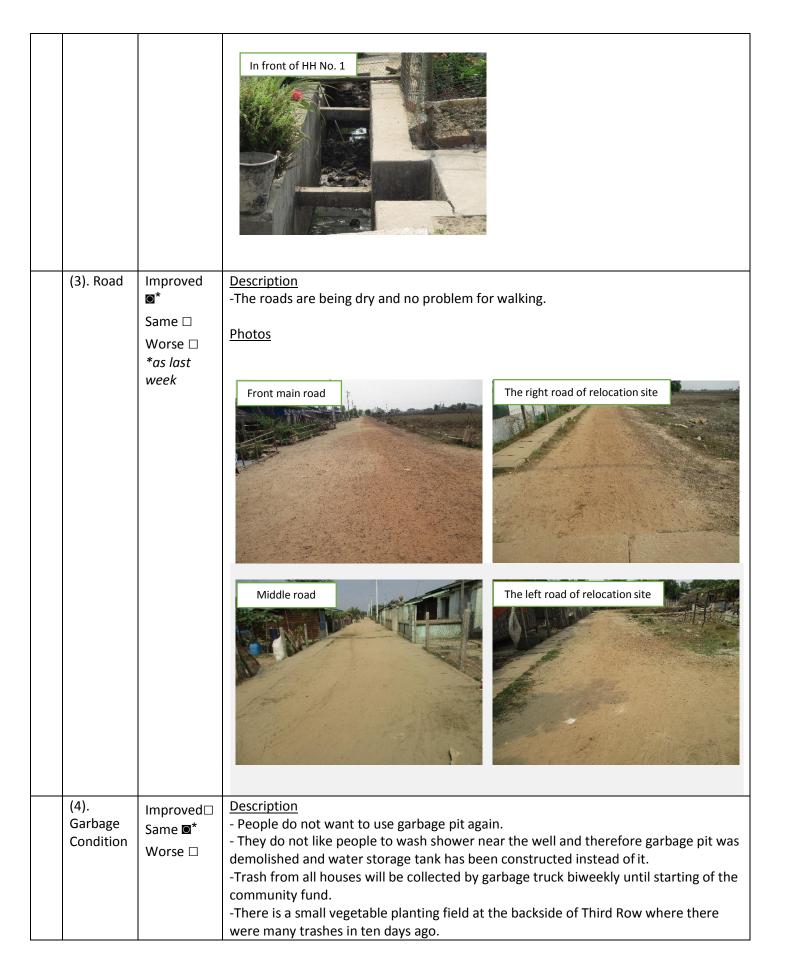
No	Item	Condition	Description and Photos		
1	Condition of	of -			
	(1). Well	Improved□ Same• *Worse□  *as last week	Description & Photos: -See ANNEX.1 - Water from both of two wells are clean and enough to use for drinking and living. There are four tube wells in the relocation site. Among them, two of the hand pumps need to be repaired, but people can get water from their own tube-wells, the rest of two hand pumps and the two wells.		
	(2). Drainage	Improved□ Same ■* Worse □ *as last week	-Water level in the drainage canals are the same as last week because there was no rain. The stream along the drainage canal may need to be rehabilitated in coming summer period in order to improve the water-flow along the stream.  Photos		
			Near Well No. 1  Near HH No. 48		
			Near HH No. 1  Near garbage pit
