Surveyor: Zaw La

Date Visited: 15.2.2016

No	Item	Condition	Description and Photos
1	Condition of -		
	(1). Well	Improved <input type="checkbox"/> Same <input checked="" type="checkbox"/> * Worse <input type="checkbox"/> <i>*as last week</i>	Description & Photos: -See ANNEX.1 - Water from both of two wells are clean and enough to use for drinking and living. One of the hand pumps needs to be repaired, but people can get water from their own tube-wells, some hand pumps and the two wells.

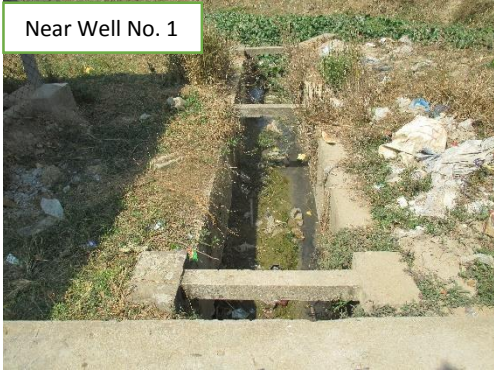
<p>Near Well No. 1</p> </div> <div style="width: 50%; text-align: center;">

(2). Drainage	Improved <input type="checkbox"/> Same <input checked="" type="checkbox"/> * Worse <input type="checkbox"/> <i>*as last week</i>	Description -Water level in the drainage canals are the same as last week because there was no rain. The stream along the drainage canal may need to be rehabilitated in coming summer period in order to improve the water-flow along the stream. Photos <div style="display: flex; flex-wrap: wrap;"> <div style="width: 50%; text-align: center;">

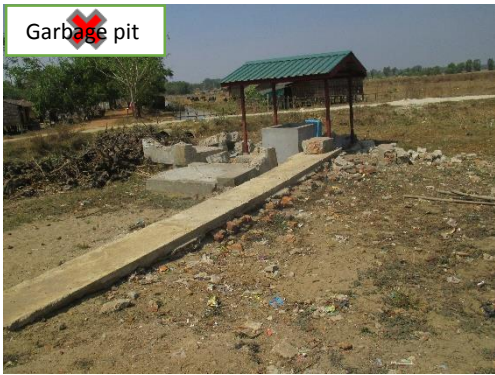
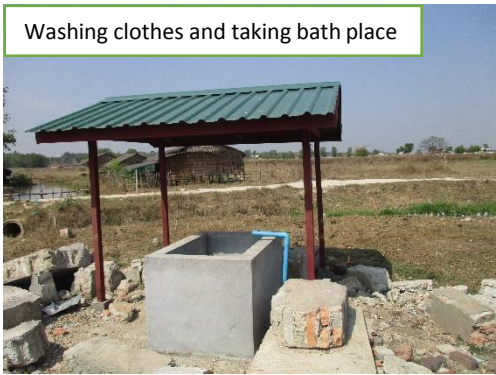
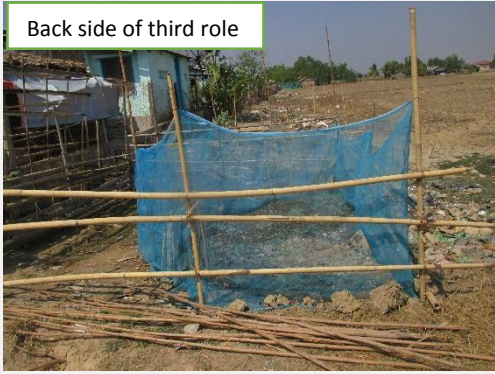
(4). Garbage Condition	<p>Improved <input type="checkbox"/></p> <p>Same <input checked="" type="checkbox"/>*</p> <p>Worse <input type="checkbox"/></p>	<p><u>Description</u></p> <p>- People do not want to use garbage pit again.</p> <p>- They do not like people to wash shower near the well and therefore garbage pit was demolished and water storage tank has been constructed instead of it.</p> <p>-Trash from all houses will be collected by garbage truck biweekly until starting of the community fund.</p> <p>-There is a small vegetable planting field at the backside of Third Row where there were many trashes in ten days ago.</p>

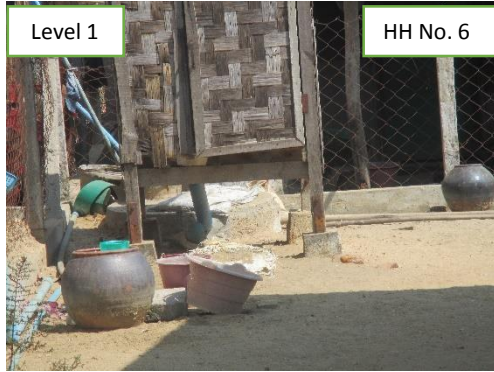
HH No. 6

- Fly proof toilet is not needed to be repaired.
- No/rarely toilet unavailable

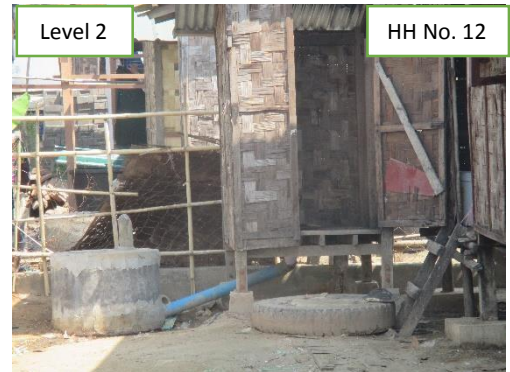
HH No. 12

- Fly proof toilet is needed to be repaired.
- Rarely toilet unavailable

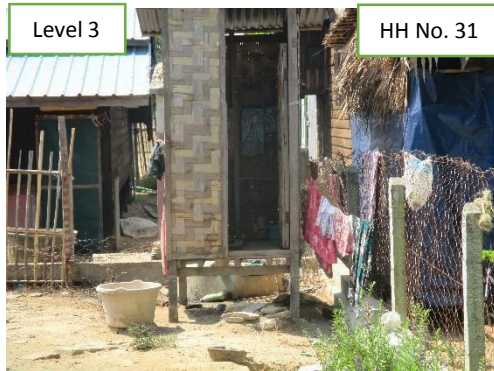
HH No. 31

- Fly proof toilet is needed to be repaired.
- Often toilet unavailable
- As the result of filling the soil and also raining, some toilets are inconvenience to use.

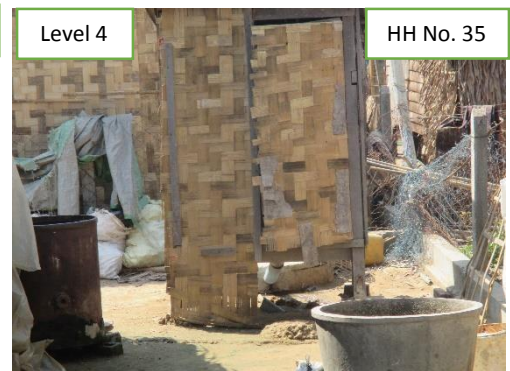
HH No. 35

- Fly proof toilet is urgently needed to be repaired.
- Often toilet unavailable

-After filling the soil, some toilets need to be lifted up.

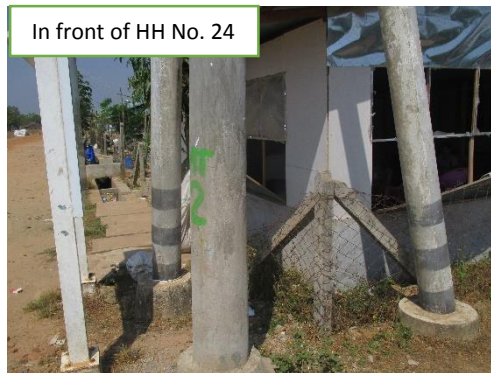
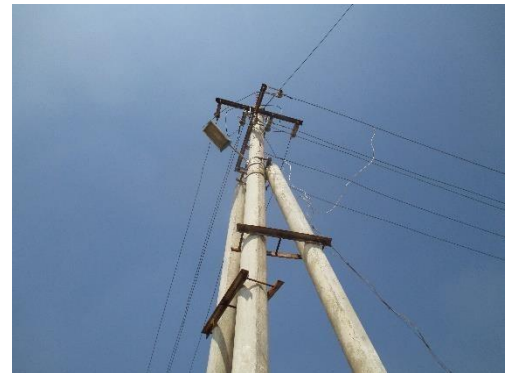
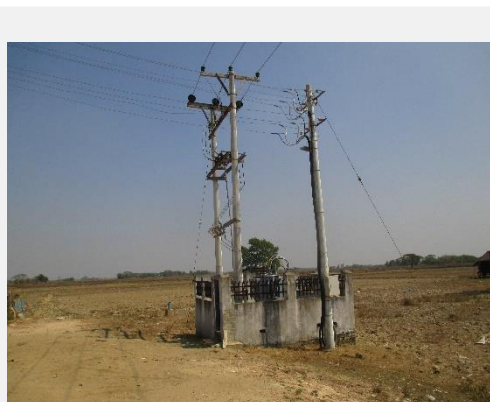
In front of HH No. 24

-Electricity comes regularly.
-Electric poles and transformer are being supported with a good foundation.
-There was a hole at an electric pole which was hit by a truck car, but the electric pole was renovated.

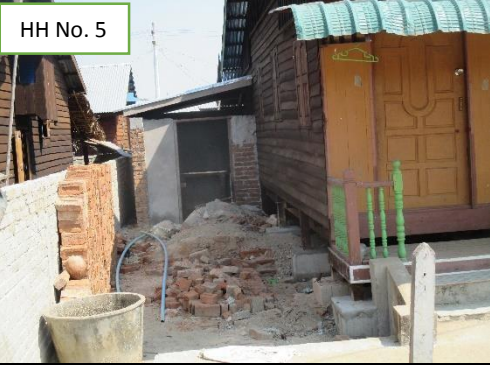
No	Item	Condition	Description and Photos																	
2	House Construct-ion	No. of houses not completed (2)	<p><u>Description</u> -HH No.5, the construction for kitchen, toilet and water tank seems to be stopped again.</p>

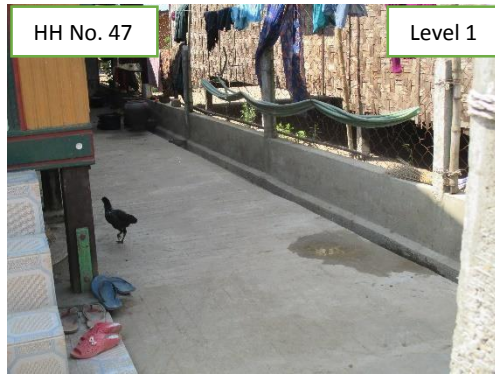
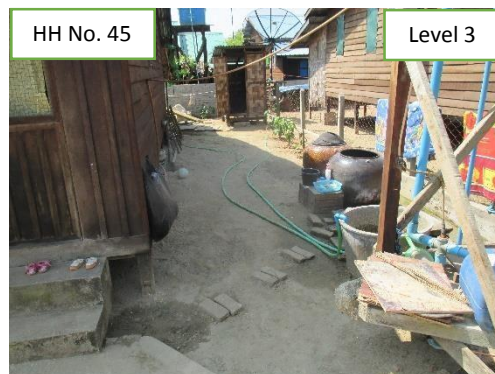
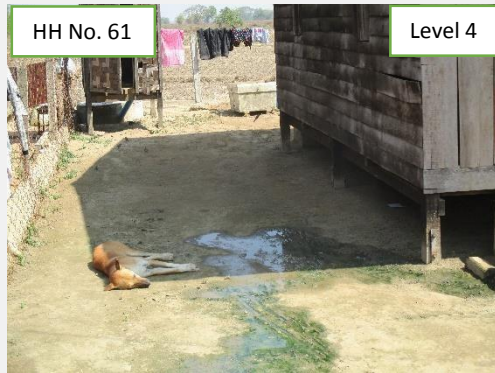
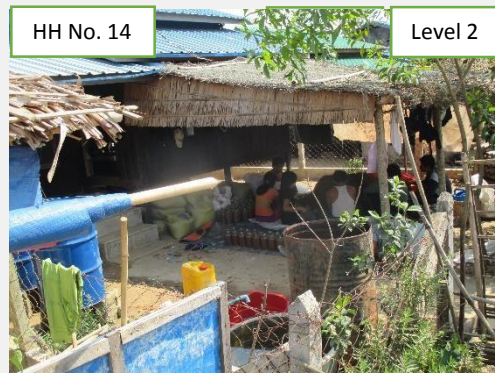
<p><Evaluation Criteria></p> <p>Level 1 -No mud and no standing water with their own drainage system in their compound</p> <p>Level 2 -No mud and no standing water in their compound</p> <p>Level 3 - Some or little mud and standing water in their compound</p> <p>Level 4 -A lot of mud and standing water in their compound</p>	Condition	No. of HHs		This week condition	Previous week condition	Level 1	63	63	Level 2	5	5	Level 3	0	0	Level 4	0	0
Condition	No. of HHs																			
	This week condition	Previous week condition																		
Level 1	63	63																		
Level 2	5	5																		
Level 3	0	0																		
Level 4	0	0

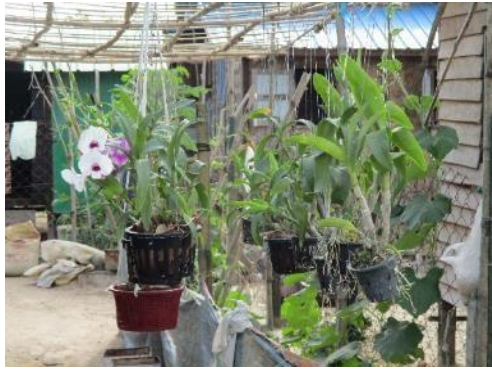
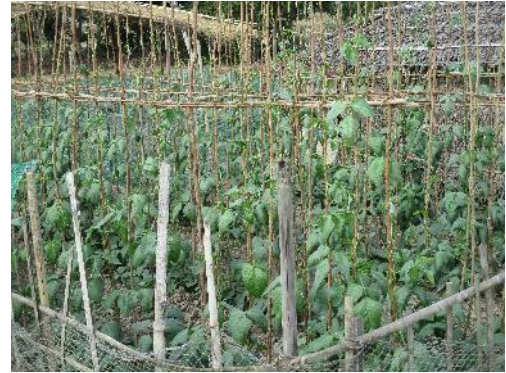
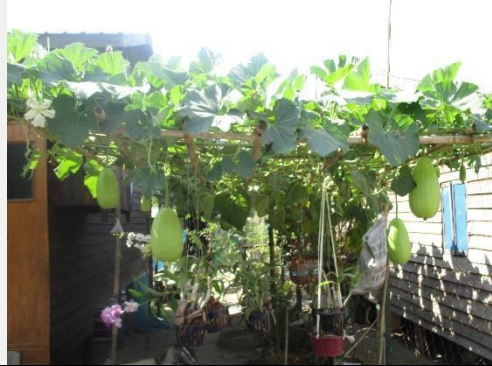
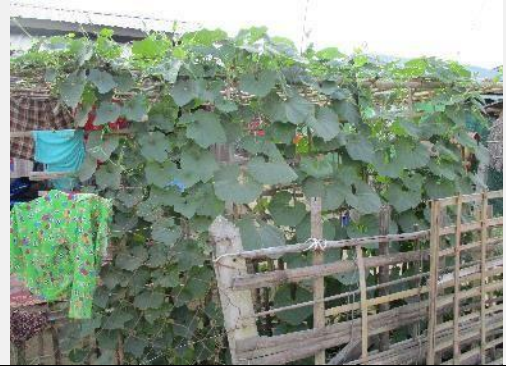
-In front of their compounds, the people planted shady trees, fruit trees, vegetables and floral plants.

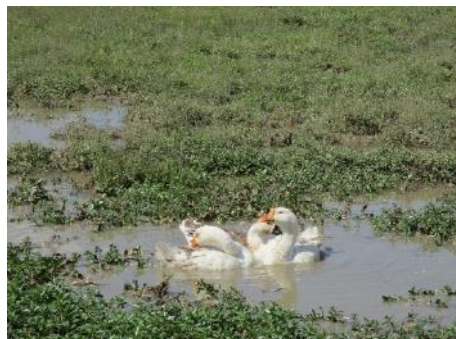
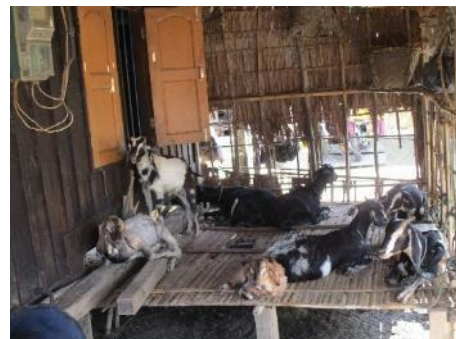
-The people are raising chicken, ducks, goats and cows.
 -Even though they have cows, some PAPs do not keep their cows in relocation site instead they keep in their farms or other places.

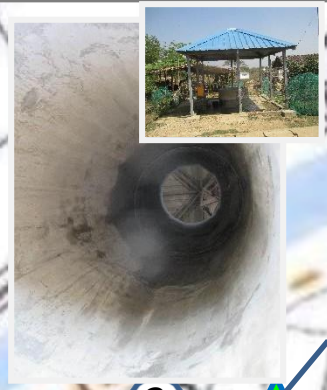
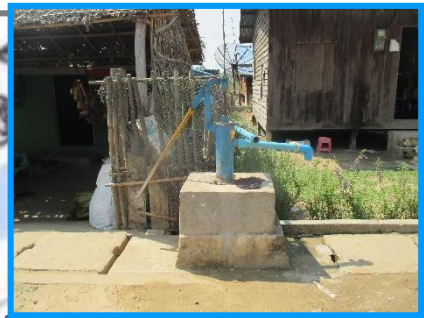
This well is repaired and now clean water can be used for drinking and living.

The buffer has been broken at the moment and it needs to be repaired.

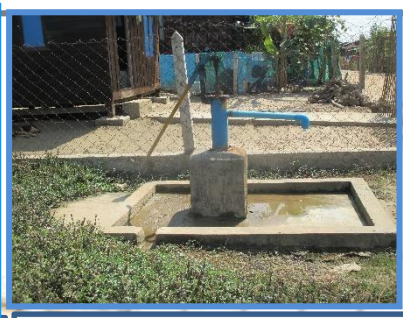
This hand pump is functioned very well. Water is clean and people nearby are using this hand pump for drinking and living.

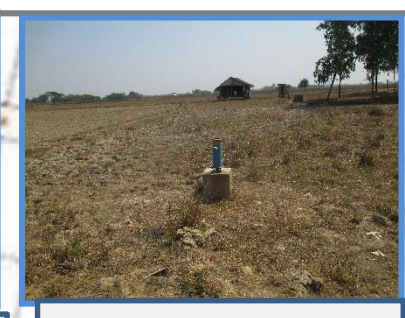
Hand pump isn't functioned.

This well is also repaired and now ready to get clean water for drinking and living use.

The buffer of the hand pump needs to be change. Therefore, people living nearby are using water from their owned pump at the moment.

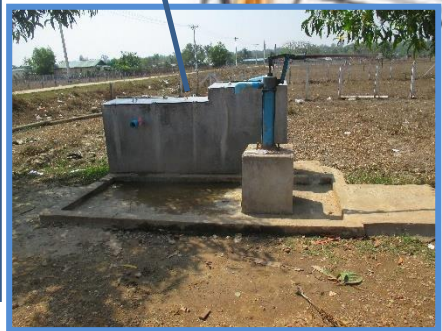
This hand pump is functioned very well. Water is clean and people living nearby are using this hand pump. Moreover water filter tank has been set up beside the hand pump for removing the smell of iron. There is no smell of iron and people enjoy water for drinking and living use.
