Surveyor: Zaw La
 Date Visited: 3.12.2015
 Time Visited: 13:30 to 14:30

Weather Condition: Sunny
 The last time of heavy raining: - 3 weeks ago

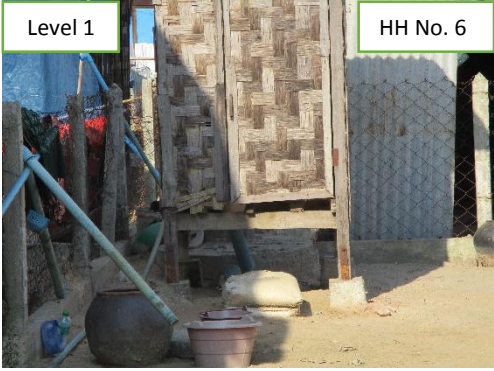
<div data-bbox="488 100 979 468"> <p>Level 1 HH No. 6</p>

- Fly proof toilet is not needed to be repaired.
- No/rarely toilet unavailable

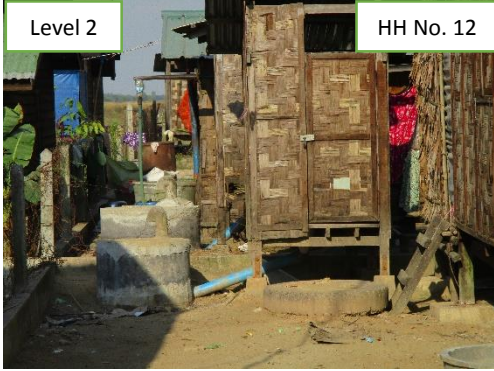
</div> <div data-bbox="995 100 1485 468"> <p>Level 2 HH No. 12</p>

- Fly proof toilet is needed to be repaired.
- Rarely toilet unavailable

-All of fly proof toilets are used by people.
-Almost all of fly proof toilets made by wood or bamboo have been lifted up as shown in pictures below and are convenient to use. Some concrete toilets are still need to be renovated. According to discussion with community people, the concrete toilets are would like to be repaired by themselves and they requested for financial support. JET had already paid for it.

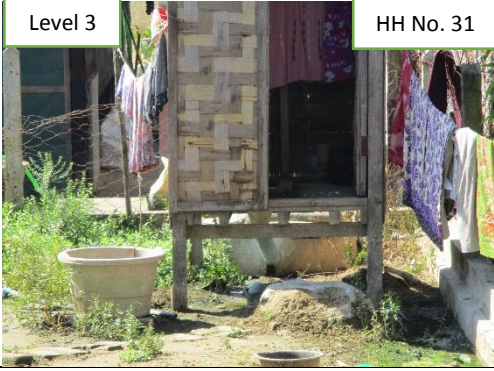
</div> <div data-bbox="488 516 979 884"> <p>Level 3 HH No. 31</p>

- Fly proof toilet is needed to be repaired.
- Often toilet unavailable
- As the result of filling the soil and also raining, some toilets are inconvenience to use.

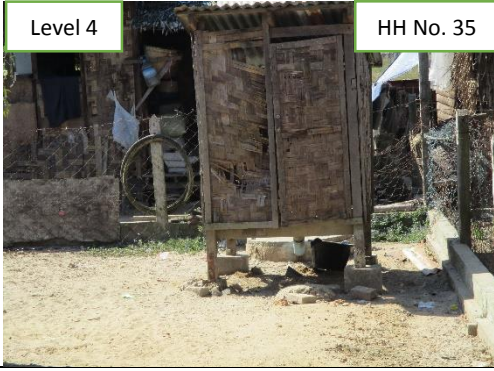
</div> <div data-bbox="995 516 1485 884"> <p>Level 4 HH No. 35</p>

- Fly proof toilet is urgently needed to be repaired.
- Often toilet unavailable
- After filling the soil, some toilets need to be lifted up.

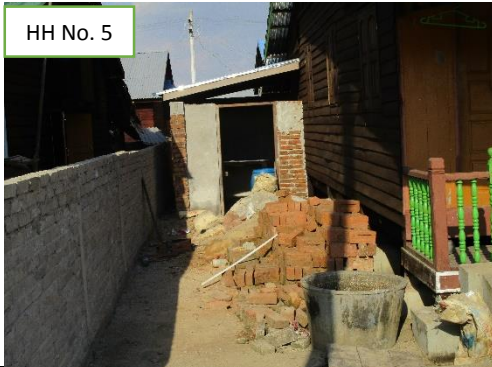
No	Item	Condition	Description and Photos
2	House Construction	No. of houses not completed (2)	<p><u>Description</u> -HH No.5, the construction for kitchen, toilet and water tank seems to be stopped again.</p>

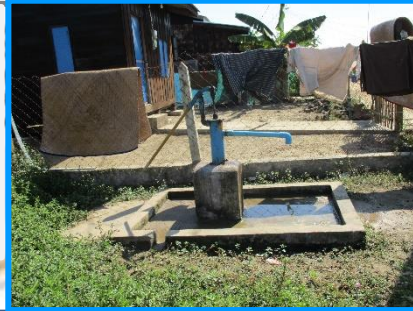
1

Water seems to be clean and people nearby are using it for drinking and living use for some months ago. But some people who took bath from this well said they felt itch on their skin. Therefore, U Ba Than, one of PAPs, pumped water by motor and he saw that water in the deepest area was very dirty with bad smell. The well also needs to be repaired as soon as possible.

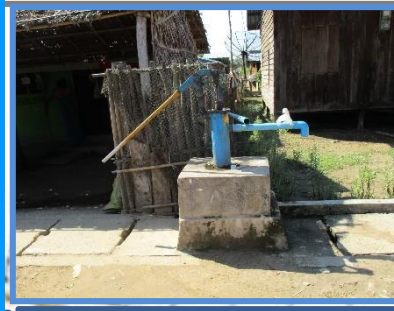
2

As the buffer has been changed with the new one and the hand pump is functioned very well now. Water is also clean and people living nearby use it for drinking and living.
