Surveyor: Zaw La
 Date Visited: 20.11.2015
 Time Visited: 15:30 to 16:00

No	Item	Condition	Description and Photos
1	Condition of -		
	(1). Well	Improved <input type="checkbox"/> Same <input checked="" type="checkbox"/> * Worse <input type="checkbox"/> <i>*as last week</i>	Description & Photos: -See ANNEX.1 - Although both of the two open wells are dirty, it seems that muddy water under the ground is passing through the crack at the wall of the well. The same as last week, both wells cannot be used and therefore people use hand pumps at the moment. In terms of avoiding the muddy groundwater passing into the well, both open wells need to be renovated again in summer. One of the hand pump need to be repaired, but people get water from their own tube-well.

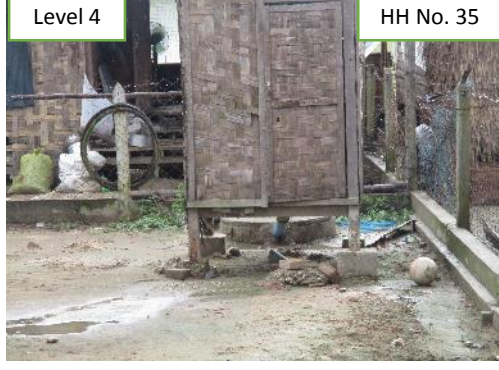
<p>Level 1 HH No. 6</p>  	<p>Level 2 HH No. 12</p>  
		<p>Level 3 HH No. 31</p>  	<p>Level 4 HH No. 35</p>

-All of fly proof toilets are used by people.
-Almost all of fly proof toilets made by wood or bamboo have been lifted up as shown in pictures below and are convenient to use. Some concrete toilets are still need to be renovated. According to discussion with community people, the concrete toilets are would like to be repaired by themselves and they requested for financial support. JET had already paid for it.

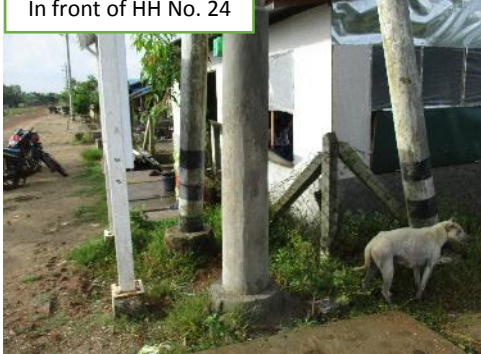
<p>(6). Electricity</p>	<p>Improved <input checked="" type="checkbox"/>* Same <input type="checkbox"/> Worse <input type="checkbox"/> <i>*as last week</i></p>	<p><u>Description</u> -Electricity comes regularly. -Electric poles and transformer are being supported with a good foundation. -There was a hole at an electric pole which was hit by a truck car, but the electric pole was renovated. <u>Photos</u></p> <div style="display: flex; justify-content: space-around;"> <div data-bbox="488 1209 979 1577"> <p>In front of HH No. 24</p>

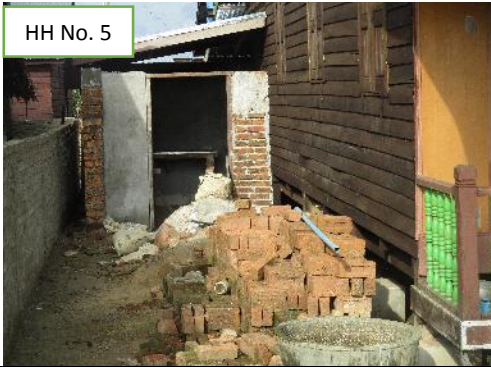
No	Item	Condition	Description and Photos
2	House Construction	No. of houses not completed (2)	<p><u>Description</u> -HH No.5, the construction for kitchen, toilet and water tank seems to be stopped again.</p>

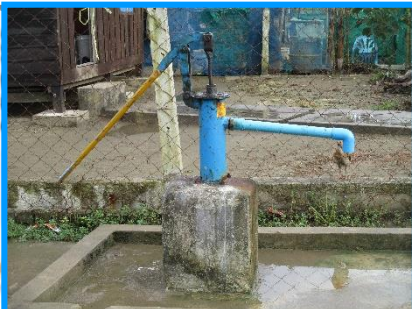
The buffer of the hand pump needs to be change. Therefore, people living nearby are using water from their owned pump at the moment.

As the buffer has been changed with the new one and the hand pump is functioned very well now. Water is also clean and people living nearby use it for drinking and living.

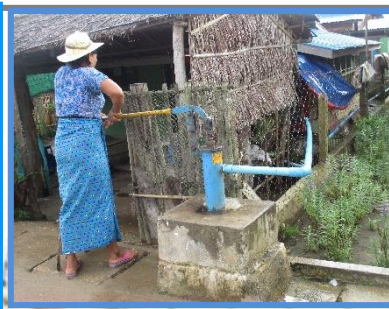
This hand pump is functioned very well. Water is clean and people nearby are using this hand pump for drinking and living.

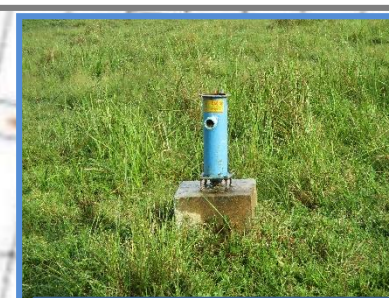
Hand pump isn't functioned.

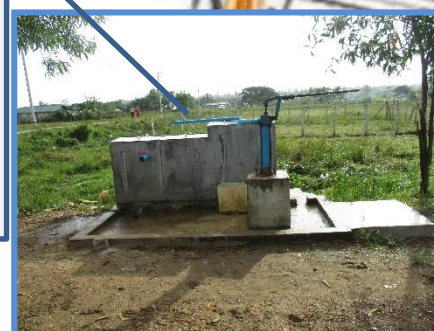
This hand pump is functioned very well. Water is clean and people living nearby are using this hand pump. Moreover water filter tank for removing the smell of iron has been set up beside the hand pump. There is no smell of iron and people enjoy water for drinking and living use.
