Surveyor: Zaw La

Date Visited: 4.11.2015

No	Item	Condition	Description and Photos
1	<b>Condition of -</b>		
	(1). Well	Improved <input type="checkbox"/> Same <input checked="" type="checkbox"/> * Worse <input type="checkbox"/>  *as last week	Description & Photos: -See ANNEX.1 - Although both of the two open wells are dirty, it seems that muddy water under the ground is passing through the crack at the wall of the well. The same as last week, both wells cannot be used and therefore people use hand pumps, or rain water at the moment. In terms of avoiding the muddy groundwater passing into the well, both open wells need to be renovated again in summer. The buffers of some hand pumps need to be changed, but people get water from their own well or rain water currently.

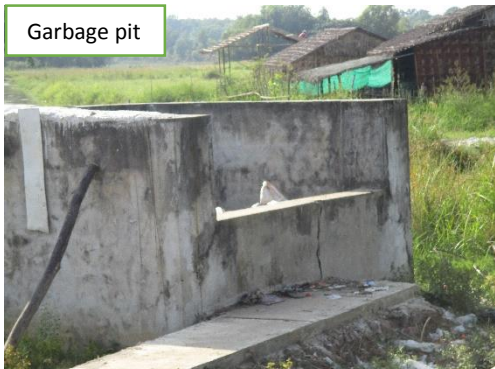
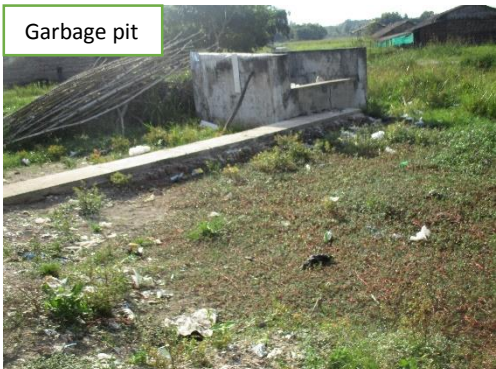
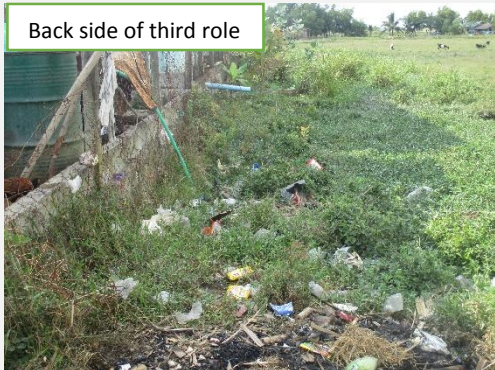
(4). Garbage Condition	<p>Improved <input type="checkbox"/></p> <p>Same <input checked="" type="checkbox"/>*</p> <p>Worse <input type="checkbox"/></p>	<p><u>Description</u></p> <p>-Garbage pit is being used by people.</p> <p>-Garbage pit was gradually increased with trash about half-full again and it needs to be collected again.</p> <p>-People throw garbage at the backside of Third Row and it needs to be clean up too.</p>

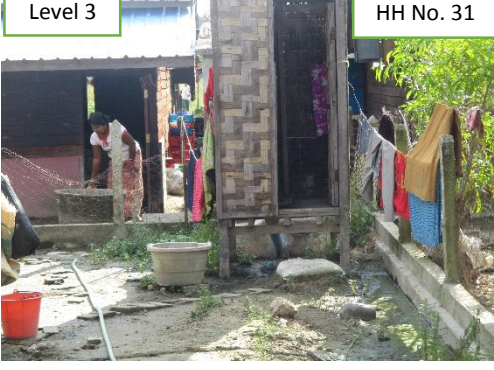
<p>Level 1 <span style="float: right;">HH No. 6</span></p>  	<p>Level 2 <span style="float: right;">HH No. 12</span></p>  
		<p>Level 3 <span style="float: right;">HH No. 31</span></p>

-All of fly proof toilets are used by people.  
-Almost all of fly proof toilets made by wood or bamboo have been lifted up as shown in pictures below and are convenient to use. Some concrete toilets are still needed to be renovated too as their floors are low and will be inconvenient to use sometimes when there is heavy rain and groundwater level is raised.

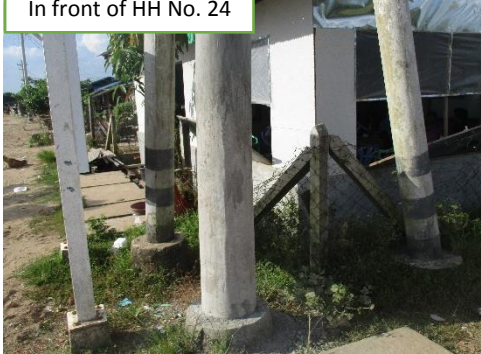
<p>(6). Electricity</p>	<p>Improved <input checked="" type="checkbox"/>*</p> <p>Same <input type="checkbox"/></p> <p>Worse <input type="checkbox"/></p> <p><i>*as last week</i></p>	<p><u>Description</u></p> <ul style="list-style-type: none"> <li>-Electricity comes regularly.</li> <li>-Electric poles and transformer are being supported with a good foundation.</li> <li>-In last week, there was a hole at an electric pole which was hit by a truck car, but the electric pole was renovated in this week.</li> </ul> <p><u>Photos</u></p> <div style="display: flex; justify-content: space-around;"> <div data-bbox="488 1209 979 1577"> <p>In front of HH No. 24</p>

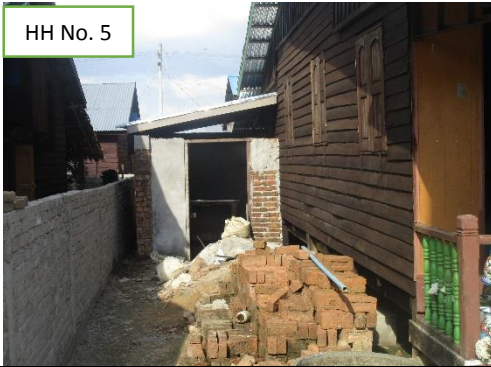
No	Item	Condition	Description and Photos
2	House Construction	No. of houses not completed (2)	<p><u>Description</u> -HH No.5, the construction for kitchen, toilet and water tank seems to be stopped again.</p>

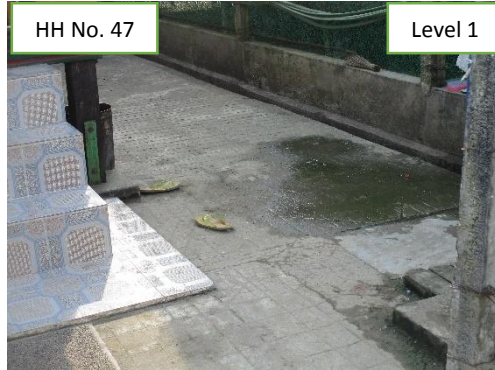
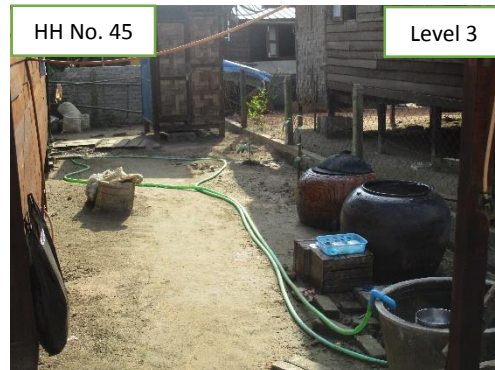
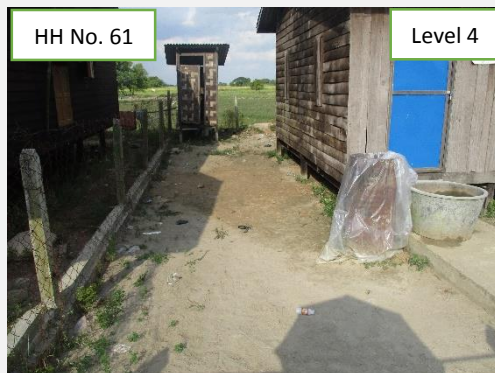
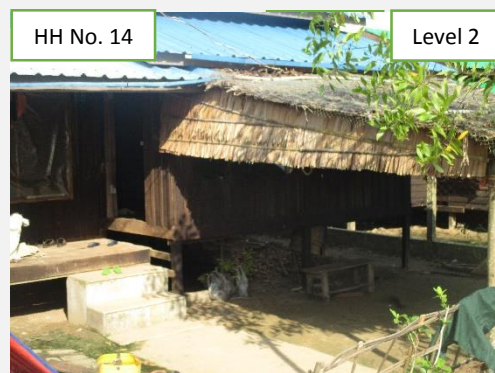
Photos

4	Other issue	Description																	
	(1). Drainage condition for rain water in their compounds	<p><u>Description</u> -Rainy season has started. -Some of the compounds are wet.</p>

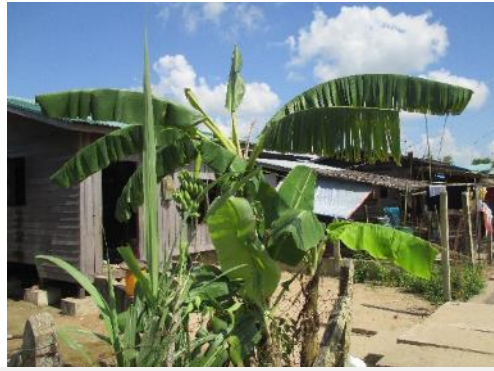
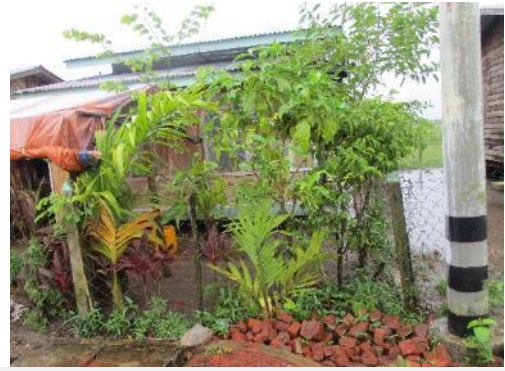
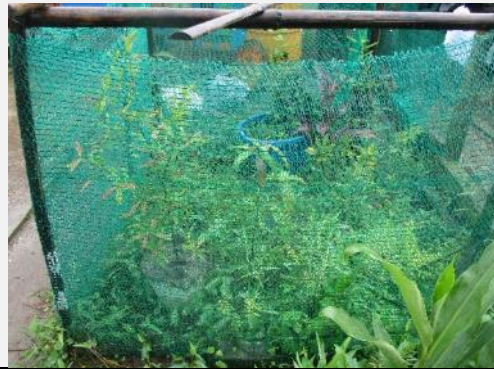
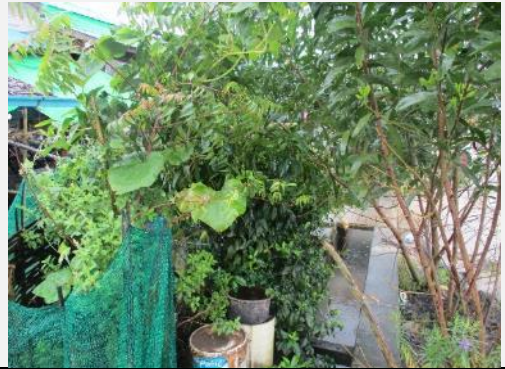
-In front of their compounds, the people planted shady trees, fruit trees, vegetables and floral plants.

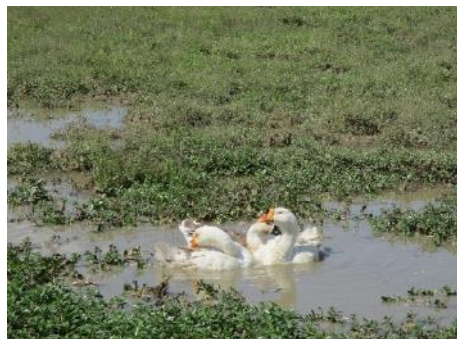
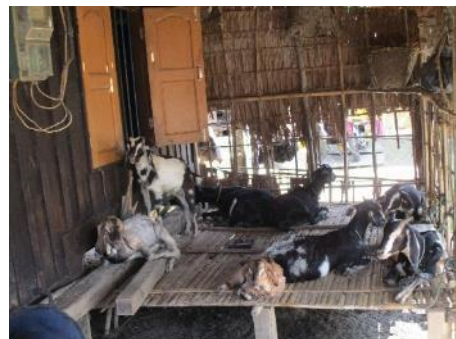
**Photos**

-The people are raising chicken, ducks, goats and cows.  
 -Even though they have cows, some houses do not keep their cows in relocation site instead they keep in their farms or other places.

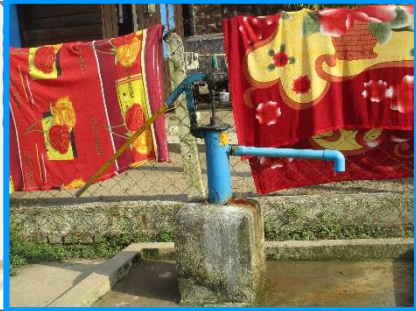
As the buffer has been changed with the new one and the hand pump is functioned very well now. Water is also clean and people living nearby use it for drinking and living.

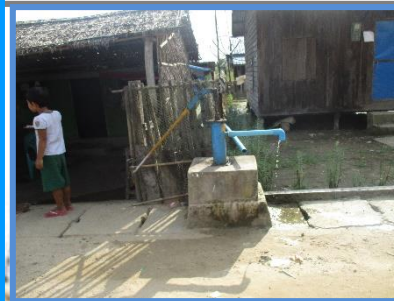
This hand pump is functioned very well. Water is clean and people nearby are using this hand pump for drinking and living.

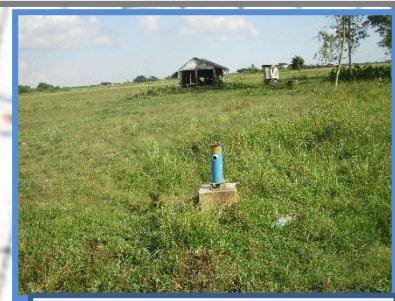
Hand pump isn't functioned.

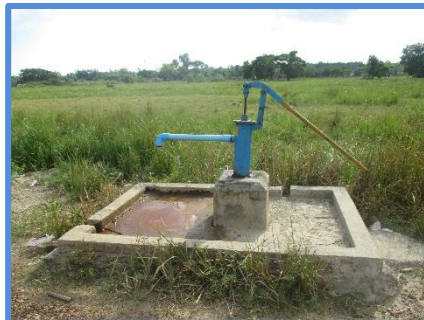
The buffer of the hand pump needs to be change. Therefore, people living nearby are using water from their owned pump or rain water at the moment.

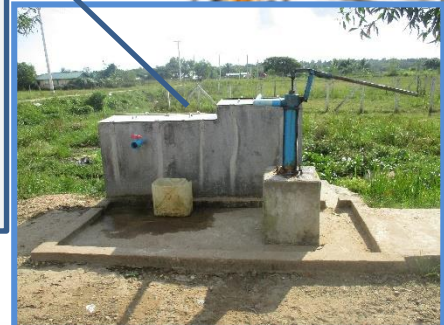
This hand pump is functioned very well. Water is clean and people living nearby are using this hand pump. Moreover water filter tank for removing the smell of iron has been set up beside the hand pump. There is no smell of iron and people enjoy water for drinking and living use.
