Surveyor: Zaw La

Date Visited: 3.8.2015

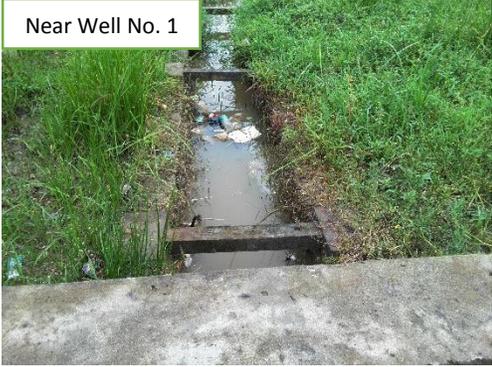
<p>Near Well No. 1</p> </div> <div style="width: 50%; text-align: center;">

(2). Drainage	Improved <input type="checkbox"/> Same <input checked="" type="checkbox"/> * Worse <input type="checkbox"/> <i>*as last week</i>	Description - Water level in the drainage canals higher than last week because there was a heavy rain last night till now. The stream along with the drainage canal needs to be rehabilitated in next summer. Photos <div style="display: flex; flex-wrap: wrap;"> <div style="width: 50%; text-align: center;">

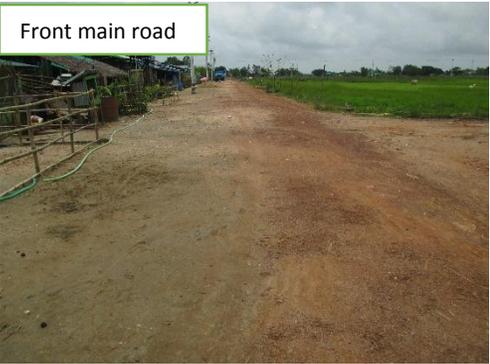
(3). Road	<p>Improved <input type="checkbox"/></p> <p>Same <input checked="" type="checkbox"/>*</p> <p>Worse <input type="checkbox"/></p> <p><i>*as last week</i></p>		<p><u>Description</u></p> <p>- The roads are being wet a bit and muddy in some areas but no problem for walking.</p> <p><u>Photos</u></p> <div style="display: flex; flex-wrap: wrap;"> <div style="width: 50%;"> <p>Front main road</p>

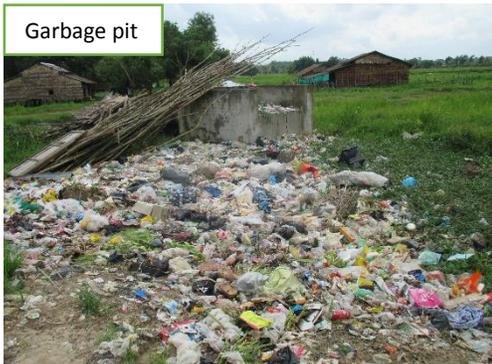
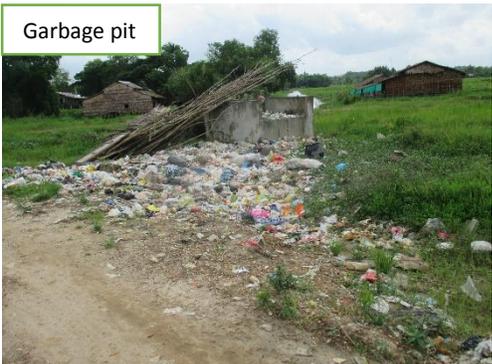
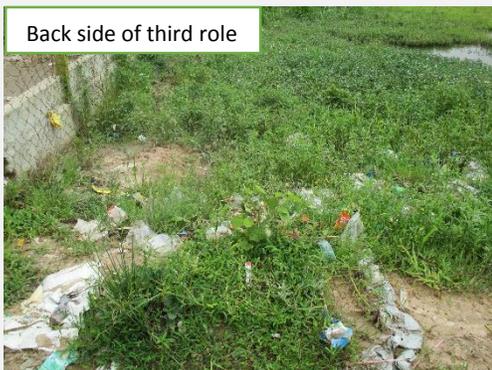
(4). Garbage Condition	<p>Improved <input type="checkbox"/></p> <p>Same <input checked="" type="checkbox"/>*</p> <p>Worse <input type="checkbox"/></p>		<p><u>Description</u></p> <p>-Garbage pit is used by people.</p> <p>-Garbage pit is over full and it needs to be cleaned up.</p> <p>-There are some smells from garbage pit.</p> <p>-People throw garbage at the backside of Third Row.</p>

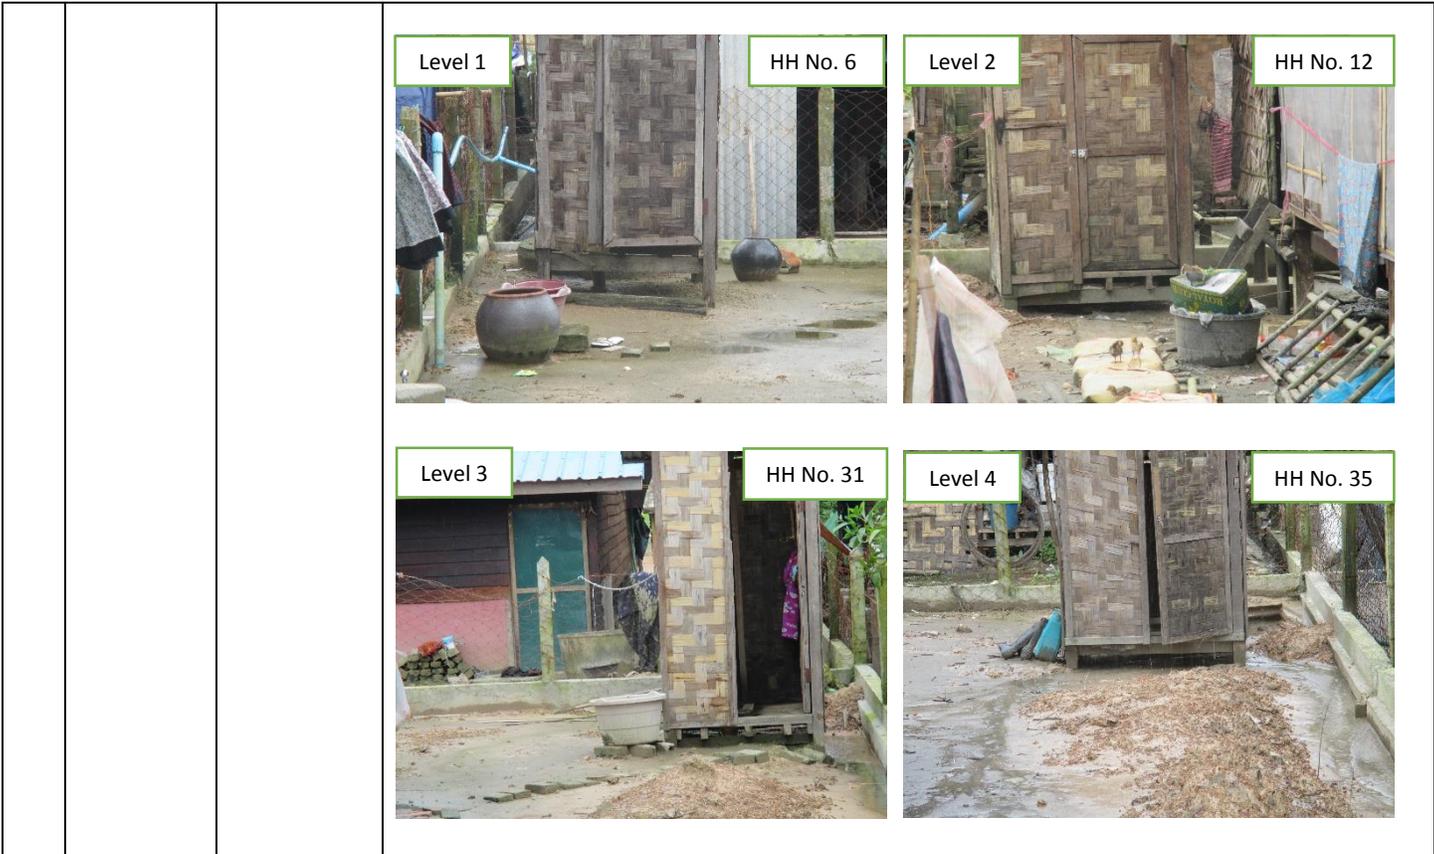
Description
-All of fly proof toilets are used by people.

- Need to repair fly proof toilet
- Often toilet unavailable
- As the result of filling the soil and also raining, some toilets are inconvenience to use.

- Need to repair urgently fly proof toilet
- Often toilet unavailable
- After filling the soil, some toilets need to be lifted up.

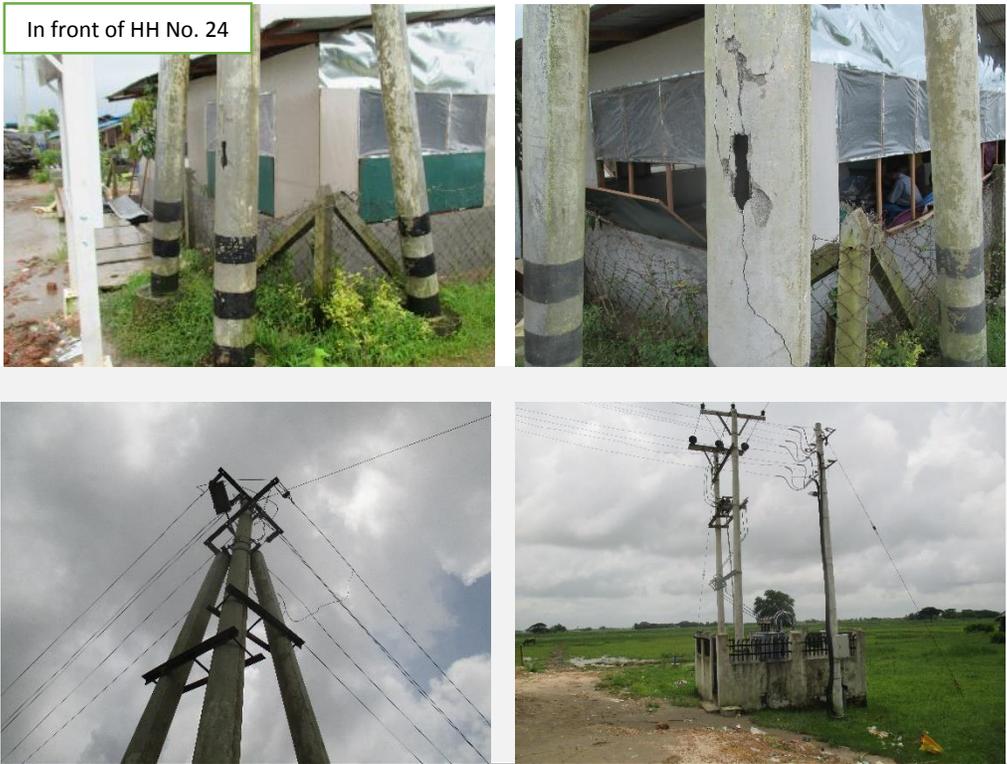
- Electricity comes regularly.
- Electric poles and transformer are supported in good foundation.
- But, there is a hole at an electric pole which was hit by a truck car. The electric pole needs to be renovated.

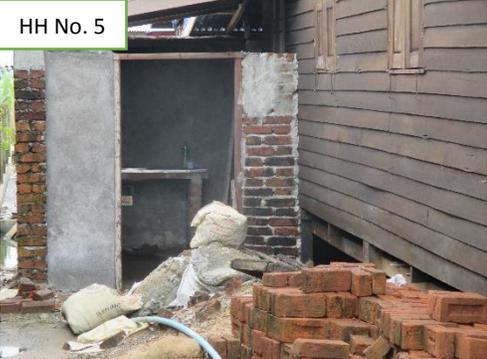
2	House Construct-ion	No. of houses not completed (2)	<p><u>Description</u> -HH No.5, the construction for kitchen, toilet and water tank seems to be started again.</p>

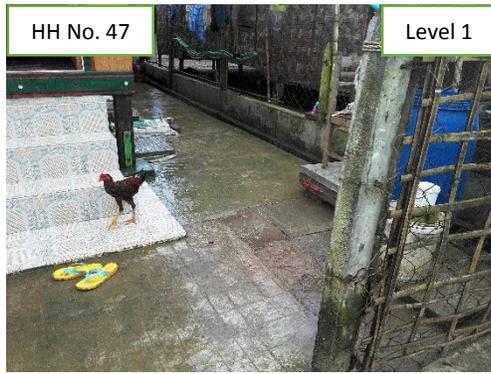
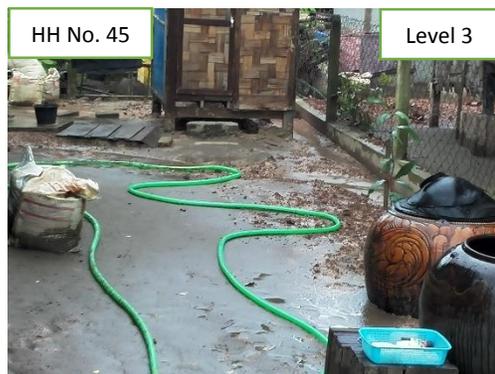
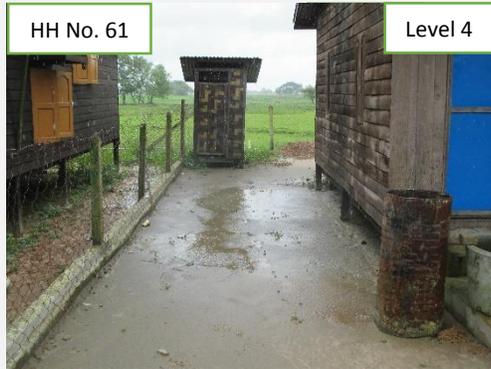
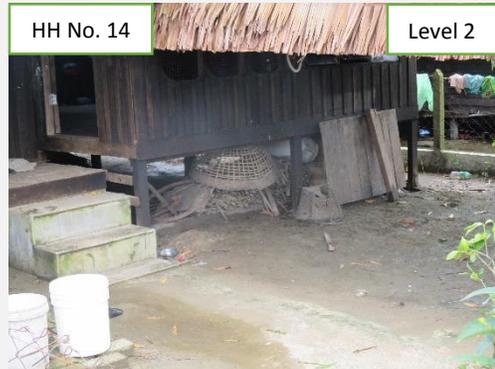
3	Living Status of PAPs (Sold house, renting, etc.)	<p><u>Description</u> (1) House ownership (1)-1 No. of house that are owned by PAPs (50) (1)-2 No. of house that were sold (18) (2) Living condition (2)-1 No. of houses where PAPs live (41) (2)-2 No. of houses where not original PAPs lives (22) (2)-3 No. of houses where nobody lives (5)</p> <p>Location Map: See ANNEX.2</p>																		
4	Other issue (1). Drainage condition for rain water in their compounds	<p><u>Description</u> -Rainy season has been started. -Most of the compounds are wet.</p>

<p><Evaluation Criteria> Level 1 -No mud and no standing water with their own drainage system in their compound Level 2 -No mud and no standing water in their compound Level 3 - Some or little mud and standing water in their compound Level 4 -A lot of mud and standing water in their compound</p>		Condition	No. of HHS		This week condition	Previous week condition	Level 1	14	14	Level 2	30	30	Level 3	20	20	Level 4	4	4
Condition	No. of HHS																			
	This week condition	Previous week condition																		
Level 1	14	14																		
Level 2	30	30																		
Level 3	20	20																		
Level 4	4	4

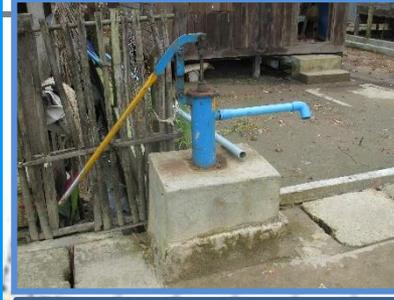
Hand pump isn't functioned.

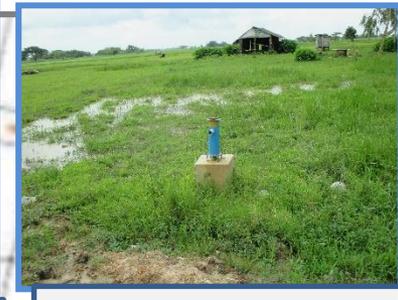
This hand pump is functioned very well. Water is clean and everyone nearby is using this hand pump.

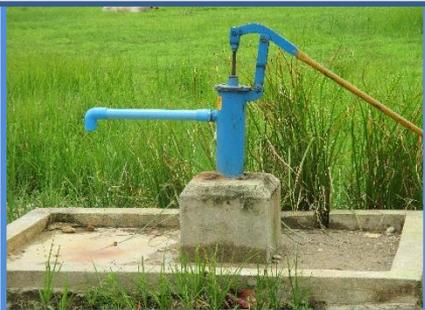
The buffer of the hand pump needs to be change. Therefore, people living nearby are using water from their owned pump or rain water at the moment.

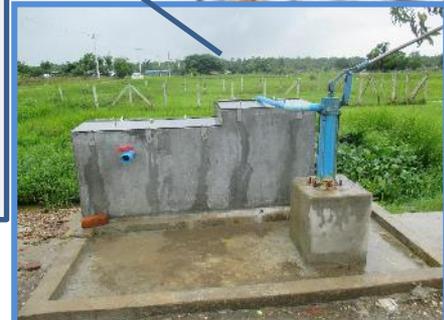
This hand pump is functioned very well. Water is clean and everyone living nearby is using this hand pump. Moreover water filter tank for remove the smell of iron has been set up beside the hand pump. There is no smell of iron and people enjoy water for drinking and living use.
