Surveyor: Zaw La  
 Date Visited: 7.9.2016  
 Time Visited: 14:00 to 14:30

No	Item	Condition	Description and Photos
1	<b>Condition of -</b>		
	(1). Well	Improved <input type="checkbox"/> Same <input checked="" type="checkbox"/> * Worse <input type="checkbox"/>  <i>*as last week</i>	Description & Photos: -See ANNEX.1 - Water from only one well is clean and can be used for drinking and living but the other well need to be cleaned as there is some trashes in the well. The amount of water in both wells is also being increased during these days. There are four tube wells in the relocation site. Among them, two of the hand pumps need to be repaired, but people can get water from their own tube-wells, one open-well and the rest of one hand pump.

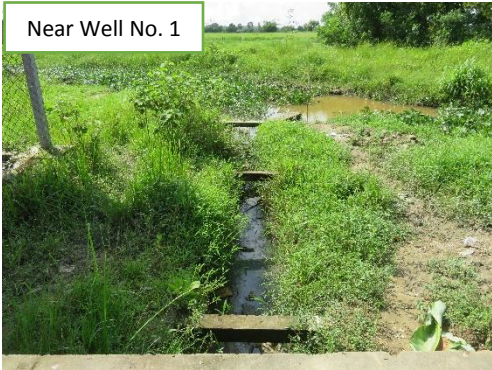
(2). <u>Drainage</u>	Improved <input type="checkbox"/> Same <input checked="" type="checkbox"/> * Worse <input type="checkbox"/> <i>*as last week</i>	<u>Description</u> There is some amount of water in the drainage canals due to the rain yesterday and some places of stream seem to be blocking at the moment. The stream along the drainage canal may need to be rehabilitated in order to improve the water-flow along the stream.  <u>Photos</u>  <div style="display: flex; flex-wrap: wrap;"> <div style="width: 50%; text-align: center;"> <p>Near Well No. 1</p>

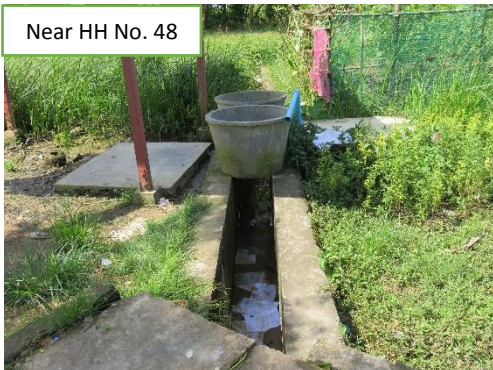
</div> <div style="width: 50%; text-align: center;"> <p>Near HH No. 48</p>

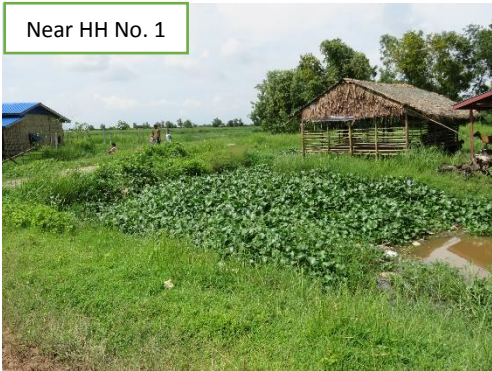
</div> <div style="width: 50%; text-align: center;"> <p>Near HH No. 1</p>

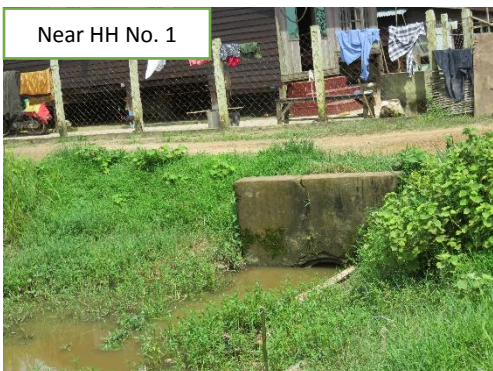
</div> <div style="width: 50%; text-align: center;"> <p>Near HH No. 1</p>

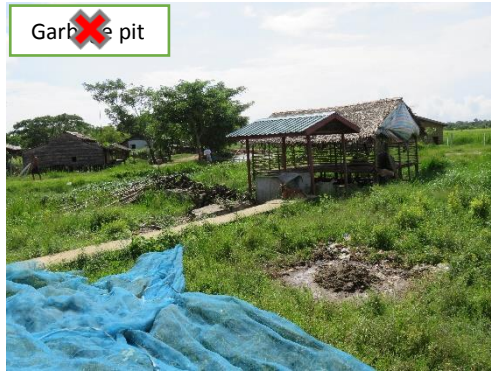
Garbage pit

<p>(4). Garbage Condition</p>	<p>Improved <input type="checkbox"/></p> <p>Same <input checked="" type="checkbox"/>*</p> <p>Worse <input type="checkbox"/></p>	<p><u>Description</u></p> <ul style="list-style-type: none"> <li>- People do not want to use garbage pit again.</li> <li>- They do not like people to take washing clothes and showering near the well and therefore garbage pit was demolished and water storage tank has been constructed instead of it.</li> <li>-Trash from all houses will be collected by garbage truck biweekly until starting of the community fund.</li> <li>-There is a small vegetable planting field at the backside of Third Row where there were many trashes before the vegetable plantation was started.</li> </ul>
---------------------------------------	---	---

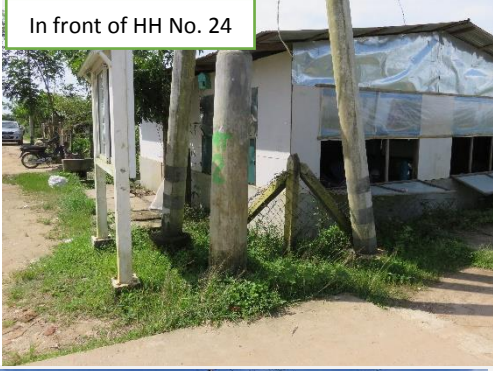
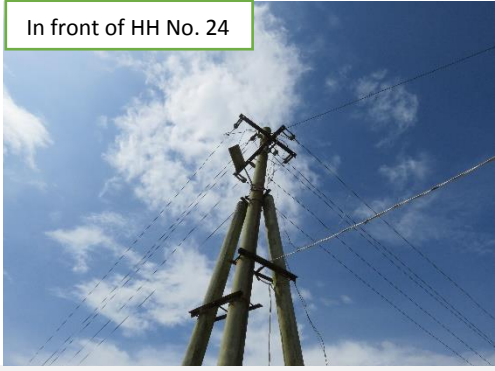
(6).	Electricity	<p>Improved <input checked="" type="checkbox"/>*</p> <p>Same <input type="checkbox"/></p> <p>Worse <input type="checkbox"/></p> <p><i>*as last week</i></p>	<p><u>Description</u></p> <ul style="list-style-type: none"> <li>-Electricity comes regularly.</li> <li>-Electric poles and transformer are being supported with a good foundation.</li> <li>-There was a hole at an electric pole which was hit by a truck car but the electric pole was renovated.</li> </ul> <p><u>Photos</u></p> <div style="display: flex; flex-wrap: wrap;"> <div style="width: 50%;"> <p>In front of HH No. 24</p>

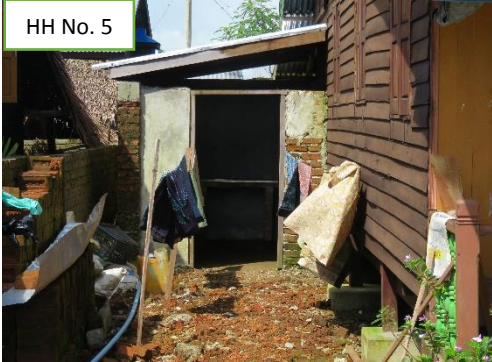
2	House Construction	No. of houses not completed (2)	<p><u>Description</u> -HH No.5, the construction for kitchen, toilet and water tank seems to be stopped again.</p>

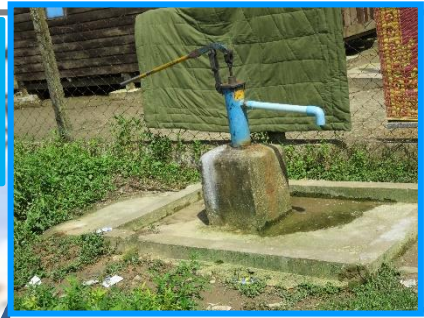
The buffer has repaired and water can be get again.

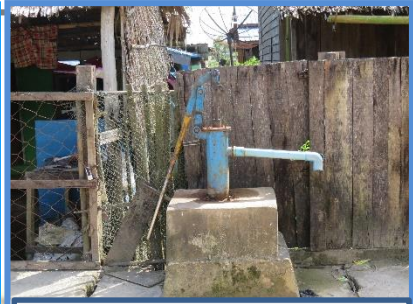
This hand pump is functioned very well. Water is clean and people nearby are using this hand pump for drinking and living.

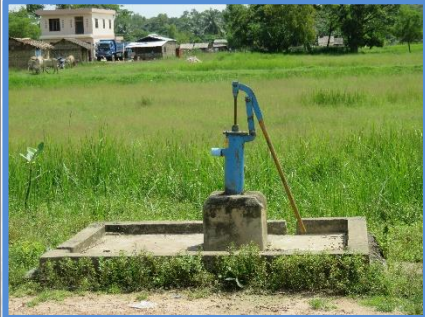
The buffer of the hand pump needs to be changed. But, people living nearby would like to use water from their owned pumps instead of this hand pump.

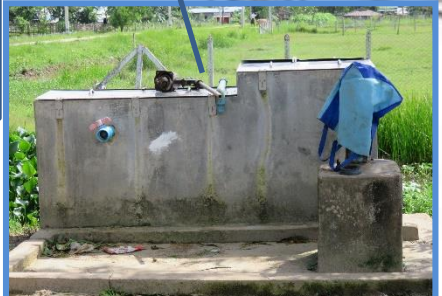
This hand pump cannot be used at the moment due to broken washer of the hand pump.
