<u>Surveyor: Sithu Nyein</u> Date Visited: 18.8.2014 Time Visited: 10:00 to 12:30

Weather Condition: Sunny and partly cloudy The last time of heavy raining: 15.8.2014

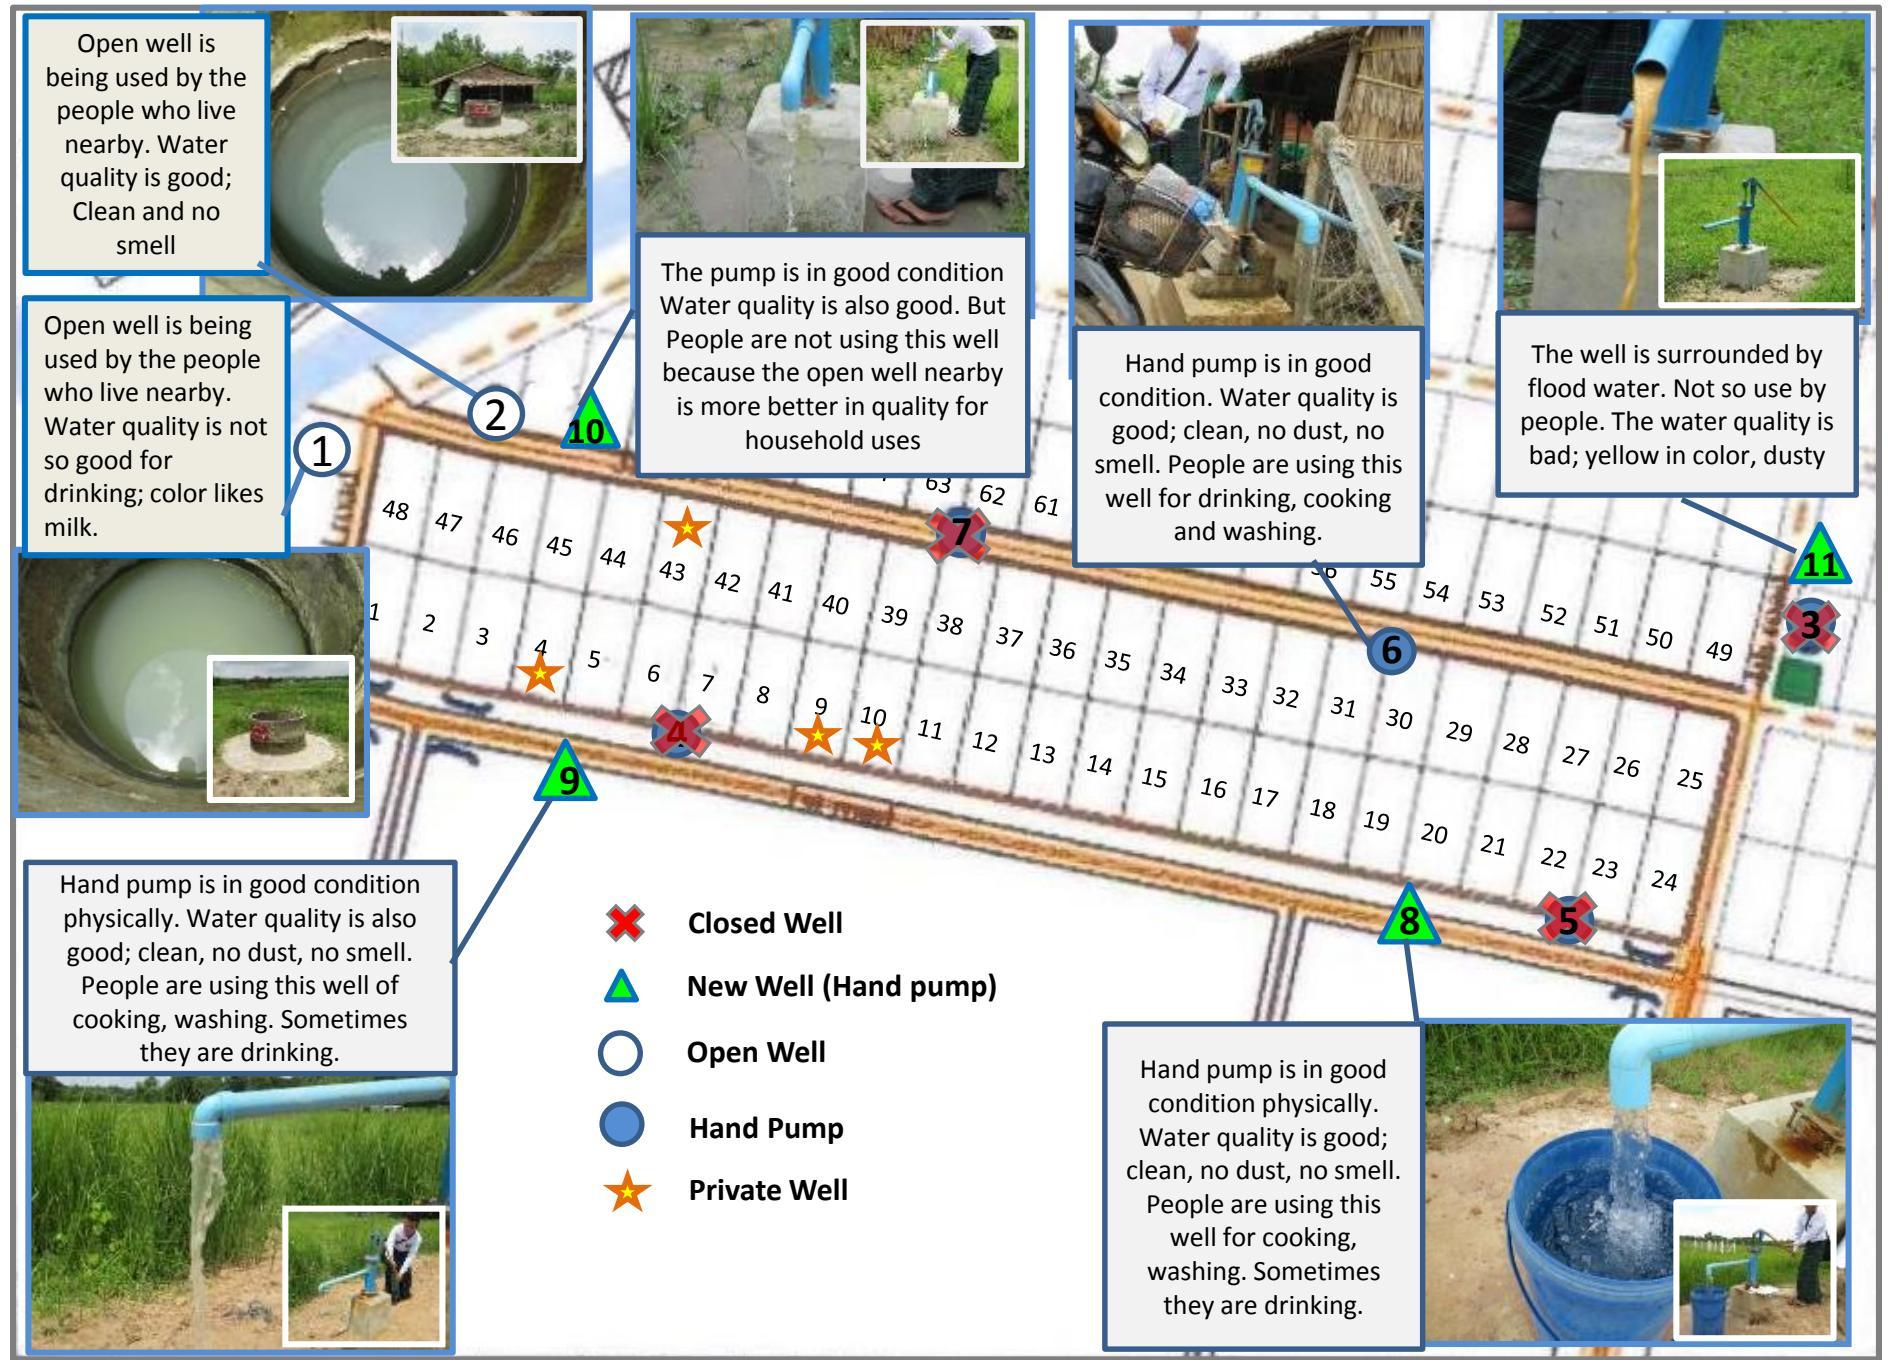
No	Item	Condition	Description and Photos
1	Condition of -		
	(1). Well	Improved □ Same ■* Worse □ *as good as last week	Description & Photos: See ANNEX.1
	(2). Drainage	Improved	Description
	(_)	Same 🗆	Water in the drainage canal is becoming lower than last week.
		Worse 🗆	Photos Image: State of the stateoo the state of the state
	(3). Road	Improved □ Same © * Worse □ *as good as last week	<u>Description</u> All roads are in good condition There are some puddles and partly muddy areas but the roads are almost dried and no problem for traffic as a whole. <u>Photos</u>
