Bi weekly Field Report

No. 71

Surveyor Zaw La
 Date visited 4 Oct 2019
 Time visited 16:00 pm

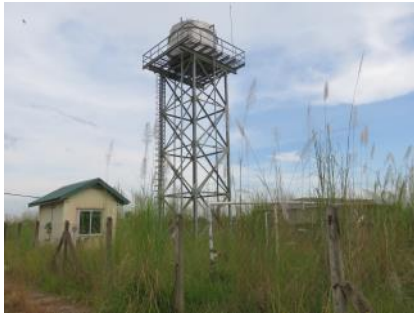
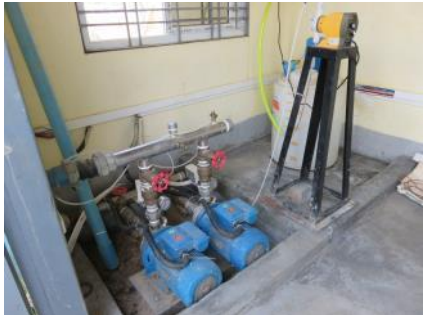
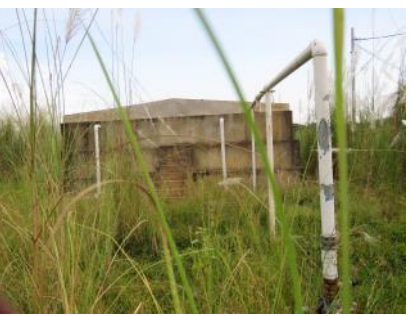
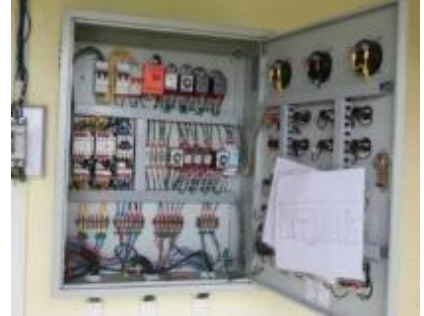
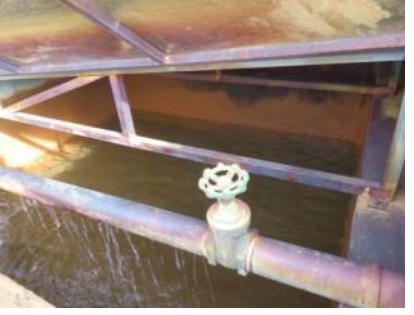
No	Item	Condition	Narrative Description and Photos
1	(1.1) Water Supply System	Improved <input type="checkbox"/> Same <input checked="" type="checkbox"/> * Worse <input type="checkbox"/> <i>*as last week</i>	<p><u>Narrative Description</u></p> <p>Water distribution system has been supporting ninety household of the zone B resettled families. The new well was drilled and installed the pipe line and its necessary instruments because the underground water of the previous well includes iron hydroxide and yellowish mud that clogged in the iron removal tank. The current water condition is quite good and no iron hydroxide and yellowish mud are found.</p> <p><u>Photos</u></p> <div style="display: flex; flex-wrap: wrap;"> <div style="width: 50%; text-align: center;">

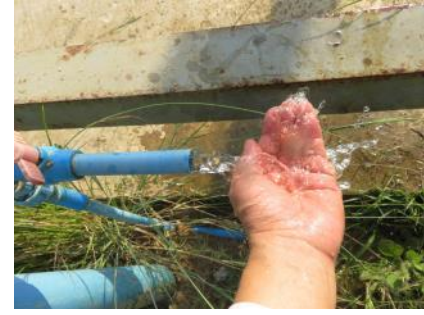
<p>Pipe line distribution water to houses</p> </div> </div>

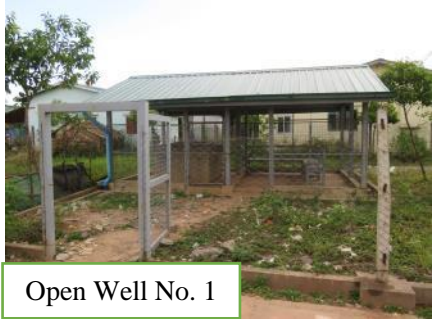
<p>Open Well No. 1</p> </div> <div style="text-align: center;">

No	Item	Condition	Narrative Description and Photos
1	(1.2) Well	Improved <input type="checkbox"/> Same <input checked="" type="checkbox"/> * Worse <input type="checkbox"/> <i>*as last week</i>	<p>– Water from two open-wells is clean enough to use for drinking and living. There are eleven tube wells in the relocation site. Residents use the water basically from the pipeline distribution system so that the frequency of water usage from the tube wells is very low. To sustain the good condition of the tube wells, the leg pumps were kept and covered the PVC pipes with the caps till the residents use.</p>
			<div style="display: flex; justify-content: space-around;"> <div style="text-align: center;">

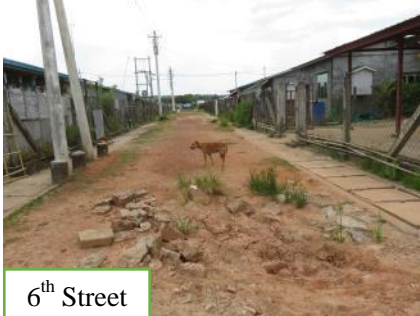
<p>6th Street</p>

(3) Road	Improved <input type="checkbox"/> Same <input checked="" type="checkbox"/> * Worse <input type="checkbox"/> <i>*as last week</i>	<p>– All the roads except 6th street are still dry and no problem for walking. 6th street is being damaged due to passing the heavy trucks that carry the soil to fill near the creek side. Therefore the exits of the drain at the 6th street are being blocked with the soil.</p> <p>Photos</p>

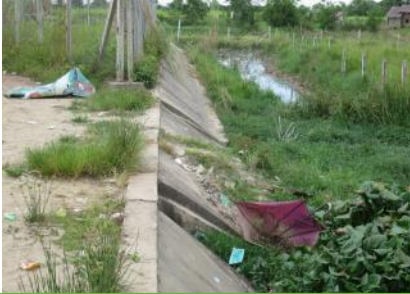
<p>Rubbishes in the creek near 1st street</p>

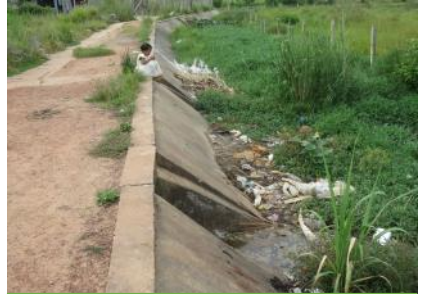
<p>Rubbishes in the creek near 2nd street</p>

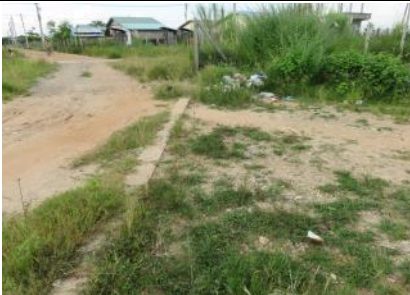
<p>The soil was filled near the creek of Main Road C in March</p>

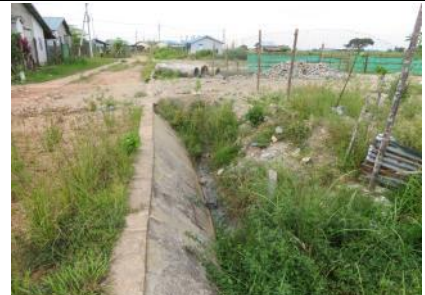
<p>The soil was filled near the creek of 6th Street in March</p>

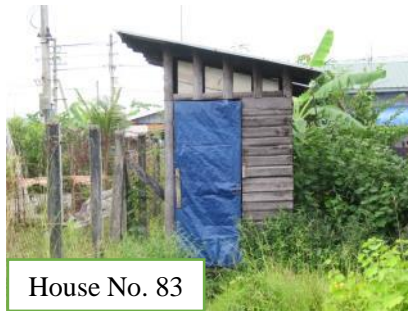
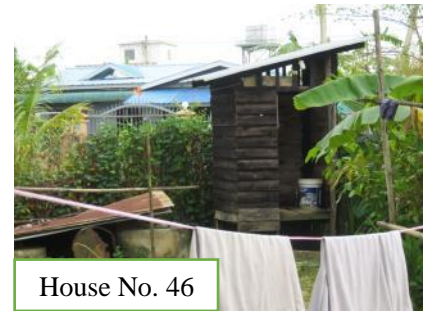
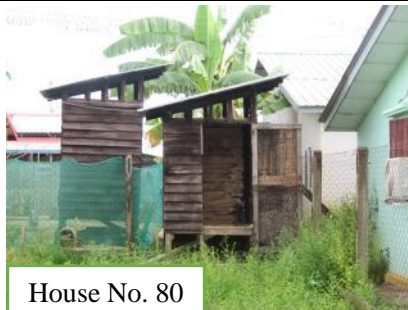
- All of the fly proof toilets are used the residents.
- All of the toilets are repaired by the following procedures;
 - Installation the extra septic tanks beside the original
 - The pipe line system is installed from the extra tank to the ditch to flow the liquid out.

The toilet renovation plan was successfully done and there is no problem at the moment.

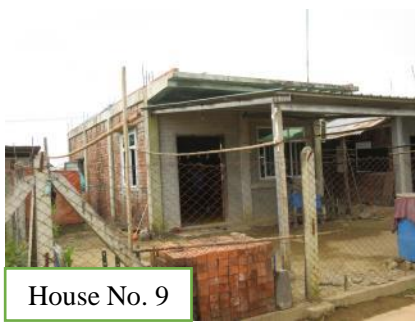
<p>House No. 9</p>

No	Item	Condition	Description and Photos
2	(1)House Construction	No. of houses which are not completed (4)	<ul style="list-style-type: none"> – In plot No.9 and 10, three houses that are planned to build as the plots are owned by father and son. The second floors of these three houses are needed to be carried on. – Plot No. 66, the house construction for the first floor has been finished and the second floor is still needed to be carried on. <p>Photos</p>

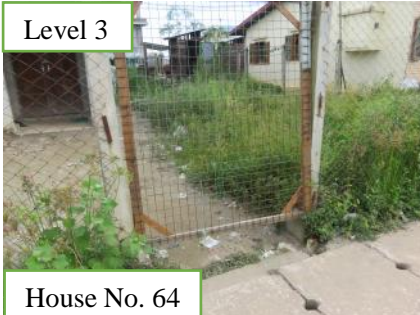
<p>Level 3</p> <p>House No. 64</p> </div> <div style="width: 50%; text-align: center;">

<p><Evaluation Criteria> Level 1 -No mud and no standing water with their own drainage system in their compound Level 2 -No mud and no standing water in their compound Level 3 - Some or little mud and standing water in their compound Level 4 -A lot of mud and standing water in their compound</p> <p><u>Photos</u></p> <div style="display: flex; flex-wrap: wrap;"> <div style="width: 50%; text-align: center;">
