Weekly Field Report

No. 38

Date Visited: 22.7.2015

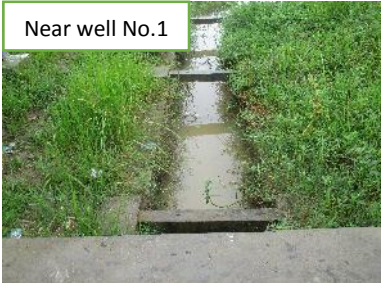
<p>Near well No.1</p> </div> <div style="width: 50%; text-align: center;">

(2). <u>Drainage</u>	Improved <input type="checkbox"/> Same <input checked="" type="checkbox"/> * Worse <input type="checkbox"/> <i>*as last week</i>	<u>Description</u> - Water level in the drainage canals is about the same level as last week because there was a heavy rain last night. The stream along the drainage canal needs to be rehabilitated in next summer. <u>Photos</u> <div style="display: flex; flex-wrap: wrap;"> <div style="width: 50%; text-align: center;">

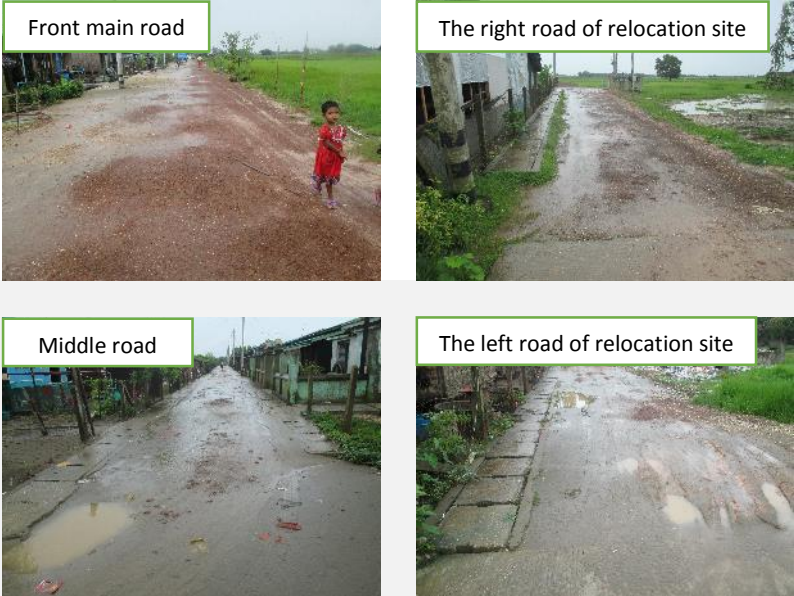
(3). Road	<p>Improved <input type="checkbox"/></p> <p>Same <input checked="" type="checkbox"/>*</p> <p>Worse <input type="checkbox"/></p> <p><i>*as last week</i></p>	<p><u>Description</u></p> <p>- The roads are being wet a bit and muddy in some areas but no problem for walking.</p> <p><u>Photos</u></p>

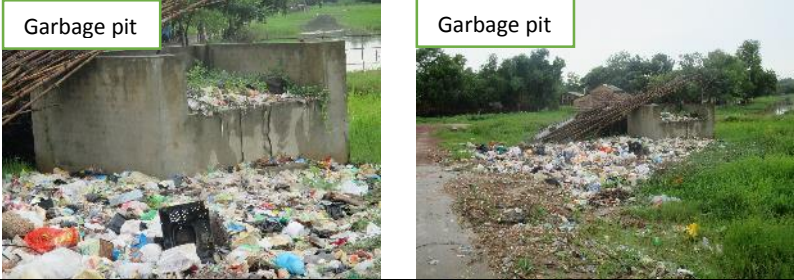
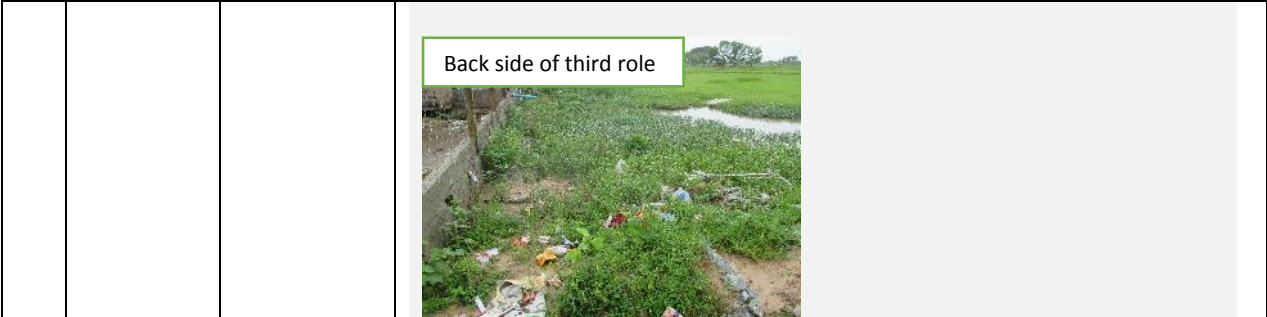
(4). Garbage Condition	<p>Improved <input type="checkbox"/></p> <p>Same <input checked="" type="checkbox"/>*</p> <p>Worse <input type="checkbox"/></p>	<p><u>Description</u></p> <p>-Garbage pit is used by people.</p> <p>-Garbage pit is over full and it needs to be cleaned up.</p> <p>-There are some smells from garbage pit.</p> <p>-People throw garbage at the backside of Third Row.</p>

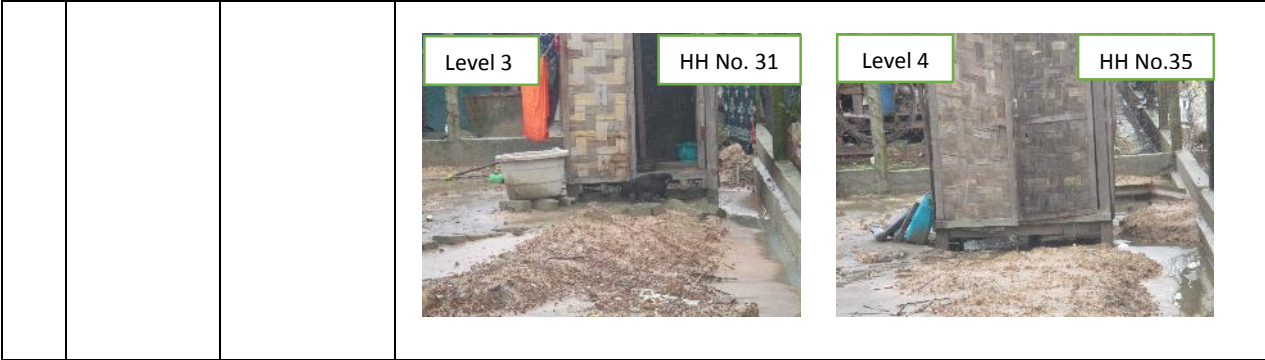
No	Item	Condition	Description																				
1	(5). Fly proof toilet	Improved <input type="checkbox"/> Same <input checked="" type="checkbox"/> * Worse <input type="checkbox"/> *as last week	<p>-All of fly proof toilets are used by people.</p>

<p><Evaluation Criteria></p> <p>Level 1</p> <ul style="list-style-type: none"> -No need to repair fly proof toilet -No/rarely toilet unavailable <p>Level 2</p> <ul style="list-style-type: none"> -Need to repair fly proof toilet -Rarely toilet unavailable <p>Level 3</p> <ul style="list-style-type: none"> -Need to repair fly proof toilet -Often toilet unavailable -As the result of filling the soil and also raining, some toilets are inconvenience to use. <p>Level 4</p> <ul style="list-style-type: none"> -Need to repair urgently fly proof toilet -Often toilet unavailable -After filling the soil, some toilets need to be lifted up. <div style="display: flex; justify-content: space-around; margin-top: 20px;"> <div data-bbox="597 1486 971 1766"> <p>Level 1 HH No. 6</p> </div> <div data-bbox="1024 1486 1398 1766"> <p>Level 2 HH No. 12</p> </div> </div>	Condition	No. of HHs		This week condition	Previous week condition	Level 1	6	6	Level 2	18	18	Level 3	29	29	Level 4	13	13	No Toilet	2	2
Condition	No. of HHs																						
	This week condition	Previous week condition																					
Level 1	6	6																					
Level 2	18	18																					
Level 3	29	29																					
Level 4	13	13																					
No Toilet	2	2

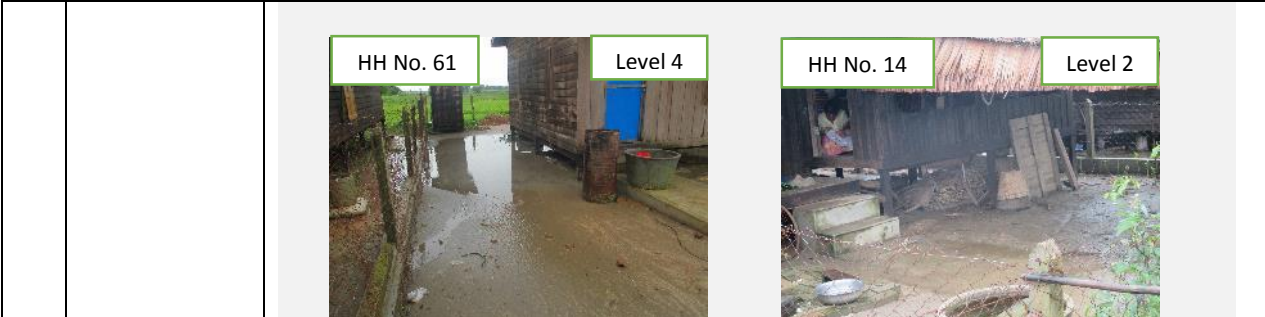
house, renting, etc.)	<p>(2) Living condition</p> <p>(2)-1 No. of houses where PAPs live (41)</p> <p>(2)-2 No. of houses where not original PAPs lives (22)</p> <p>(2)-3 No. of houses where nobody lives (5)</p> <p>Location Map: See ANNEX.2</p>																	
4	Other issue																	
(1). Drainage condition for rain water in their compounds	<p><u>Description</u></p> <p>-Rainy season has been started.</p> <p>-Most of the compounds are being wet.</p>

<p><Evaluation Criteria></p> <p>Level 1</p> <p>-No mud and no standing water with their own drainage system in their compound</p> <p>Level 2</p> <p>-No mud and no standing water in their compound</p> <p>Level 3</p> <p>- Some or little mud and standing water in their compound</p> <p>Level 4</p> <p>-A lot of mud and standing water in their compound</p> <p><u>Photos</u></p> <div style="display: flex; justify-content: space-around;"> <div data-bbox="511 1272 889 1556"> <p>HH No. 47 Level 1</p> </div> <div data-bbox="959 1272 1338 1556"> <p>HH No. 47 Level 3</p> </div> </div>	Condition	No. of HHs		This week condition	Previous week condition	Level 1	14	14	Level 2	30	30	Level 3	20	20	Level 4	4	4
Condition	No. of HHs																	
	This week condition	Previous week condition																
Level 1	14	14																
Level 2	30	30																
Level 3	20	20																
Level 4	4	4

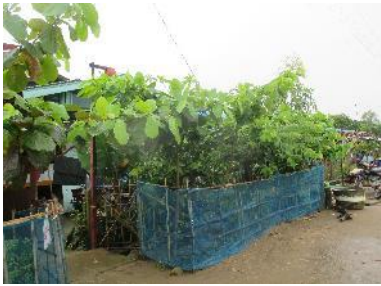
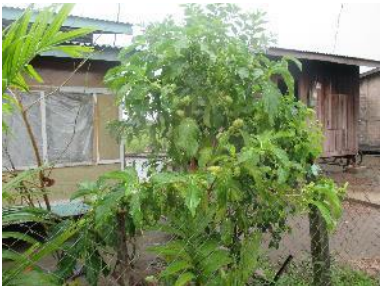
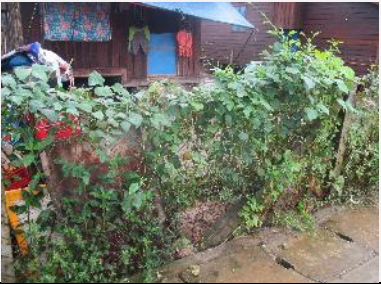
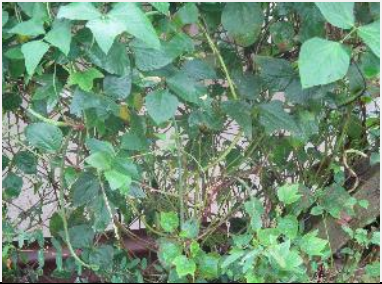
4	(2) Plantation	<p>Description</p> <p>-In front of their compounds, they planted shady trees, fruit trees, vegetables and floral plants.</p>

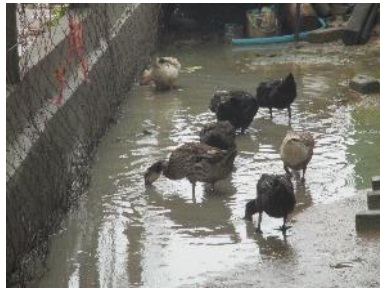
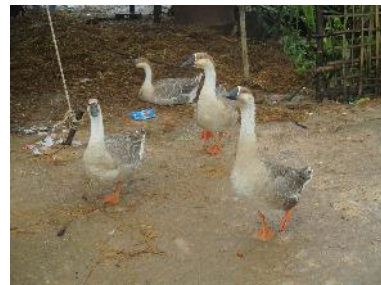
Photos

4	(3) Livestock	<p>Description</p> <p>-They are raising chicken, ducks, goats, pigs and cows.</p>
----------	---------------	--

-Even though they have cows, they do not keep their cows in relocation site instead they keep in their farms or other places.

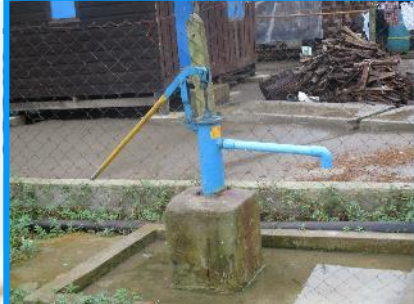
Water is clean and people nearby are using it for drinking and living use. A pulley wheel, bucket and a rope have been set up but the rope seems to be thin and it is better to be changed with thick one for the better use.

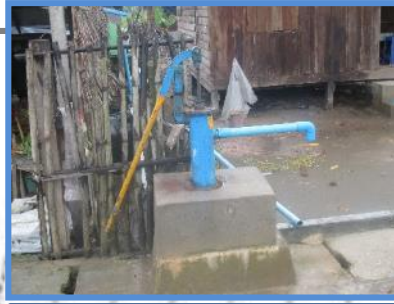
Water is not very clean with the rain and the well has to be repaired again after the raining season. A pulley wheel, bucket and a rope have set already but the rope seems to be thin and it is better to change with a thick one for the better use.

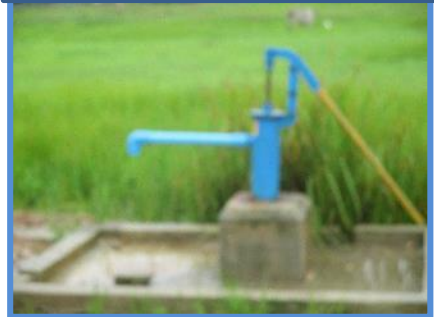
This hand pump is also functioned very well. Water is clean and everyone nearby is using this hand pump. Now the raining season has started and the groundwater level is raising up and therefore the amount of water is enough to use.

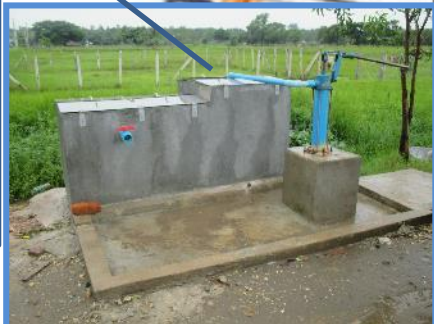
This hand pump is functioned very well. Water is clean and everyone living nearby is using this hand pump. Moreover water filter tank for remove the smell of iron has been set up beside the hand pump. There is no smell of iron and people enjoy water for drinking and living use.
