Weekly Field Report

No. 37

Date Visited: 16.7.2015

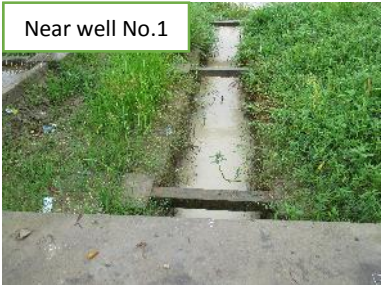
<p>Near well No.1</p> </div> <div style="text-align: center;">

(2). <u>Drainage</u>	Improved <input type="checkbox"/> Same <input checked="" type="checkbox"/> * Worse <input type="checkbox"/> <i>*as last week</i>	<u>Description</u> -Water level in the drainage canals is about the same level as last week because there was small amount of rain almost the whole day. The stream along the drainage canal needs to be rehabilitated in next summer. <u>Photos</u> <div style="display: flex; flex-wrap: wrap; justify-content: space-around;"> <div style="text-align: center;">

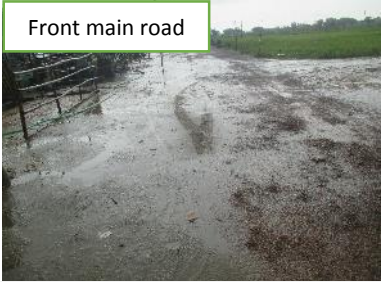
<p>(3). Road</p>	<p>Improved <input type="checkbox"/> Same <input checked="" type="checkbox"/>* Worse <input type="checkbox"/> <i>*as last week</i></p>	<p><u>Description</u> -The roads are being wet a bit and muddy in some areas but no problem for walking.</p> <p><u>Photos</u></p> <div style="display: flex; flex-wrap: wrap;"> <div style="width: 50%; text-align: center;"> <p>Front main road</p>

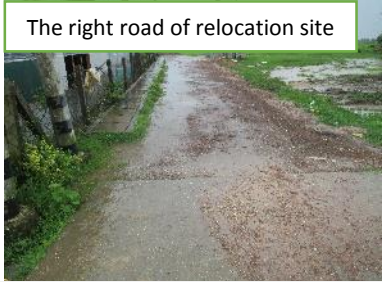
</div> <div style="width: 50%; text-align: center;"> <p>The right road of relocation site</p>

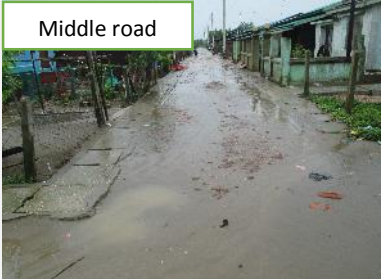
</div> <div style="width: 50%; text-align: center;"> <p>Middle road</p>

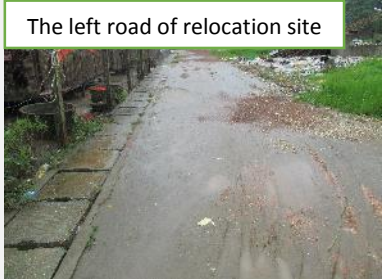
</div> <div style="width: 50%; text-align: center;"> <p>The left road of relocation site</p>

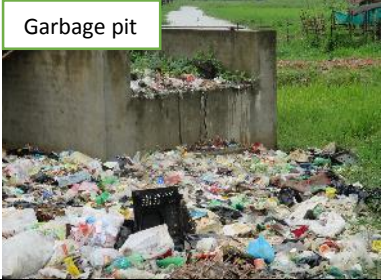
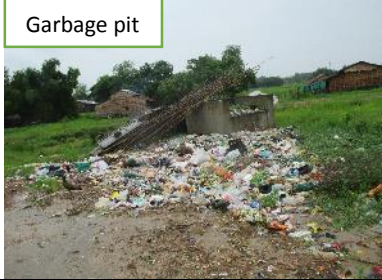
<p>(4). Garbage Condition</p>	<p>Improved <input type="checkbox"/> Same <input checked="" type="checkbox"/>* Worse <input type="checkbox"/></p>	<p><u>Description</u> -Garbage pit is used by people. -Garbage pit is over full and it needs to be cleaned up. -There are some smells from garbage pit. -People throw garbage at the backside of Third Row.</p> <div style="display: flex;"> <div style="width: 50%; text-align: center;"> <p>Garbage pit</p>

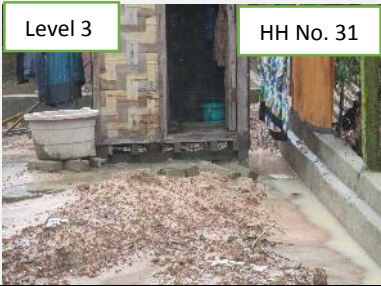
<div style="display: flex; justify-content: space-around;"> <div style="text-align: center;"> <p>Level 3</p>

<p>No 1</p>	<p>Item (5). Fly proof toilet</p>	<p>Condition Improved <input type="checkbox"/> Same <input checked="" type="checkbox"/>* Worse <input type="checkbox"/> *as last week</p>	<p>Description -All of fly proof toilets are used by people.</p>

<p><Evaluation Criteria> Level 1 -No need to repair fly proof toilet -No/rarely toilet unavailable Level 2 -Need to repair fly proof toilet -Rarely toilet unavailable Level 3 -Need to repair fly proof toilet -Often toilet unavailable -As the result of filling the soil and also raining, some toilets are inconvenience to use. Level 4 -Need to repair urgently fly proof toilet -Often toilet unavailable -After filling the soil, some toilets need to be lifted up. (Remark: The toilet picture of level 4 has changed due to bamboo type and concrete type.)</p> <div style="display: flex; justify-content: space-around;"> <div data-bbox="609 1551 987 1835"> <p>Level 1 HH No. 6</p> </div> <div data-bbox="1019 1551 1398 1835"> <p>Level 2 HH No. 12</p> </div> </div>	Condition	No. of HHs		This week condition	Previous week condition	Level 1	6	6	Level 2	18	18	Level 3	29	29	Level 4	13	13	No Toilet	2	2
Condition	No. of HHs																						
	This week condition	Previous week condition																					
Level 1	6	6																					
Level 2	18	18																					
Level 3	29	29																					
Level 4	13	13																					
No Toilet	2	2

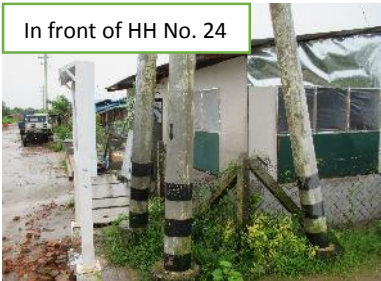
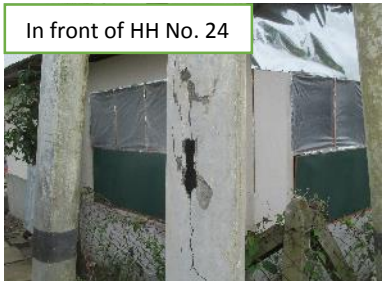
(6). Electricity	Improved <input type="checkbox"/> Same <input checked="" type="checkbox"/> * Worse <input type="checkbox"/> <i>*as last week</i>	<u>Description</u> -Electricity comes regularly. -Electric poles and transformer are supported in good foundation. -But, there is a hole at an electric pole which was hit by a truck car. The electric pole needs to be renovated. <u>Photos</u>	<div style="display: flex; justify-content: space-around;"> <div style="text-align: center;"> <p>In front of HH No. 24</p>

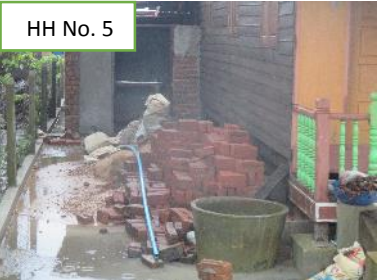
</div>
No	Item	Condition	Description and Photos
2	House Construct- ion	No. of houses not completed (2)	<u>Description</u> -Renovation of HH No.1 is finished. -HH No.5, the construction for kitchen, toilet and water tank seems to be started again. <div style="text-align: center; margin-top: 10px;"> <p>HH No. 5</p>

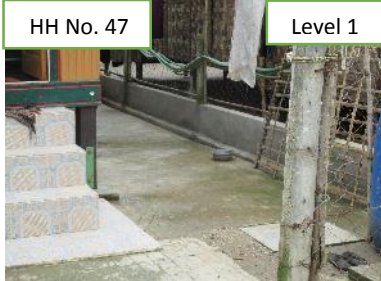
<p>HH No. 47 Level 1</p> </div> <div style="text-align: center;">

Condition	No. of HHs		This week condition	Previous week condition	Level 1	14	14	Level 2	30	30	Level 3	20	20	Level 4	4	4
Condition	No. of HHs																	
	This week condition	Previous week condition																
Level 1	14	14																
Level 2	30	30																
Level 3	20	20																
Level 4	4	4																
	<p><Evaluation Criteria></p> <p>Level 1 -No mud and no standing water with their own drainage system in their compound</p> <p>Level 2 -No mud and no standing water in their compound</p> <p>Level 3 - Some or little mud and standing water in their compound</p> <p>Level 4 -A lot of mud and standing water in their compound</p> <p><u>Photos</u></p>																	
	<div style="display: flex; justify-content: space-around;"> <div style="text-align: center;">

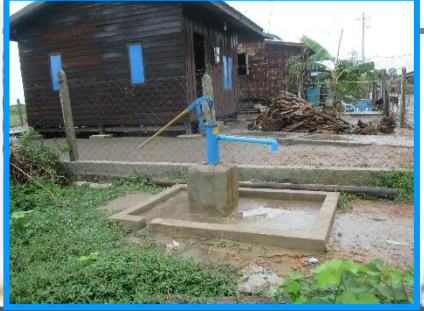
Water is clean and people nearby are using it for drinking and living use. A pulley wheel, bucket and a rope have been set up but the rope seems to be thin and it is better to be changed with thick one for the better use.

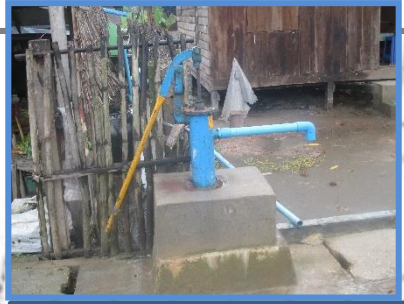
Water is not very clean with the rain and the well has to be repaired again after the raining season. A pulley wheel, bucket and a rope have set already but the rope seems to be thin and it is better to change with a thick one for the better use.

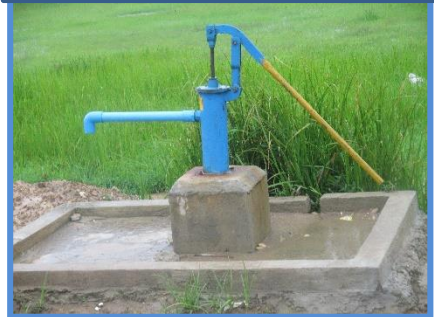
This hand pump is being also functioned very well. Water is clean and everyone living nearby is using this hand pump. Now the raining season has started and the groundwater level is raising up and therefore the amount of water is enough to use.

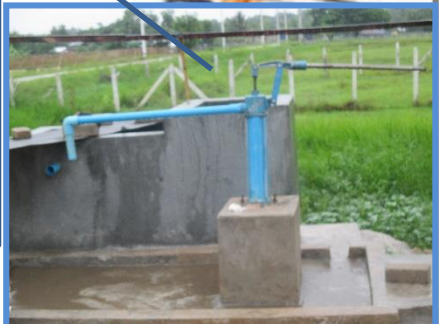
This hand pump is functioned very well. Water is clean and everyone living nearby is using this hand pump. Moreover water filter tank for remove the smell of iron has been set up beside the hand pump. There is no smell of iron and people enjoy water for drinking and living use.
