Weekly Field Report

No. 10

Surveyor: Sithu Nyein

Date Visited: 21.10.2014

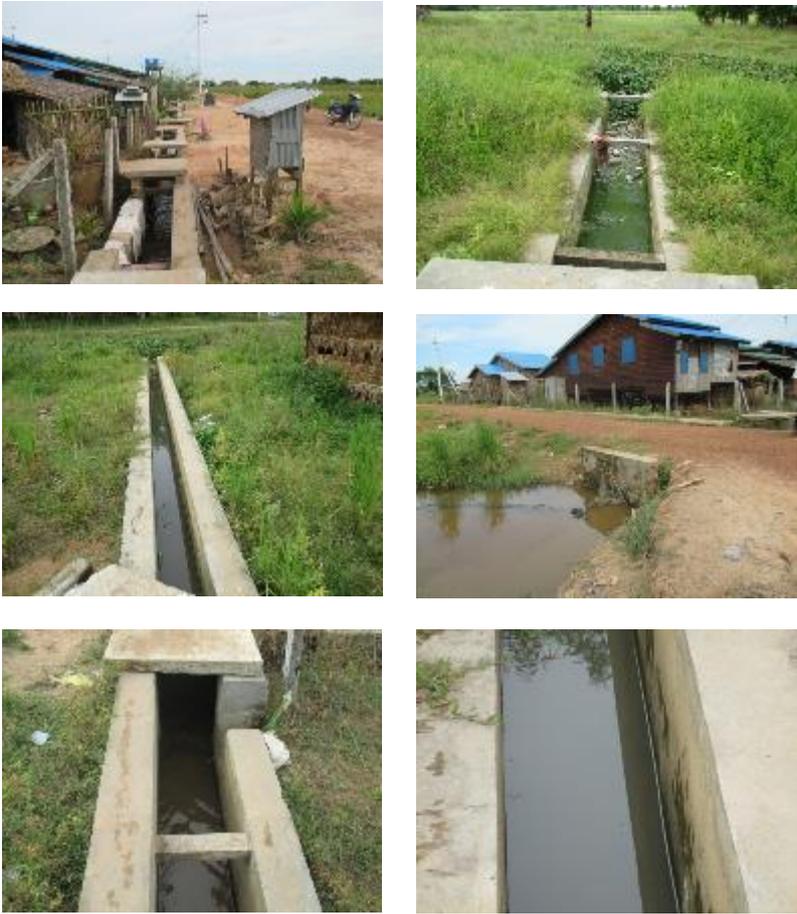
No	Item	Condition	Description and Photos
1	Condition of -		
	(1). Well	Improved <input type="checkbox"/> Same <input type="checkbox"/> Worse <input checked="" type="checkbox"/>	Description & Photos: -See ANNEX.1 -Hand Pump of Well No. 6, 9 and 11 are needed to repair.
	(2). Drainage	Improved <input type="checkbox"/> Same <input checked="" type="checkbox"/> Worse <input type="checkbox"/> <i>*as last week</i>	<p><u>Description</u></p> <p>-Water level in the drainage canal is near to the bottom.</p> <p><u>Photos</u></p>

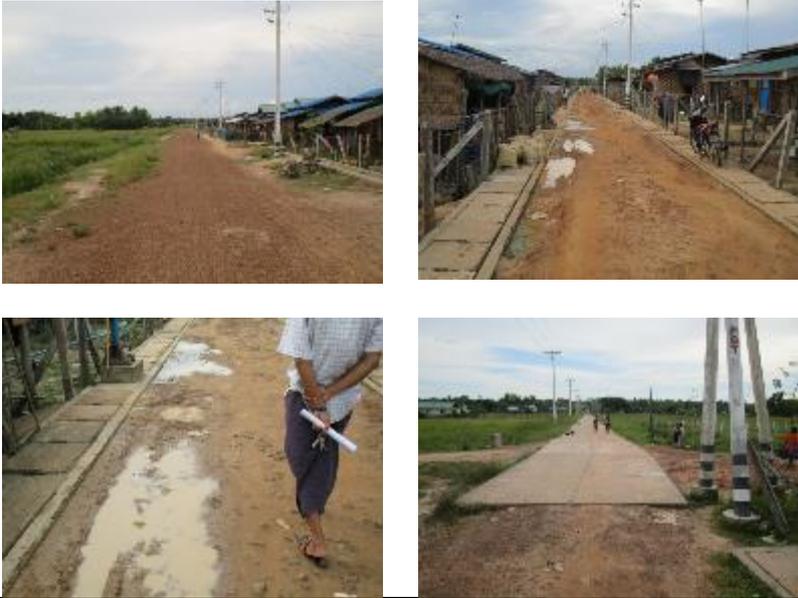
(3). Road	Improved <input type="checkbox"/> Same <input checked="" type="checkbox"/> * Worse <input type="checkbox"/> <i>*as last week</i>	<p><u>Description</u></p> <p>-There are some puddles and partly muddy area but the roads are almost dry and no problem for traffic as a whole.</p>

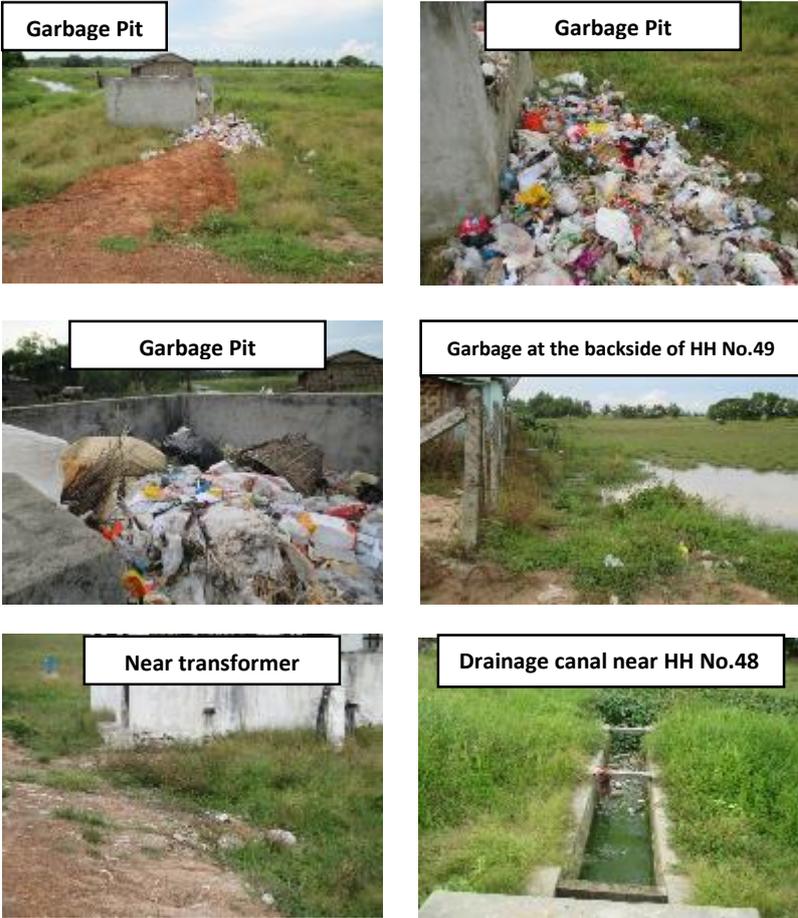
(4). Garbage Condition		<p>Improved <input type="checkbox"/></p> <p>Same <input type="checkbox"/></p> <p>Worse <input checked="" type="checkbox"/></p>	<p><u>Description</u></p> <ul style="list-style-type: none"> -Garbage pit is used by people. -Smells are emerging from garbage pit. -Garbage pit is overfull.

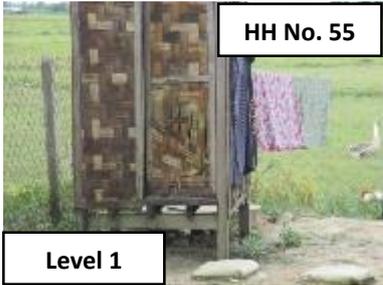
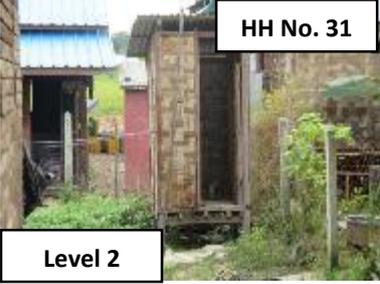
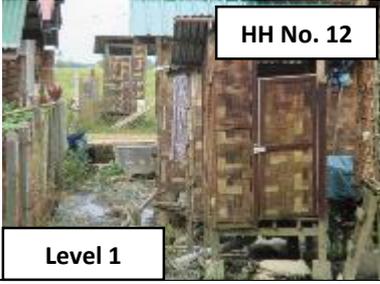
No	Item	Condition	Description and Photos																				
1	(5). Fly proof toilet	Improved <input type="checkbox"/> Same <input checked="" type="checkbox"/> Worse <input type="checkbox"/> <i>*as last week</i>	<p><u>Description</u> -All of fly proof toilets are being used by people.</p>

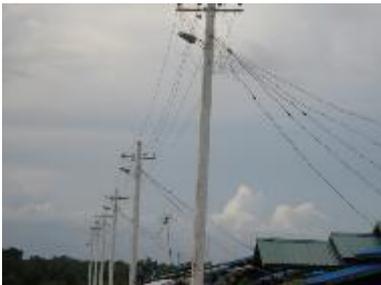
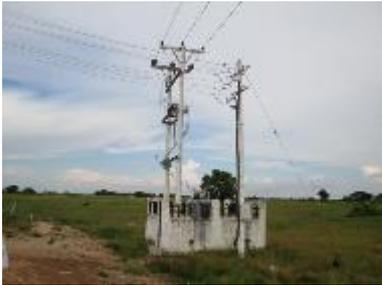
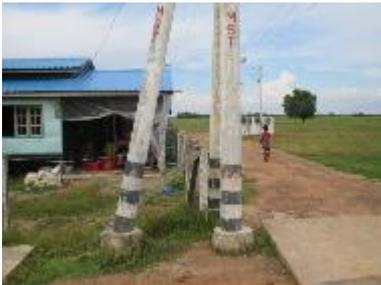
Condition	No. of HHs		This week condition	Previous week condition	Level 1	42	42	Level 2	21	21	Level 3	0	0	Level 4	0	0	No Toilet	5	5
Condition	No. of HHs																						
	This week condition	Previous week condition																					
Level 1	42	42																					
Level 2	21	21																					
Level 3	0	0																					
Level 4	0	0																					
No Toilet	5	5																					
	(6). Electricity	Improved <input type="checkbox"/> Same <input checked="" type="checkbox"/> * Worse <input type="checkbox"/> <i>*as last week</i>	<p><u>Description</u> -Electricity is coming regularly -Electric poles and transformer are supported in good foundation.</p> <p><u>Photos</u></p>

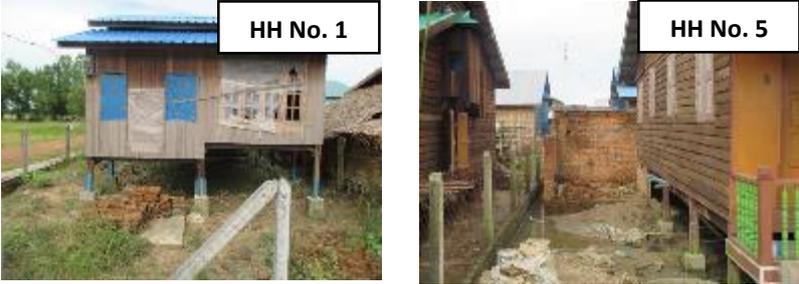
No	Item	Condition	Description and Photos																	
2	House Construction	No. of houses not completed (2)	<p><u>Description</u> -HH No.1 doesn't have ladder and nobody is living -In HH No.5, the construction for kitchen, toilet and water tank seems stopped. Nobody lives.</p> <p><u>Photos</u></p>

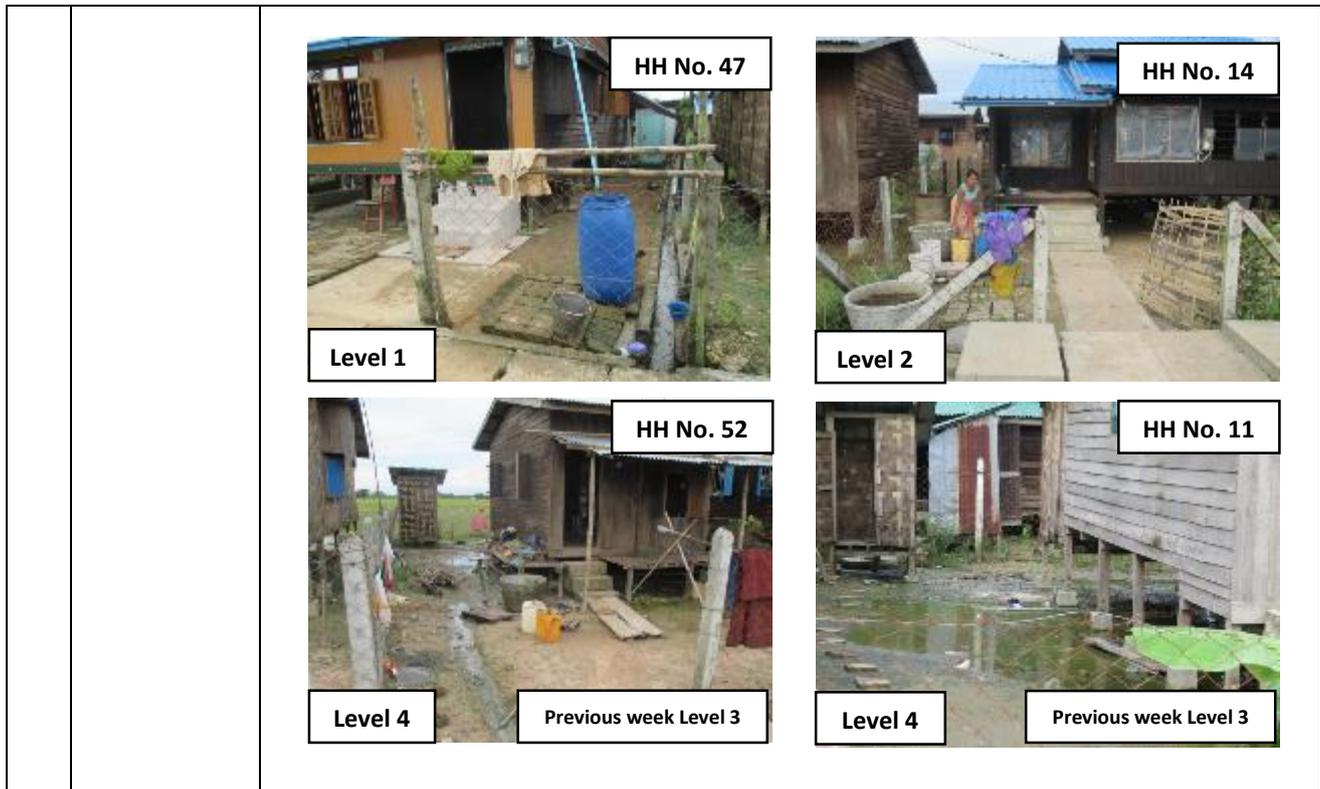
3	Living Status of PAPs (Sold house, renting, etc.)	<p><u>Description</u> (1) House ownership (1)-1 No. of house that are owned by PAPs (49) (1)-2 No. of house that were sold (19) (2) Living condition (2)-1 No. of houses where PAPs live (38) (2)-2 No. of houses where not original PAPs lives (27) (2)-3 No. of houses where nobody lives (3) Yellow= Changes from previous week</p>	<p>Location Map: See ANNEX.2</p>																	
4	Other issues																			
	(1). Drainage condition for rain water in their compounds	<p><u>Description</u> -Because of heavy rain, there are puddles and muddy area in some compounds.</p>

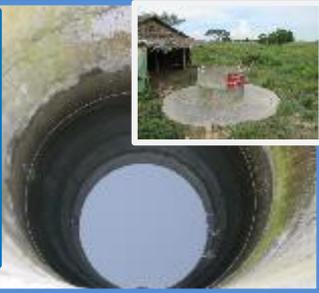
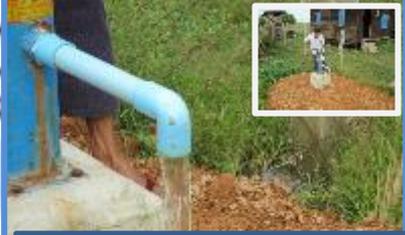
Water is clean and has no sand, no clay and no smell. People are using this well for cooking and washing. Sometimes they are drinking

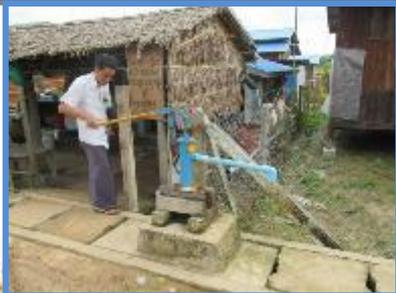
Hand pump is functioned. Water is clean and has no sand, no clay but it has smell of mud. People are using this well for washing.

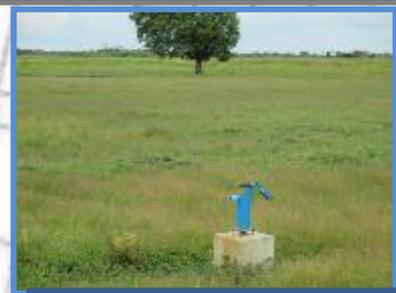
Hand pump isn't functioned very well. The washer needs to be repaired. A lot of water needs to be poured every time before pumping. People are using this well for washing.

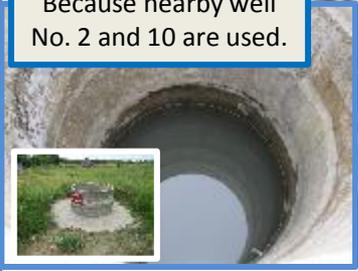
Hand pump isn't functioned.

The color of water likes gray and has no sand, no clay and no smell. People are not using this well. Because nearby well No. 2 and 10 are used.

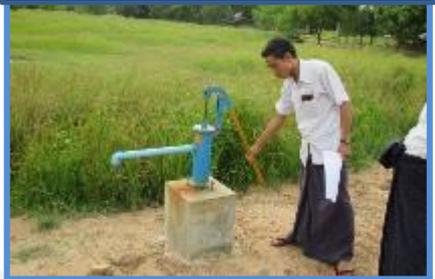
Hand pump isn't functioned very well. The washer needs to be repaired. Water needs to be poured every time before pumping. People are using this well for washing.

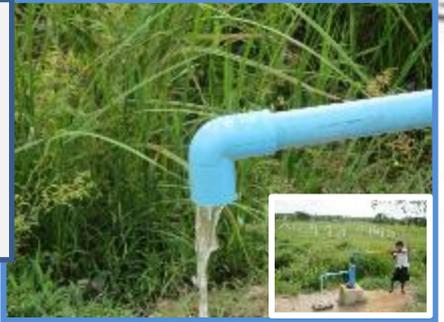
Hand pump is functioned. Water is clean and has no sand, no clay, and no smell. People are using this well for cooking and washing. Sometimes they are drinking.
